McKechnie Aluminium Solutions Limited
Monitoring Programme
Annual Report
2013-2014

Technical Report 2014-68

February 2015

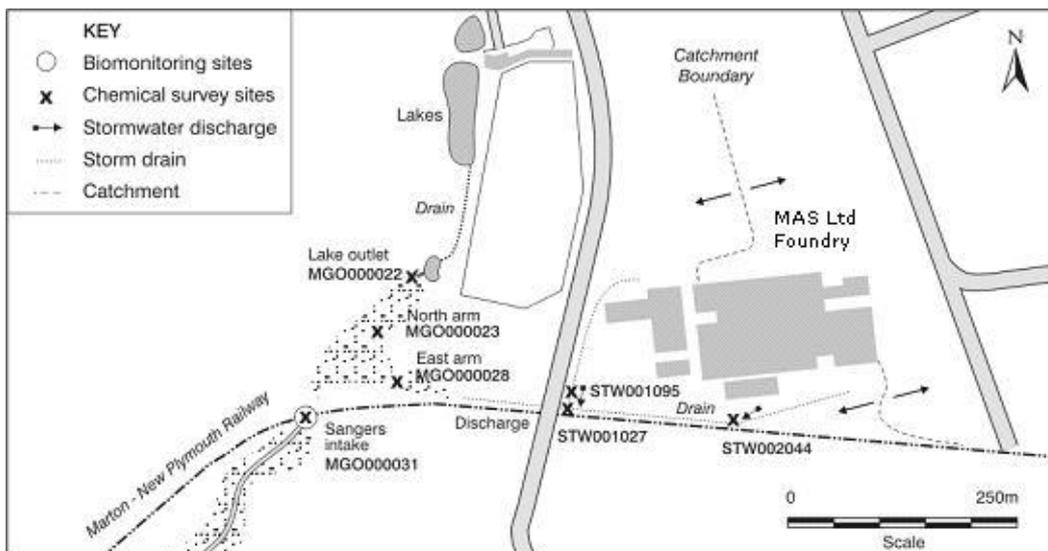
Figure 1 MASL foundry site, showing the boundary between Mangaone and Mangati stream catchments and water monitoring sites

The MASL manufacturing plant extends across the boundary between two stormwater catchments (Figure 1). Drainage from the western side (3.9 hectares) is to the eastern headwaters of the Mangaone Stream, about four kilometres from where the stream enters the Waiwhakaiho River. Drainage from the eastern side (4.9 hectares) is to the Mangati Stream. There are separate consents for stormwater discharges to the two catchments. This report relates to the western stormwater discharge. The eastern stormwater discharge, consent 3139, is monitored under the Mangati Stream Catchment Monitoring Programme.

Approximately 40% of the site draining to the Mangaone catchment is planted, 16% roofed, 41% tar seal or concrete, and 3% bare gravel.

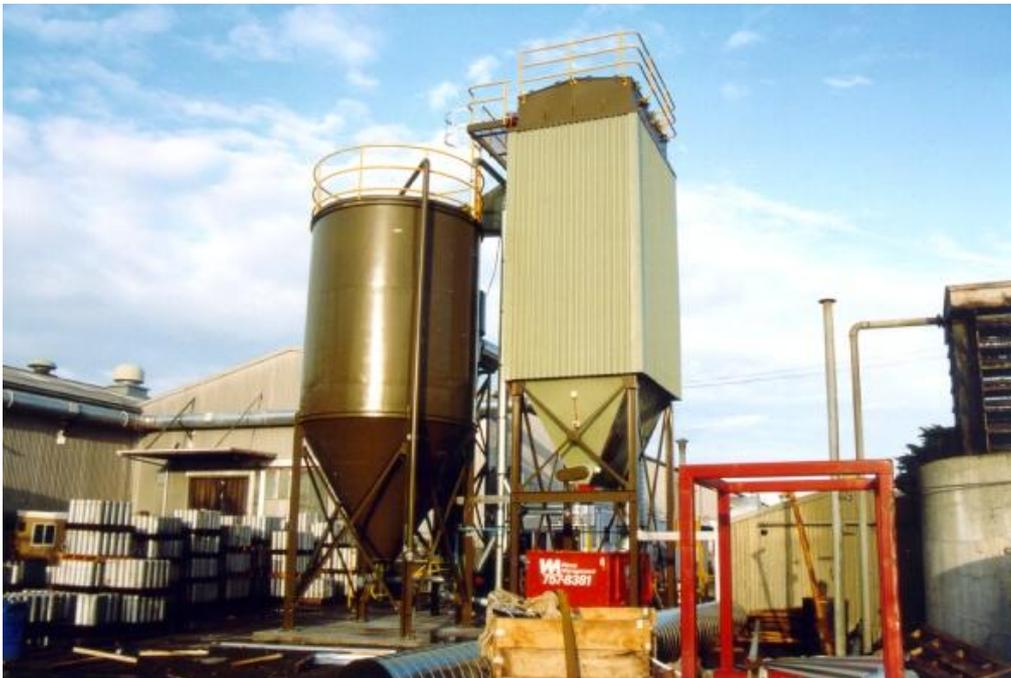
Photo 1 MASL Baghouse

The Company receives clean in-house production and purchased scrap aluminum extrusions and ingots for re-melting and casting into extrusion log. A small amount of fumeless cleaning flux is used during the melting process. Small additions of silicon and magnesium are made to the aluminum in the gas fired furnace after it is melted for alloying purposes. The furnace burners are turned to low during dross removal, which combined with the fumeless flux, means that there are no emissions generated. No toxic metals are used during the melting process.

Before the aluminum is cast, further fumeless cleaning flux is used, along with casting table and launder coating applications. Continuous lubricant is injected into molds during the casting process.

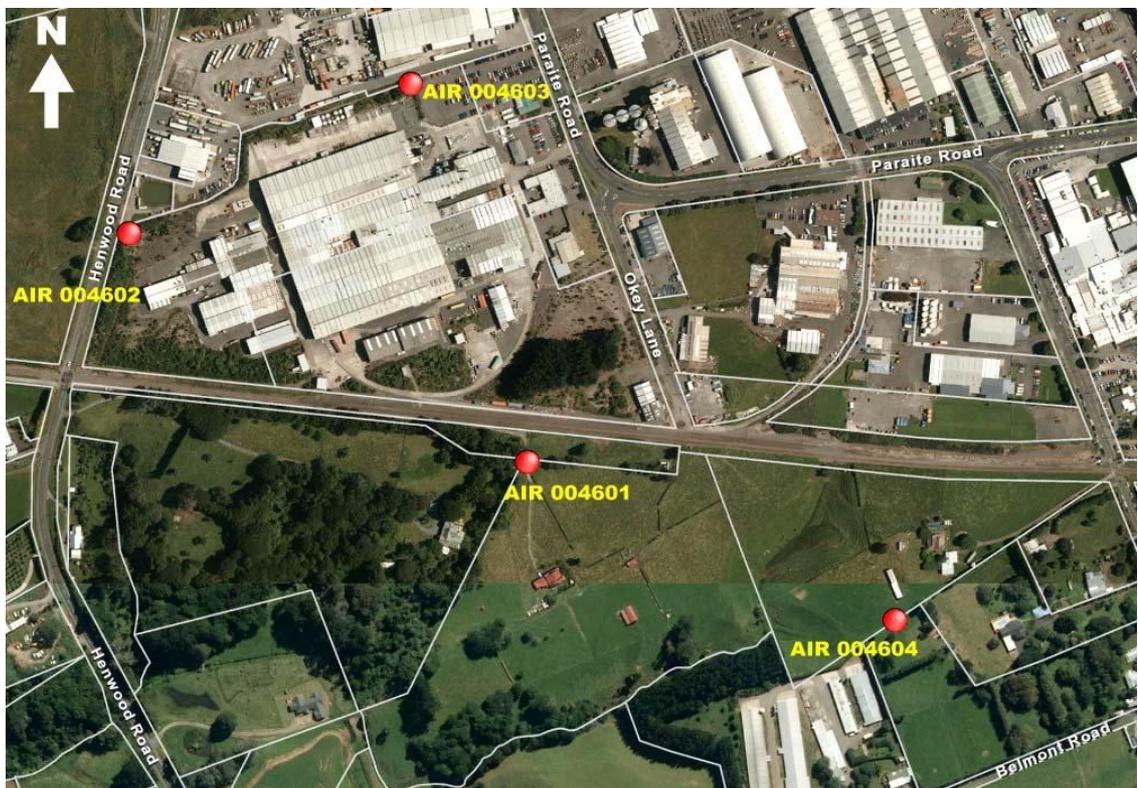
Figure 3 Locations of dust deposition monitoring sites in relation to the MASL site.

In the 2013-2014 period, gauges were deployed on one occasion at four locations in the vicinity of the foundry site for a period of 21 days. The locations of the monitoring sites around the foundry are shown in Figure 3 above.

The highest dissolved copper result was found at site AIR004604 which is the farthest site from the plant. This would suggest that the source of the copper was from the vicinity of the gauge rather than the MASL site.

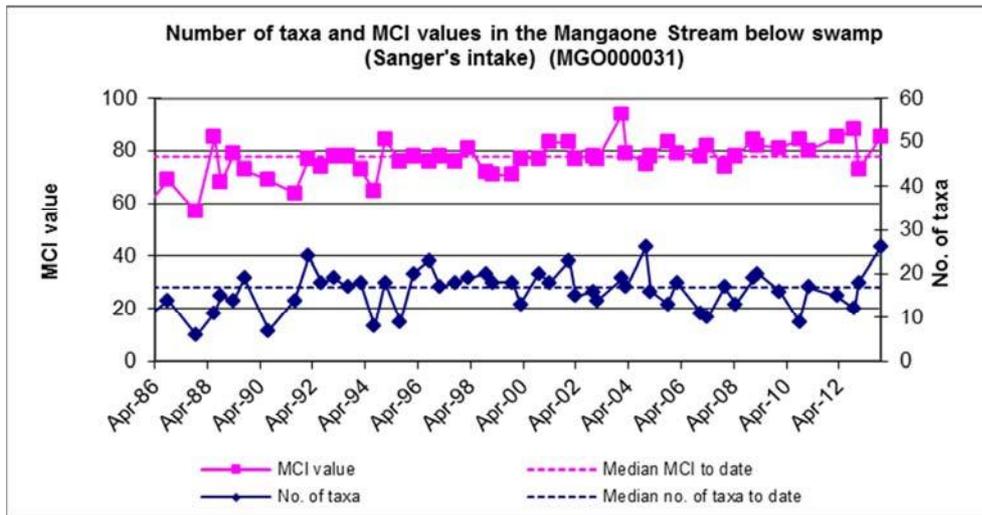
Figure 2 Taxa numbers and MCI scores recorded to date at site 3

The moderate proportion of 'tolerant' taxa in the community (50% of richness) was reflected in the MCI score of 85 units which was eight units higher than the median of previously recorded scores, a statistically insignificant difference (Table 2 and Figure 2), and a score typical of weedy habitats that are in good condition. MCI scores have consistently been near to or above the median since 2000, and the current result follows this pattern. It also indicates that the result from the last survey was a one-off (Figure 2). The SQMCI_s score of 4.5 was also typical of weedy habitats, and slightly higher than the long term median for this site due principally to the numerical dominance of two 'moderately sensitive' amphipod taxa.

Overall, this indicates that the community was in average to above average condition, and there is no indication that the stormwater discharge from the MASL site had had any impact on this community.

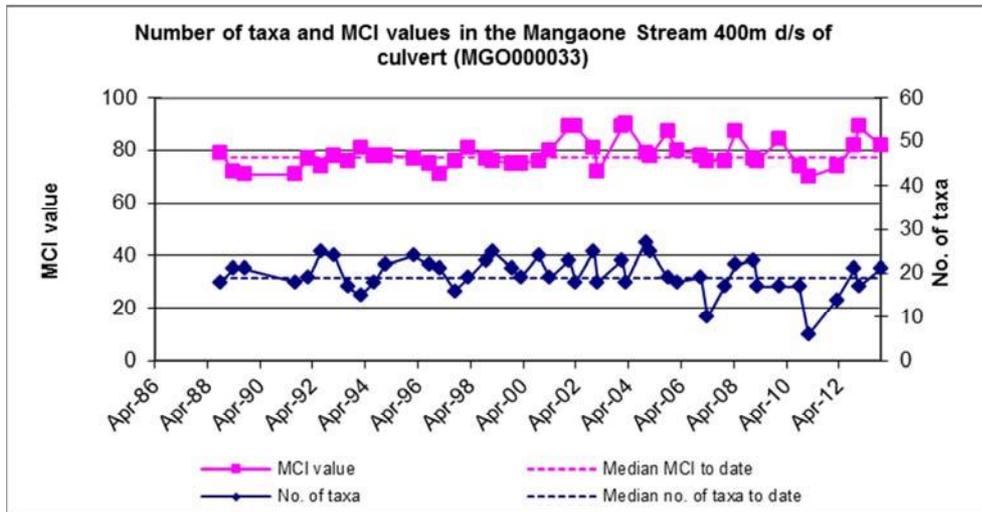
Figure 3 Taxa numbers and MCI scores recorded to date at site 4

Community richness at site 4 (21 taxa) was two taxa higher than the median richness found by all previous surveys (Table 2, Figure 3) and slightly less than that recorded upstream in the current survey.

The absence of impacts from the MASL stormwater discharge was also recorded at site 4, with the MCI score (82) being five units higher than the median, reflecting the similar proportion of 'tolerant' taxa present (48% of richness) in the community. The variability in numbers of taxa recorded at sites 3 and 4 in the Mangaone tributary to date is illustrated in Figure 4.

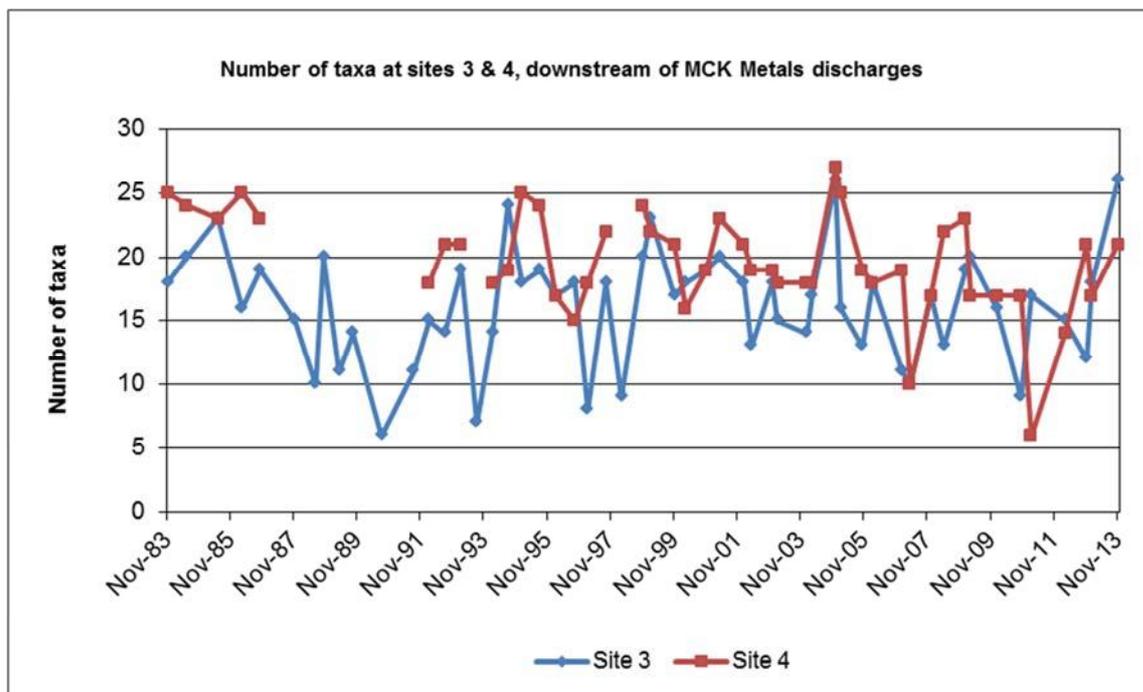
Figure 4 Number of taxa at sites 3 and 4 in an unnamed tributary of the Mangaone Stream in relation to discharges from MASL

Macroinvertebrate communities at site 3 (closer to the swampy headwaters and MASL stormwater discharge) have generally contained lower numbers of taxa than the communities at site 4 (see medians and ranges in Table 2), although this result was not repeated in the current survey. The lower numbers of taxa at site 3 may be explained by the close proximity of this site to the upstream swamp. The swampy habitat may not be a significant source of colonisation of stream invertebrates by means of downstream drift. In the current survey, community richness at site 3 was nine taxa more, and at site 4 two taxa more, than their respective historical median values.

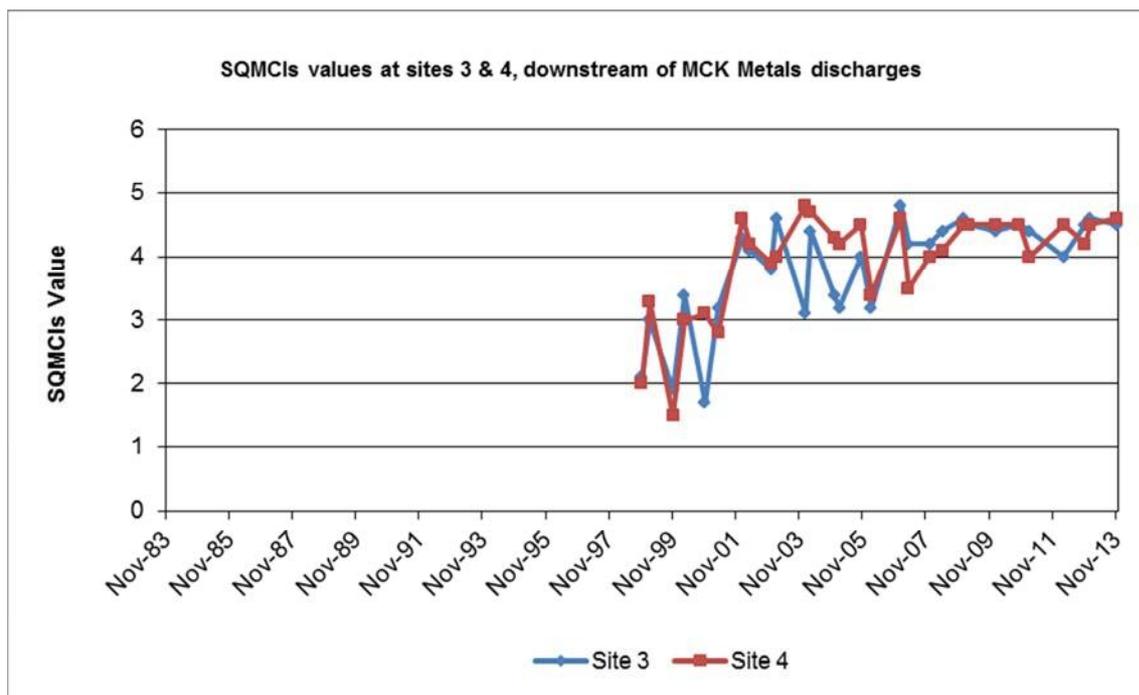
Figure 5 SQMCI₅ values at sites 3 and 4 in an unnamed tributary of the Mangaone Stream in relation to discharges from MASL Ltd

SQMCI_s values from both sites have generally varied between 4 and 5 units (particularly at site 4) in more recent surveys and this trend has continued in this survey. Slow-flowing, muddy-bedded and weedy stream macroinvertebrate communities most commonly produce SQMCI_s values in the range of 2 to 4 units. The abundances of 'moderately sensitive' taxa (eg amphipods) in this weedy stream increased these values toward the upper range found in most streams of this type. The recent increased abundances of such 'moderately sensitive' taxa suggest that water quality or habitat quality may have improved slightly during the past seven years (Figure 5), particularly at site 3.

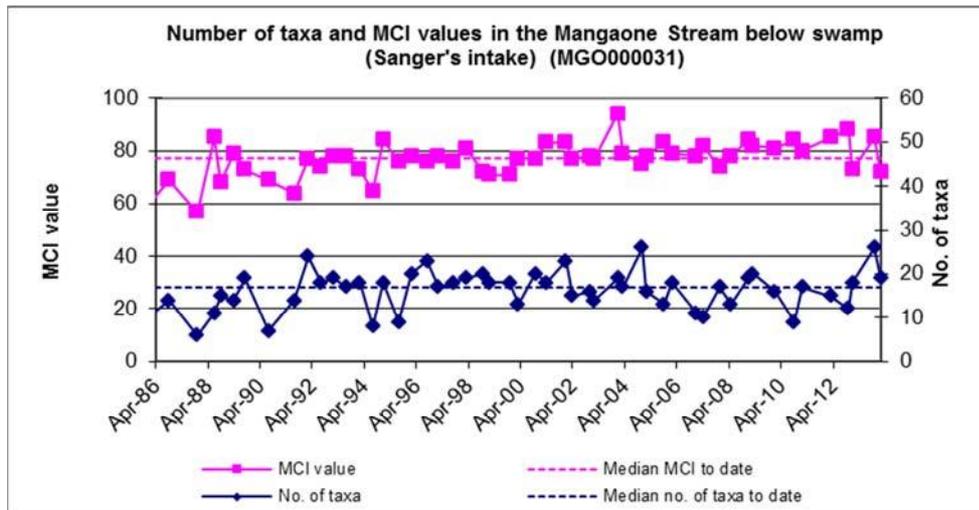
Figure 2 Taxa numbers and MCI scores recorded to date at site 3

The moderate high proportion of 'tolerant' taxa in the community (68% of richness) was reflected in the MCI score of 72 units which was six units less than the median of previously recorded scores, a statistically insignificant difference (Table 2 and Figure 2), and a score typical of weedy habitats that are in good condition. MCI scores have consistently been near to or above the median since 2000, and the current result follows this pattern. It is similar to the score recorded in the previous spring survey, but a statistically significant reduction from that recorded in the spring 2013 survey (Figure 2). This indicates deterioration from the spring survey, but the SQMCI₅ score of 4.5 was equal to that recorded previously, and was also typical of weedy habitats, and slightly higher than the long term median for this site due principally to the numerical dominance of two 'moderately sensitive' amphipod taxa.

The change in MCI score is likely related to summer flow and habitat conditions, which are generally less favourable to 'sensitive' taxa, due to warmer waters and lower dissolved oxygen concentrations, especially in weedy streams. Overall, this indicates that the community was in average condition, and there is no indication that the stormwater discharge from the MASL site had had any impact on this community.

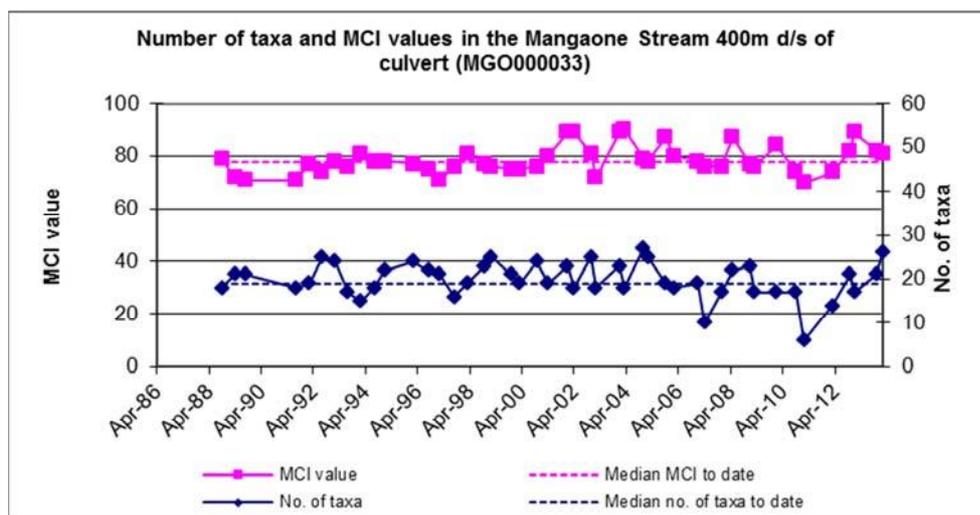
Figure 3 Taxa numbers and MCI scores recorded to date at site 4

Community richness at site 4 (26 taxa) was seven taxa higher than the median richness found by all previous surveys (Table 2, Figure 3), the second highest richness recorded at this site to date, and slightly less than that recorded upstream in the current survey.

The absence of impacts from the MASL stormwater discharge was also recorded at site 4, with the MCI score (81) being four units higher than the median, reflecting the reduced (when compared with site 3) proportion of ‘tolerant’ taxa present (50% of richness) in the community. The variability in numbers of taxa recorded at sites 3 and 4 in the Mangaone tributary to date is illustrated in Figure 4.

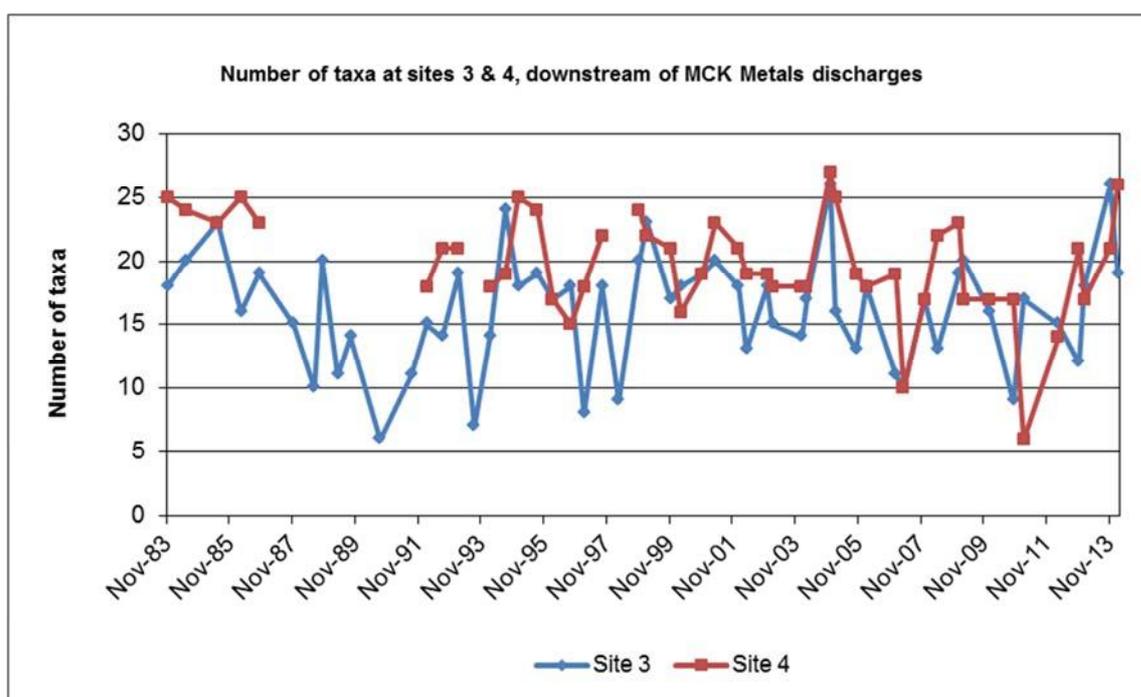
Figure 4 Number of taxa at sites 3 and 4 in an unnamed tributary of the Mangaone Stream in relation to discharges from MASL

Macroinvertebrate communities at site 3 (closer to the swampy headwaters and MASL stormwater discharge) have generally contained lower numbers of taxa than the communities at site 4 (see medians and ranges in Table 2), and this result was repeated in the current survey. The lower numbers of taxa at site 3 may be explained by the close proximity of this site to the upstream swamp. The swampy habitat may not be a significant source of colonisation of stream invertebrates by means of downstream drift. In the current survey, community richness at site 3 was two taxa more, and at site 4 five taxa more, than their respective historical median values.

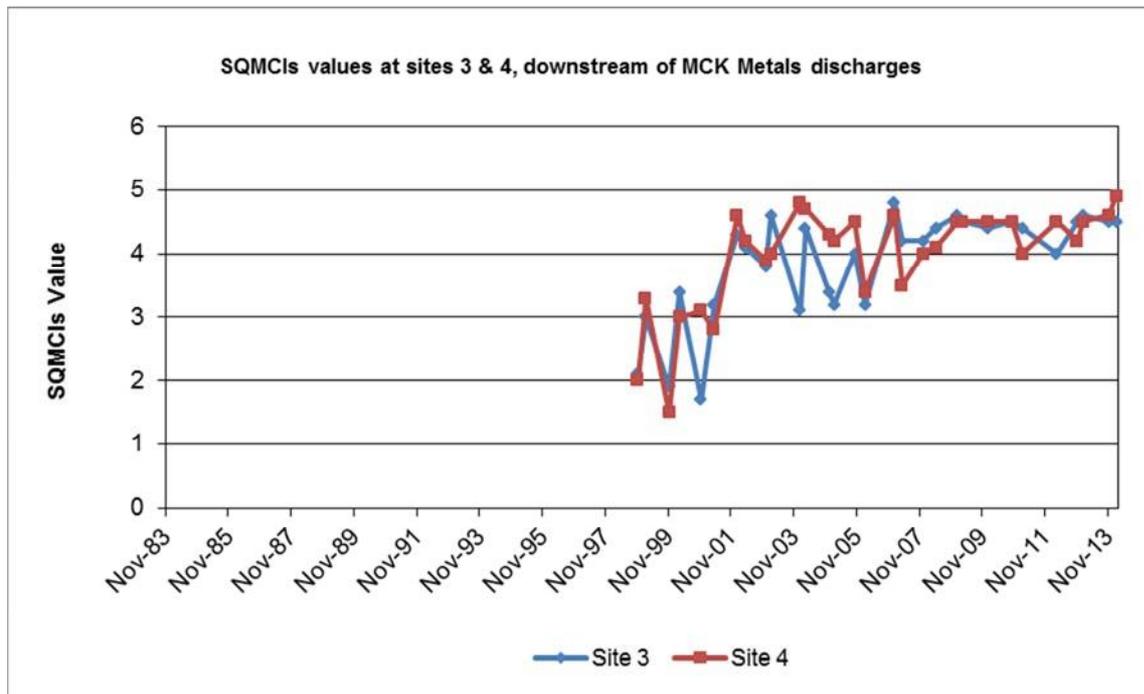
Figure 5 SQMCI₅ values at sites 3 and 4 in an unnamed tributary of the Mangaone Stream in relation to discharges from MASL

SQMCI₅ values from both sites have generally varied between 4 and 5 units (particularly at site 4) in more recent surveys and this trend has continued in this survey. Slow-flowing, muddy-bedded and weedy stream macroinvertebrate communities most commonly produce SQMCI₅ values in the range of 2 to 4 units. The abundances of 'moderately sensitive' taxa (eg amphipods) in this weedy stream increased these values toward the upper range found in most streams of this type. The recent increased abundances of such 'moderately sensitive' taxa suggest that water quality or habitat quality may have improved slightly during the past eight years (Figure 5), particularly at site 3.
