Pacific Natural Gut String Company Limited
Monitoring Programme
Annual Report
2015-2016

Technical Report 2016-105

August 2016

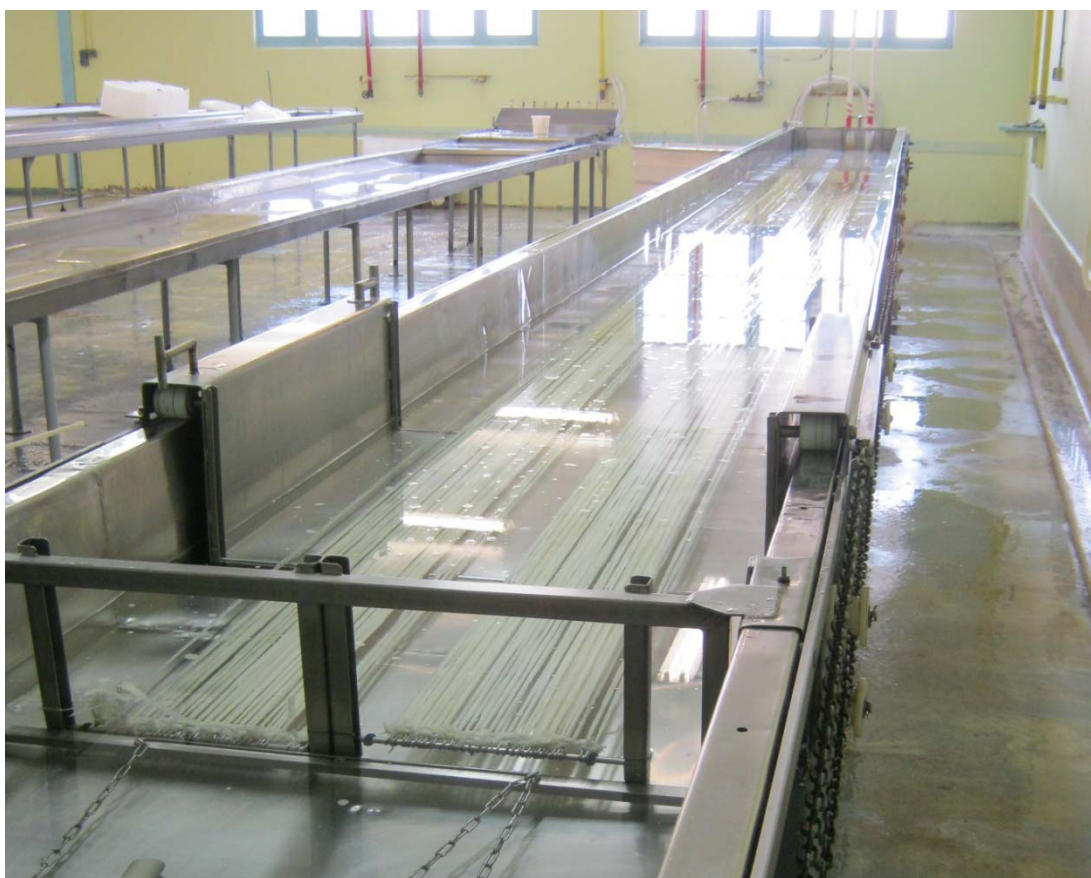
Photo 1 Factory operating in 2012

The Company began its operation in 1976, with processing activities at the factory consisting of the production of high quality natural gut strings for tennis, squash and badminton racquets (Photograph 1). The factory was once a dairy processing plant with an outfall discharging to the Tasman Sea via the cliff.

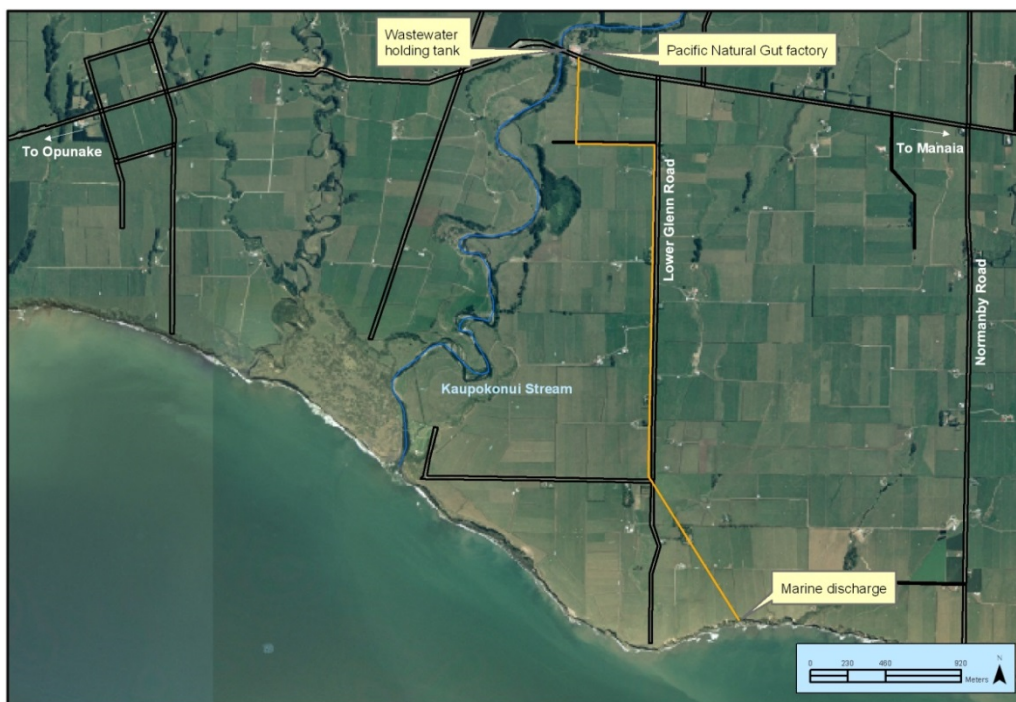
Figure 1 Location of the factory and marine outfall

Although the Company's operation is sited on the banks of the Kaupokonui River (Figure 1) it neither takes water from, nor discharges water to, this river.

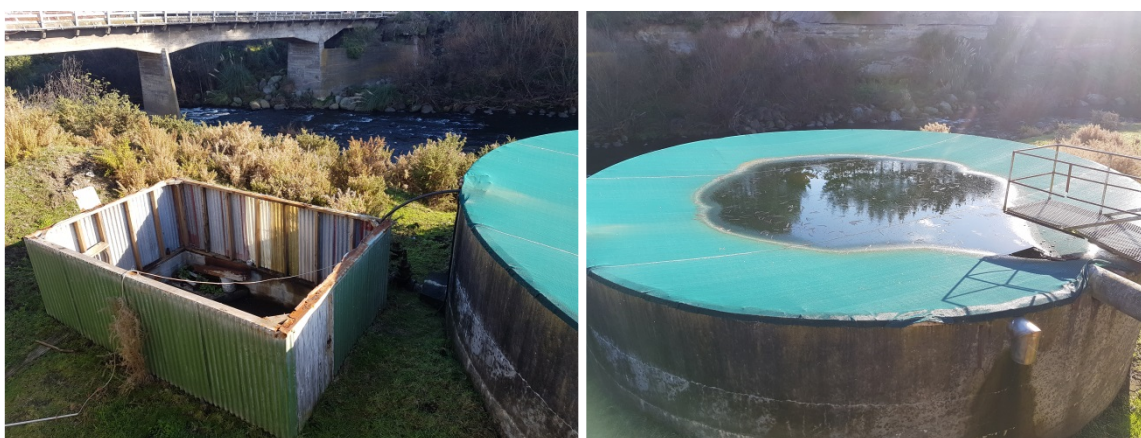
Photo 2 Left: Pump shed roof removed to access faulty pump. Right: Holding tank at capacity. 20 June 2016

At the time of the inspection, the holding tank had reached capacity and was discharging through the overflow pipe (Photo 2). A sample was collected from the surface of the holding tank.

The Company's contingency plan regarding wastewater disposal has been actioned since March 2016, as the effluent pump has been removed for repair (Photo 2). The plan states that site wastewater is to be removed from the holding tank by a vacuum truck and disposed of into the Company's sump on Lower Glenn Road. However, the holding tank had reached capacity at the time of the inspection on 20 June 2016. It was later discovered that the Company had not provided the local staff with the necessary payment for the removal service.

Although the factory has not been in operation for three years, the site has continued to be well managed by the local staff. The period under review was no exception. Any issues with chemical storage were promptly resolved, and up until the pump was removed, the stormwater in the holding tank was discharged appropriately. However, an issue was noted towards the end of the monitoring period regarding the emptying of the tank while the pump was out of commission. At the time of the last inspection the tank was at capacity and vacuum trucks could not be ordered. This was because the Company were yet to provide the local staff with the necessary payment for the service. This situation must be remedied to comply with the contingency plan. At the time of writing this report the local manager stated that it would not be long before the new pump was installed.
