Pacific Natural Gut String Company Limited
Monitoring Programme
Annual Report
2016-2017

Technical Report 2017-44

Taranaki Regional Council
Private Bag 713
STRATFORD
October 2017

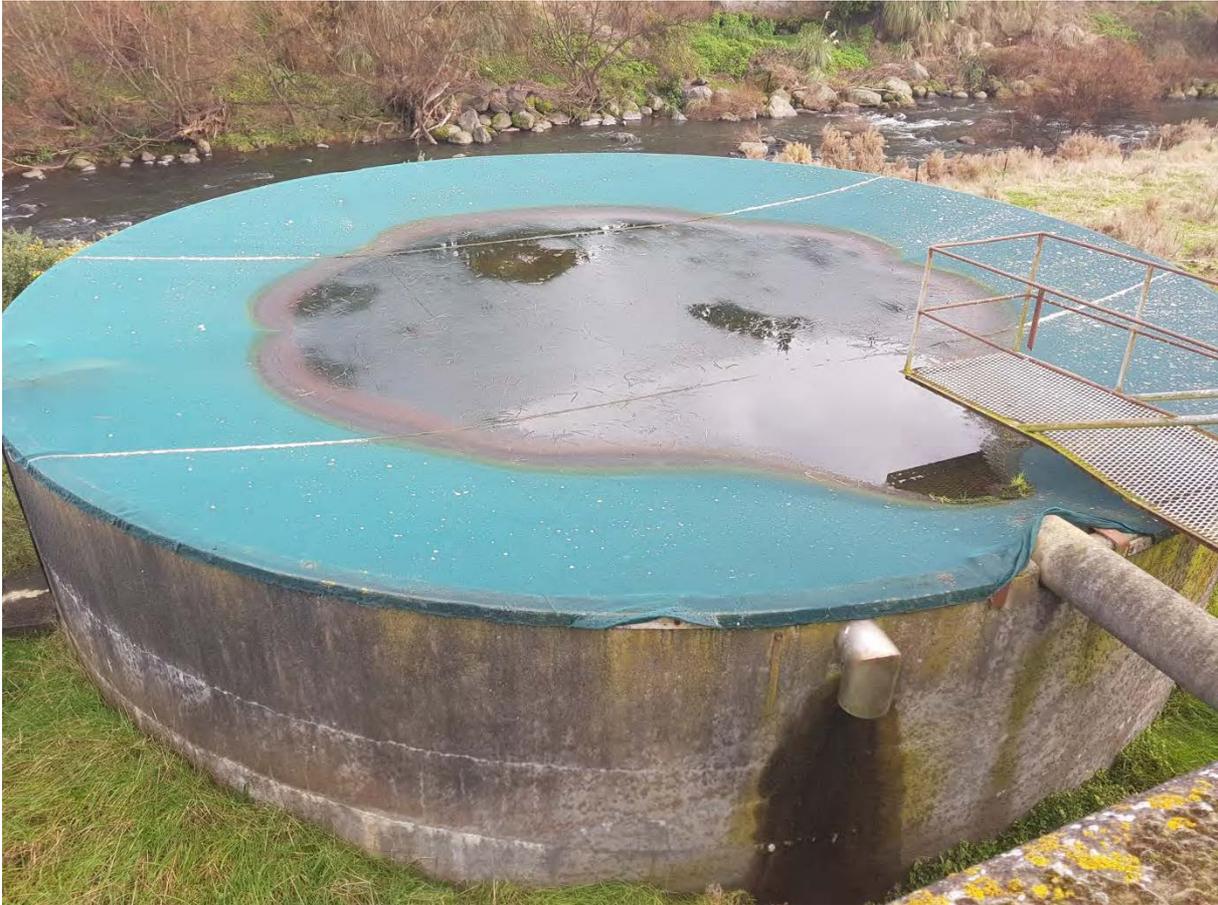
The holding tank appeared to be close to capacity at the time of the inspection. A previous employee of the Company informed Council staff that all excess stormwater in the holding tank continued to be discharged through the overflow pipe (Photo 2). A grab sample was not collected due to sample site inaccessibility.

Photo 2 Water visible at the discharge pipe from previous overflow events (16 June 2017)

The issue noted towards the end of the 2015-2016 monitoring year regarding the emptying of the holding tank while the pump was out of commission had not been resolved. The effluent pump, which was removed for repair in the previous monitoring year, had not yet been replaced due to the Company not providing local staff with the funds. Excess water in the holding tank was discharging from the overflow pipe rather than being removed by vacuum trucks and discharged appropriately, as per the contingency plan.
