Taranaki Galvanizers Ltd
Monitoring Programme
Annual Report
2017-2018

Technical Report 2018-17

Taranaki Regional Council
Private Bag 713
STRATFORD
October 2018

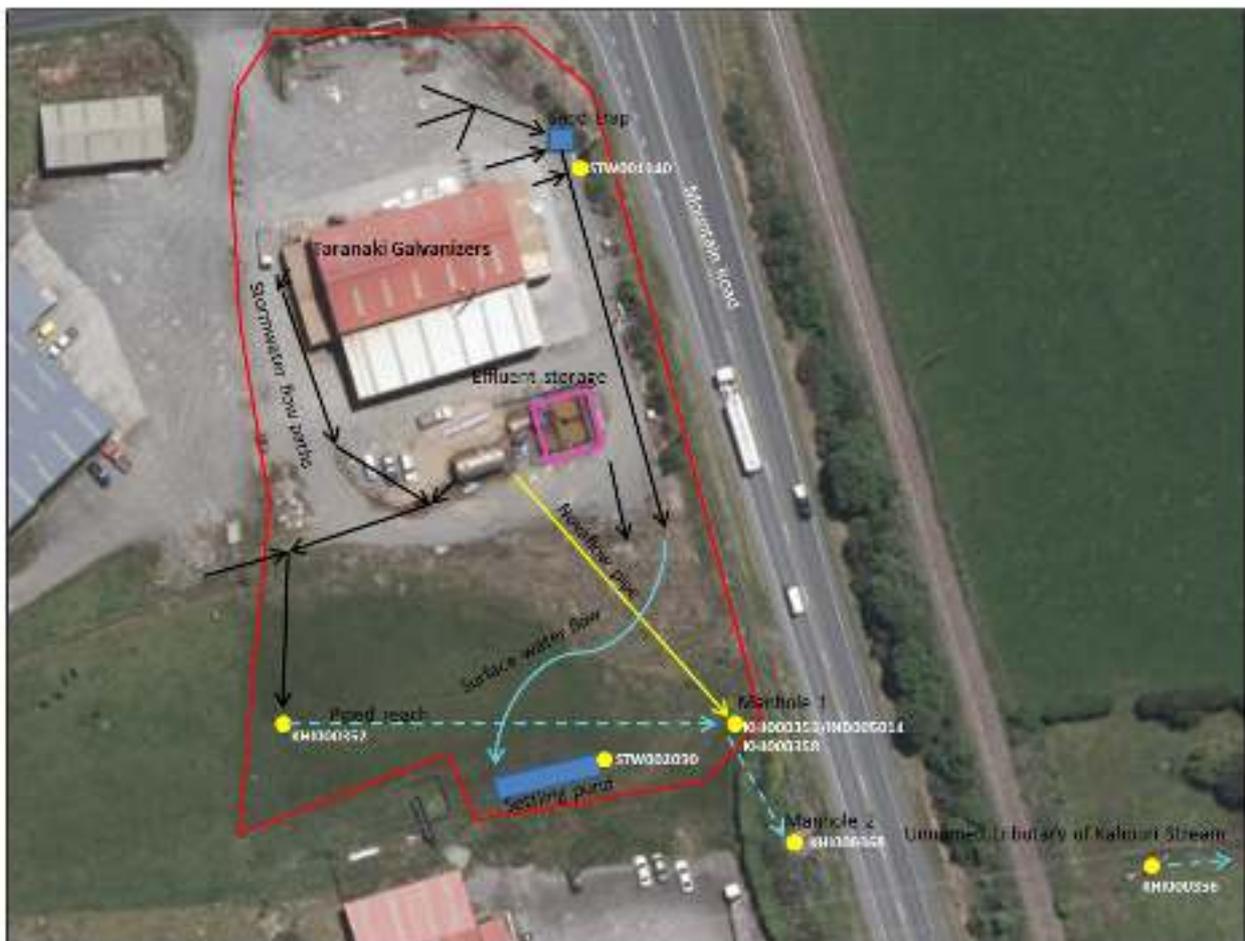
Figure 1 Taranaki Galvanizers site layout

Stormwater from the southern side of the site either flows overland to a grated manhole (manhole 1 in Figure 1) on the southeastern corner of the site or via a black nova flow pipe that then discharges into this same manhole. The industrial discharge novaflow pipe conveys both site stormwater and some groundwater seepage from the southern end of the site and is therefore referred to as an industrial discharge as opposed to only a stormwater discharge. The piped unnamed tributary enters manhole 1 immediately above the point of discharge from the industrial discharge novaflow pipe (Photo 1).

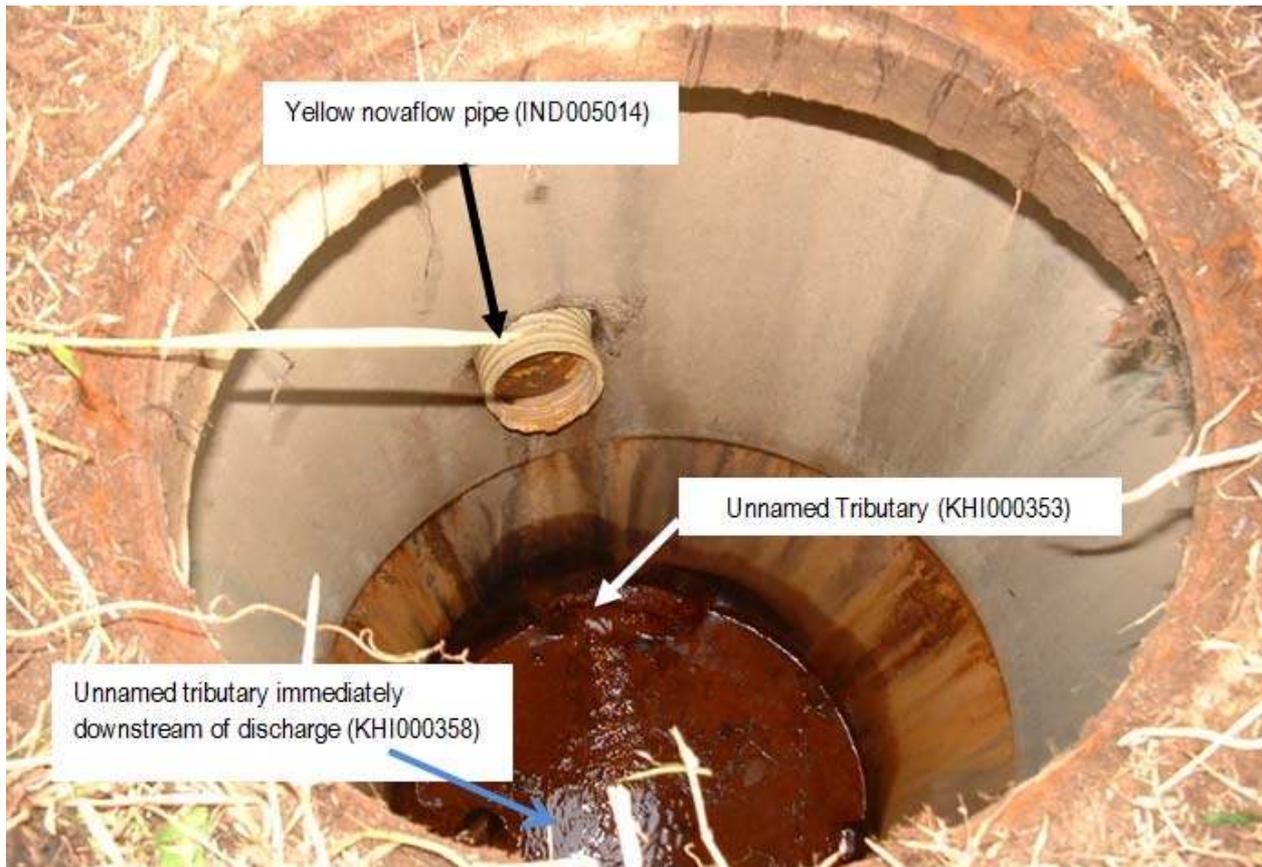
Photo 1 The view down manhole 1

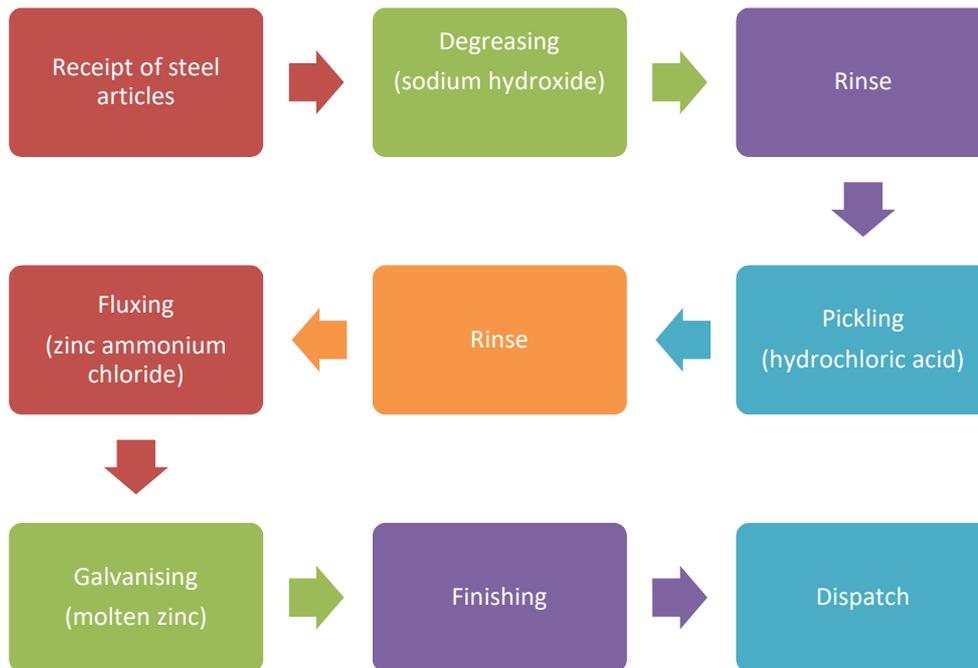
The Company utilise a hot-dip galvanising process which protects steel from corrosion by providing a thick, tough metallic zinc alloy coating. The process consists of various stages of preparation and treatment prior to completion of the process. A brief description of the process is given in Figure 2.

Figure 2 Hot-dip galvanising process undertaken at Taranaki Galvanizers

Articles of steel to be galvanised are initially immersed in a hot sodium hydroxide degreasing or stripping bath to remove any oil or grease contaminants. Oils removed from the surface of the steel remain on the surface of the degreasing bath. After degreasing, the articles are rinsed in a water bath to reduce the carry-over of caustic solution into the next phase of the process.

The next stage of the process involves the removal of mill scale, rust, paint and other oxides from the article being galvanised by 'pickling', or acid treatment, in hydrochloric acid. Again, the article is rinsed in water to remove any excess acid and to minimise the amount of acid carried over to the next stage in the process.

The acid-cleaned steel is then immersed in a flux solution containing zinc ammonium chloride to remove the oxide film which forms on the highly reactive steel surface after acid cleaning and prevents further oxidation prior to galvanising. The fluxing treatment also assists with the adhesion of the molten zinc to the steel, thereby providing a more uniform coating.

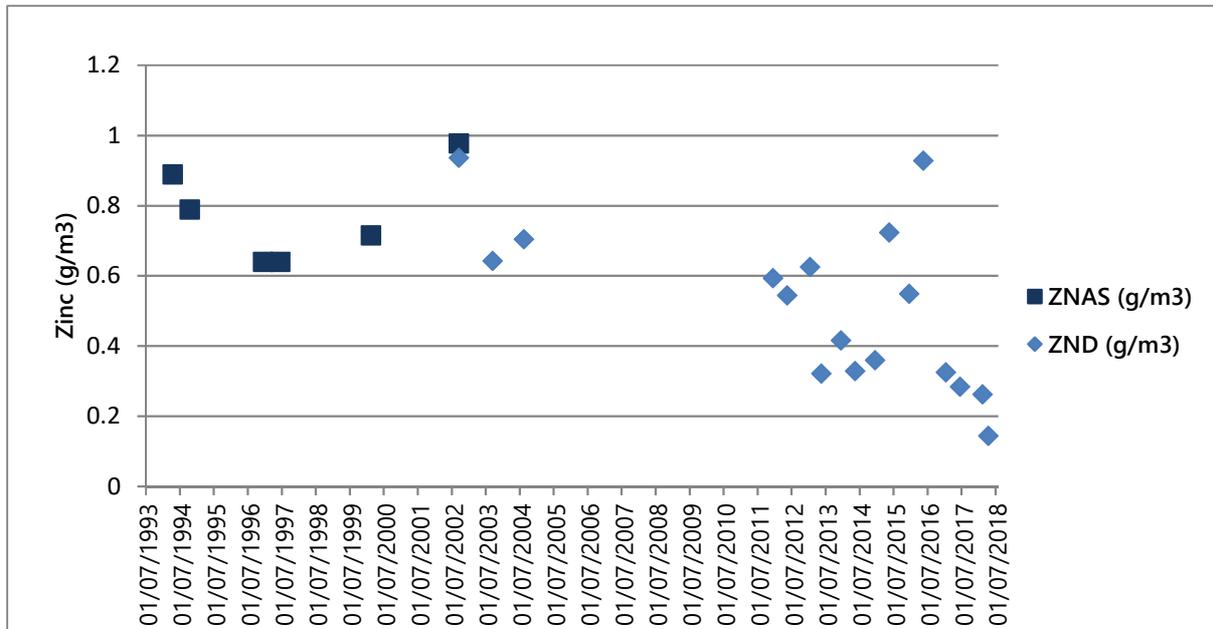
Discharge sampling undertaken in the reported period, at site upstream 2 (KHI000353) showed that the latest concentrations of dissolved zinc (0.263 g/m³ and 0.145 g/m³) were the lowest recorded dissolved zinc concentrations since measurements began (Figure 3).

Figure 3 Zinc concentrations in the unnamed tributary of the Kahouri Stream immediately upstream of the Company's industrial discharge since 1994 (site KHI000353)

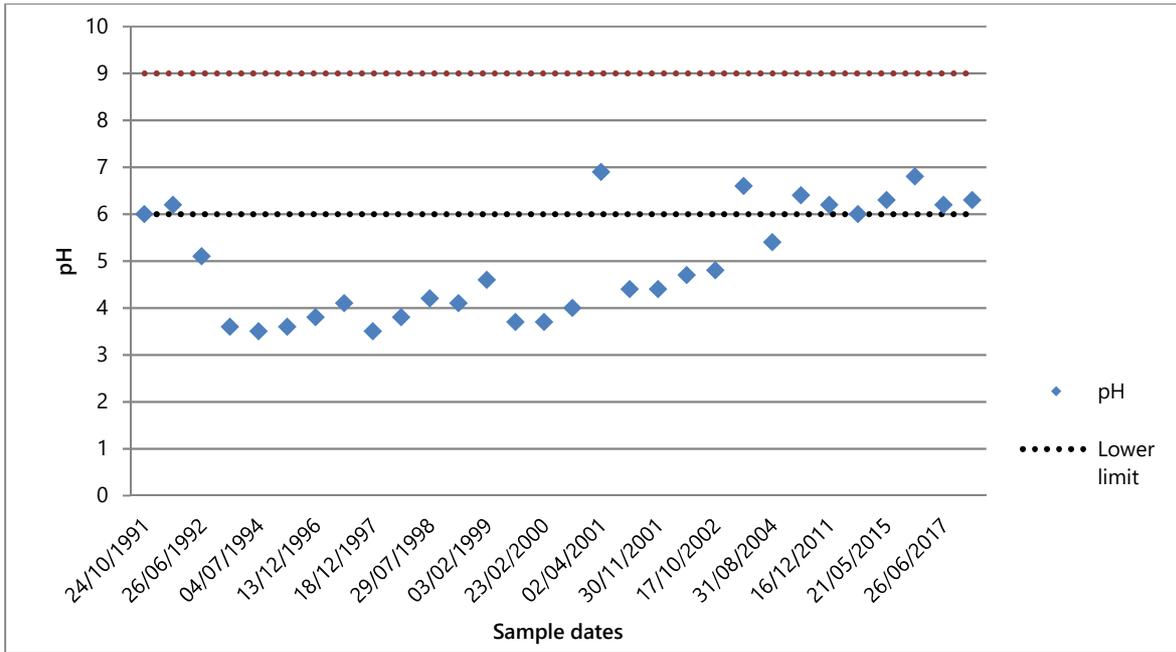
Special condition 4 of consent 4657-2 has specified limits on certain constituents of the discharges including; pH, hydrocarbons, suspended solids and zinc. Although historical discharges do not relate to this consent, these conditions can be a useful guide, to which comparisons can be made. Previous sampling records have shown that pH levels have increased markedly since the 1990's to within the lower end of the consented pH range in the last few years (Figure 4). The concentrations of suspended solids have consistently fallen within the specified consent limits at the industrial discharge site (IND005014) (Table 4).

Figure 4 pH levels recorded in the discharge (IND005014) from the Company's site between October 1991 and April 2018 ¹

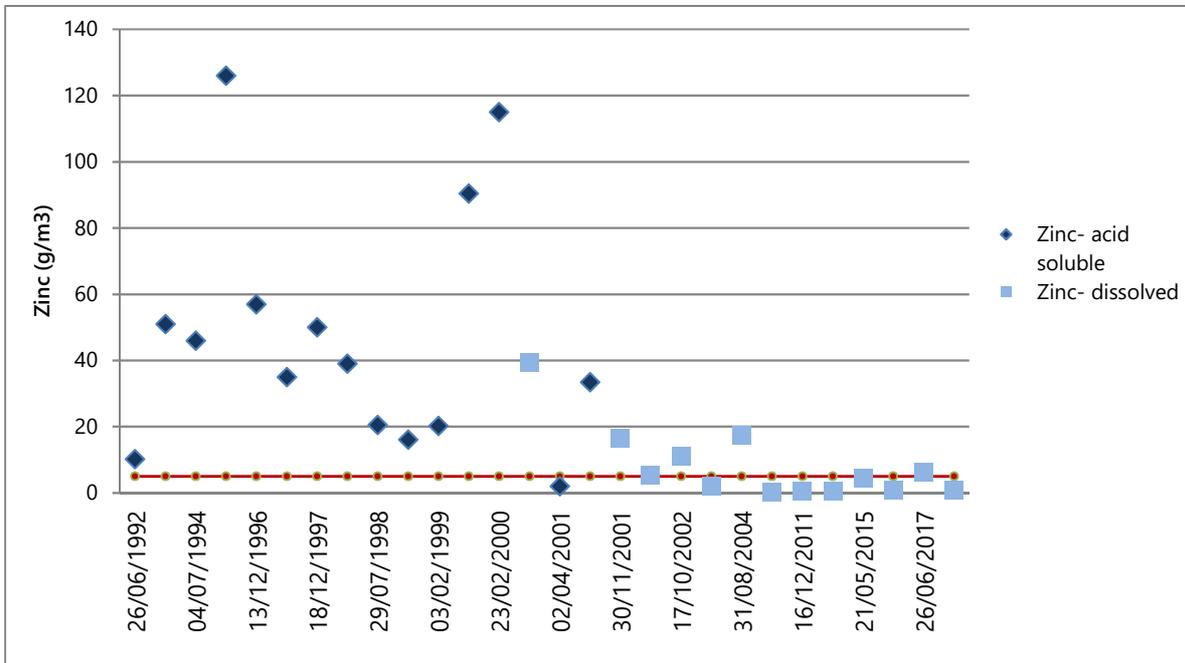
Dissolved zinc concentrations have fallen within the consent limit of 5 g/m³ (consent conditions granted June 2010) and had decreased considerably over the last 12 years. The most recent result is the latest in a continuing downward trend (Figure 5). The historical disposal of galvanising waste materials into a bore on the Company's site is considered to be the most likely source of zinc contamination in this discharge. Sampling was not undertaken in the 2013/14 due to lack of discharge.

Figure 5 Zinc concentrations recorded in the discharge sample (IND005014) from the Company's site between June 1992 and May 2015

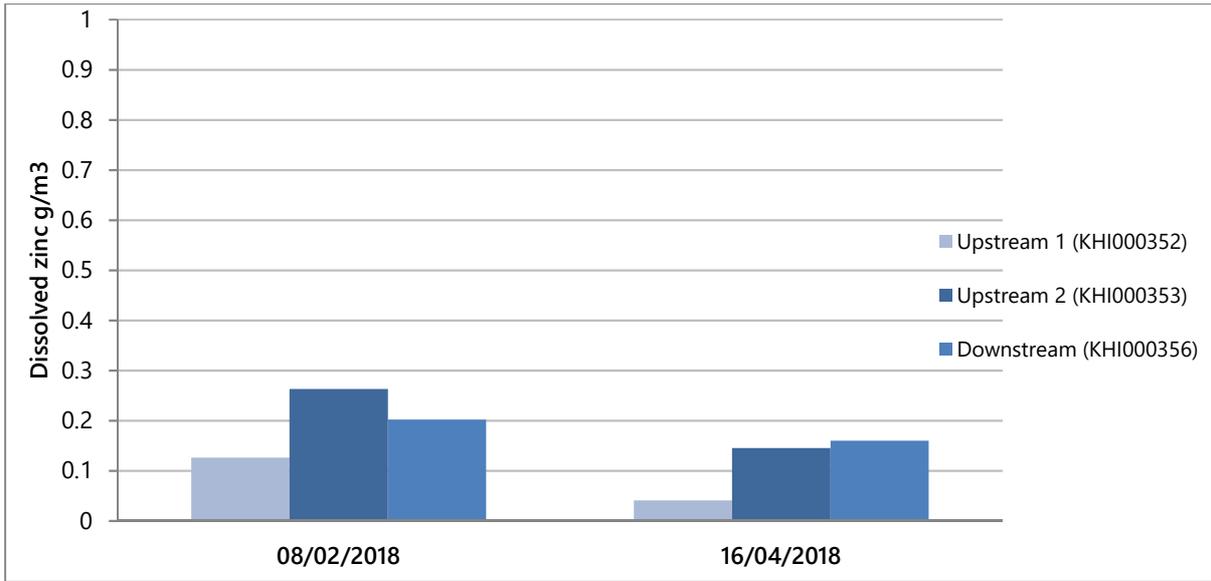
There was a slight increase of zinc between the lower upstream site (2) and the downstream site during the April inspection. Both the industrial and stormwater discharges were discharging at the time of the inspection and likely caused the increase, as it is such a small increase it is deemed insignificant and therefore unlikely to be causing any adverse environmental effects.

It should be noted that the leaching of historic zinc from the contaminated bore has a much more significant effect on water quality as shown by the increase between upstream sites 1 and 2 (Figure 6) on both occasions.

Figure 6 Dissolved zinc concentrations in the unnamed tributary of the Kahouri Stream upstream and downstream of the site.

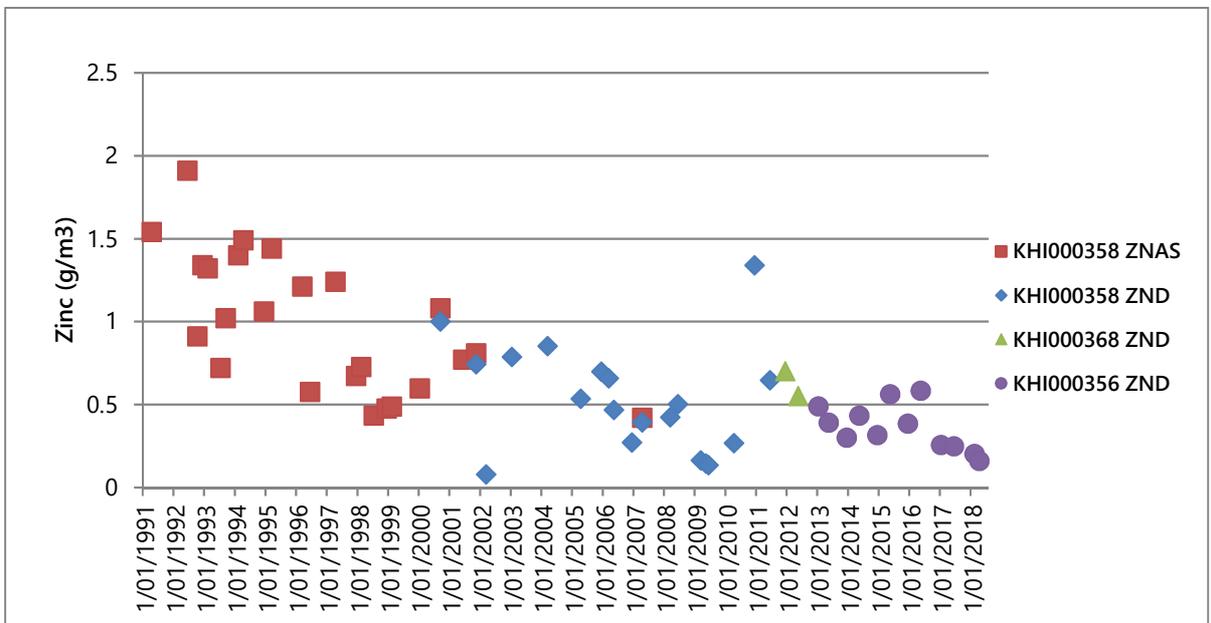
Monitoring of the unnamed tributary of the Kahouri Stream has shown that zinc concentrations in the tributary decreased during the 1990's, then remained relatively constant, varying between the detection limit of 0.005 g/m³ and 1 g/m³. Recent monitoring data suggest that zinc concentrations are still relatively stable and decreasing over time at the downstream site (KHI000356) (Figure 7). Results for the downstream sites previously sampled (KHI000358 (1991-2010) and KHI000368 (2010-2012)), and the current downstream site (KHI000356) show a decline over time (Figure 7). It is considered likely that it will take some years before the zinc concentrations in the tributary are reduced significantly due to the level of contamination (from the bore) under the Company's site.

Figure 7 Zinc concentrations in the unnamed tributary of the Kahouri Stream downstream of the Taranaki Galvanizers industrial discharge since 1991 ¹
