Stratford District Council Closed Landfills (Stratford, Huiroa and Pukengahu)

Monitoring Programme

Annual Report

Technical Report 2022-18

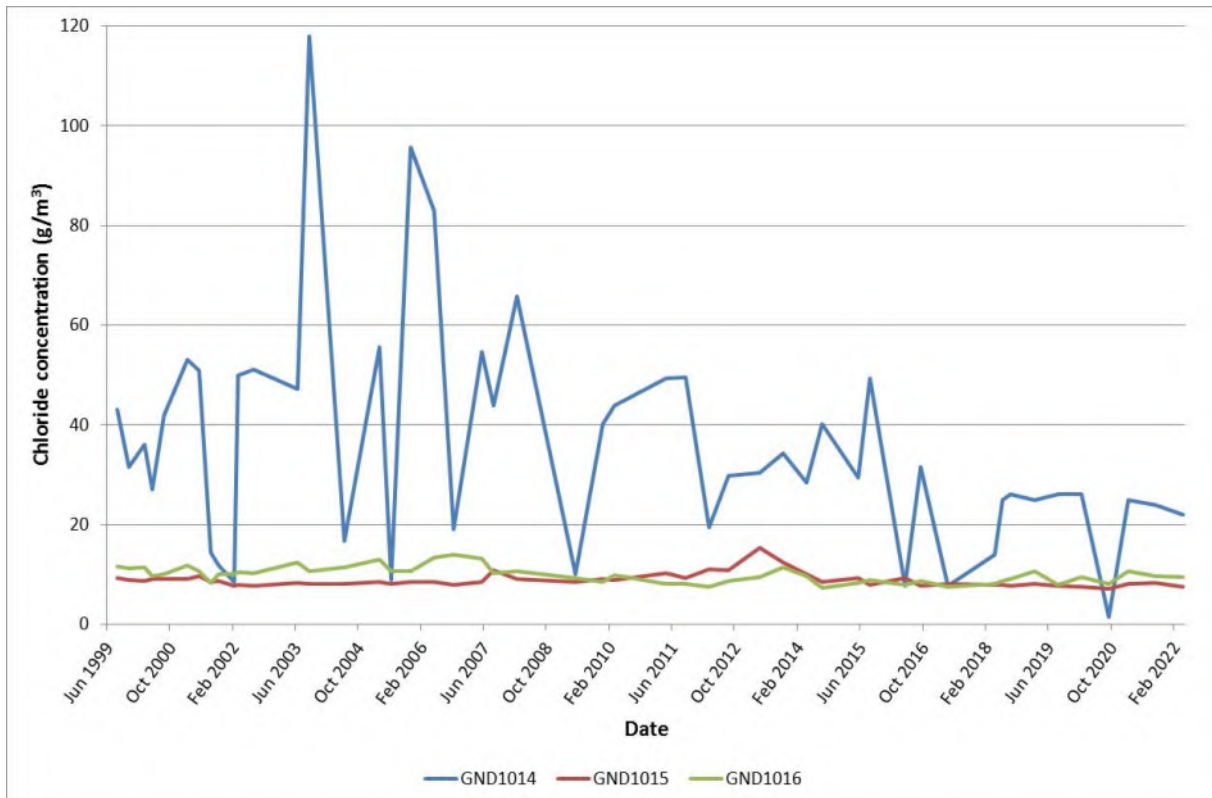
Figure 3 Graph showing chloride levels in the groundwater at the Stratford landfill

Figure 3, Figure 4 and Figure 5 show how bore GND1014 is affected by landfill indicator species; ammoniacal nitrogen, chloride, and zinc. The graphs also show how the levels of chloride and ammonia are apt to fluctuate against the more stable background levels found in the two bores mid and up gradient from the filled area (more so in the case of chloride and ammoniacal nitrogen). Historically zinc has found to be higher in the down gradient bore and has also fluctuated in the up gradient bores, which may indicate other local effects in the groundwater.

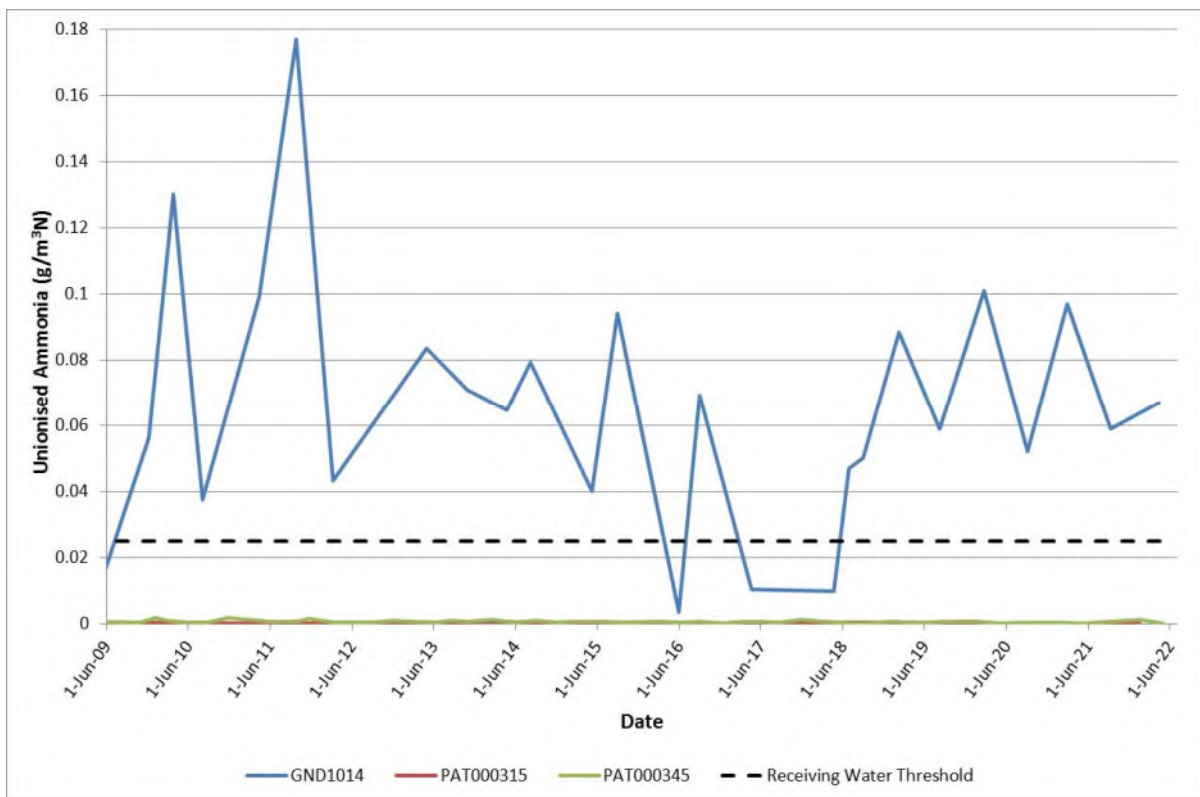
Figure 6 Graph showing unionised ammonia levels in the down gradient bore (GND1014) groundwater and the downstream surface water sites (PAT000315 and PAT000345) at the Stratford landfill

Figure 6 compares the unionised ammonia in the down gradient bore (GND1014) which is most impacted by the landfill due to its location. Given the dependency of unionised ammonia on pH and temperature there is a seasonal variation in ammonia levels which presents as a saw tooth pattern in Figure 6. This makes it hard to determine an overall trend. Although the unionised ammonia presented in the groundwater is high this doesn't appear to have significantly influenced levels in the surface water which remains well below the 0.025 g/m³ guideline for the long term protection of aquatic ecosystems.

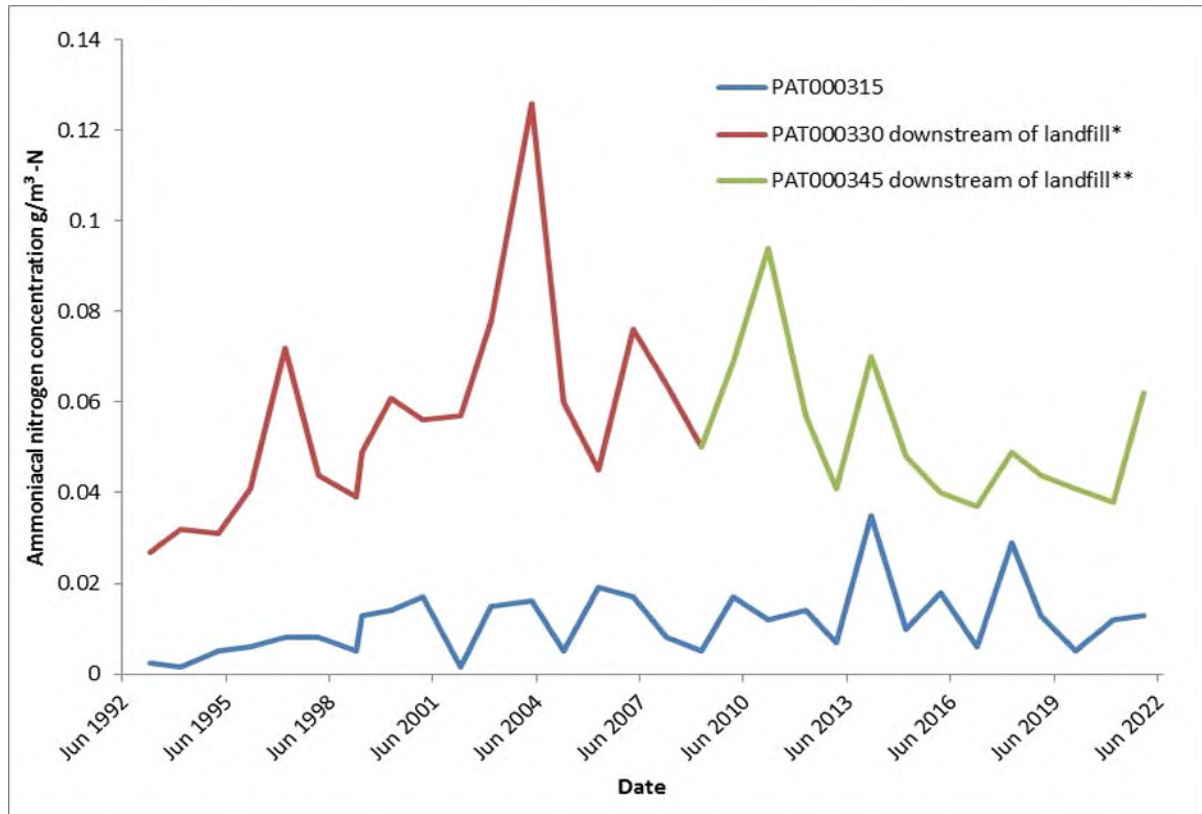
Figure 7 Graph showing ammoniacal nitrogen levels in the Patea Stream up and downstream of the landfill (where comparative data is available)

Figure 7 shows the ammoniacal nitrogen data gathered over the past 30 years. It is noted that, as the Stratford WWTP had an upgrade in 2009, the discharge point of the WWTP was moved and the sites used to

monitor the downstream effects of the landfill have also changed. Monitoring at site PAT000330 ceased in March 2009, with monitoring continuing at site PAT000345, further downstream.

Whilst there is some separation between the sites' locations, the graph indicates that a similar, stable, and modest rise in ammoniacal nitrogen has occurred in the Patea River as result of the landfill's presence. The highest level of ammoniacal nitrogen found downstream of the landfill since monitoring began was 0.87 g/m^3 at site PAT000345, on 16 March 2005 (prior to the WWTP upgrade and not plotted in Figure 7). Under the pH and temperature conditions prevailing at the time of sampling, this ammoniacal nitrogen concentration would have resulted in an unionised ammonia concentration of 0.014 g/m^3 , well below the 0.025 g/m^3 unionised ammonia guideline used for the long term protection of aquatic ecosystems.

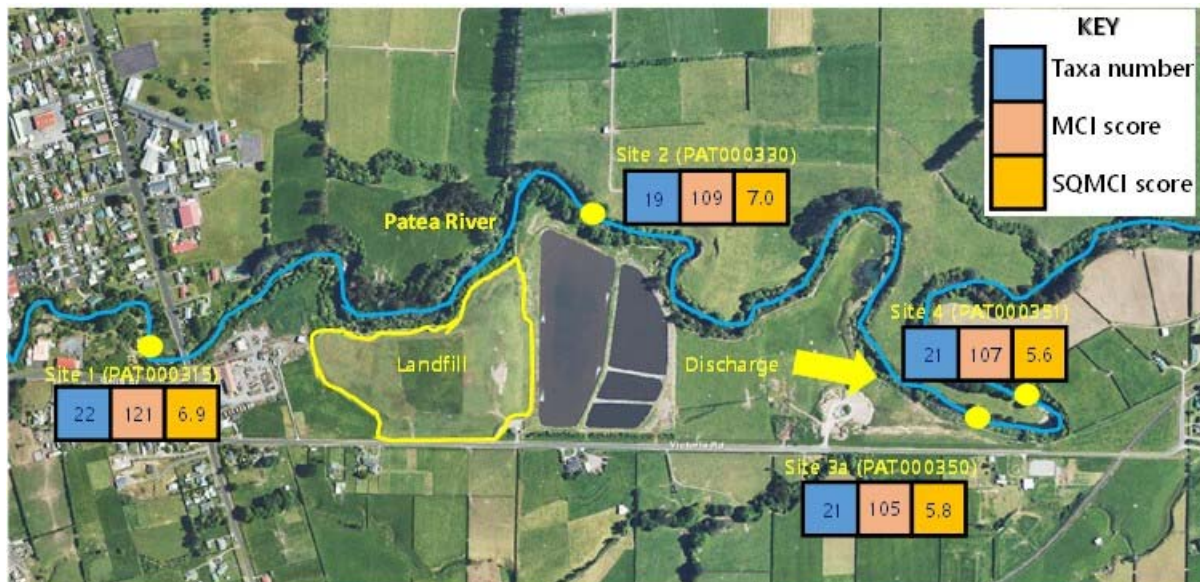
Figure 8 Biomonitoring sites with taxa number, MCI and SQMCI scores for each site, January 2022

Macroinvertebrate richness at all four sites (Table 5, Figure 8) was moderate with very little difference among sites (0-3 taxa). Taxa richness were only slightly lower than historic medians (1-4 taxa). It was unlikely that there had been any significant acute toxic discharges emanating from either the closed landfill or sewage discharge.

The MCI scores categorised site 1 as being in 'very good' health while the three downstream sites were in 'good' health. There were significant differences between site 1 and the three downstream sites. The lower three sites had scores 12-16 MCI units lower than site 1. This suggested a decline downstream of the closed landfill. There were no significant differences among the three downstream sites. There were no significant differences among the three downstream sites. The SQMCI categorised site 1 as being in 'very good health', site 2 as being in 'excellent' health, and sites 3a and 4 as being in 'good' health. Sites 1 and 2 had scores very similar to each other indicating that the closed landfill was not having a significant impact on macroinvertebrate communities while sites 3a and 4 had significantly lower SQMCI scores than both site 1 and site 2. This indicated that WWTP discharges were having an impact on downstream macroinvertebrate communities.

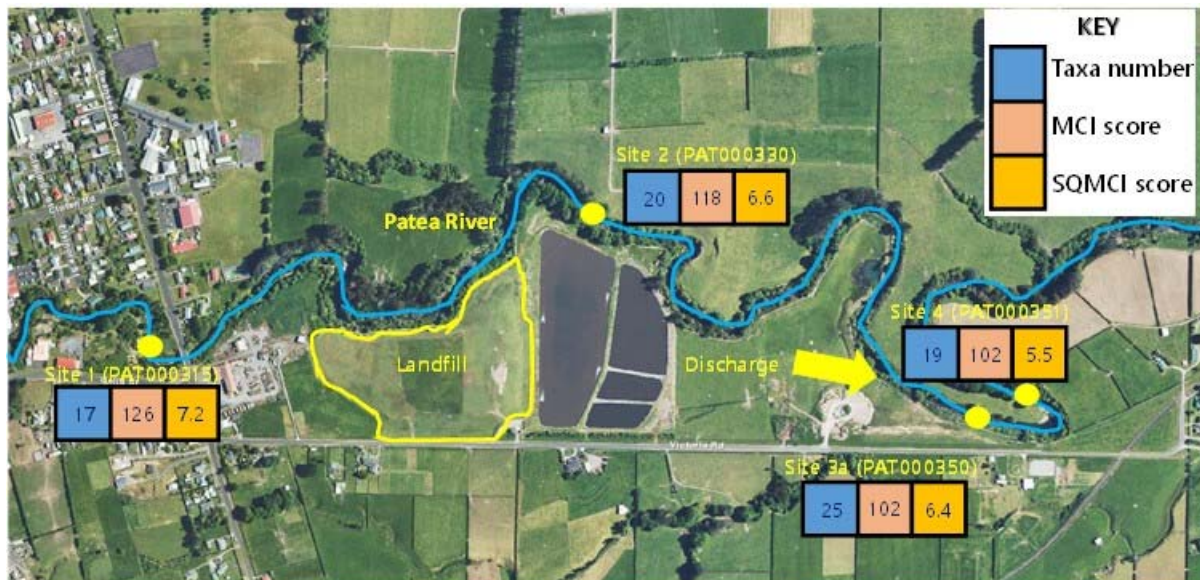
Figure 9 Biomonitoring sites with taxa number, MCI and SQMCI scores for each site, March 2022

The SQMCI categorised site 1 as being in 'excellent' health, site 2 and 3a as being in 'very good' health, and site 4 as being in 'good' health. Congruent with MCI scores, SQMCI scores declined in a downstream direction. However, in contrast to MCI scores, there were no significant difference between sites 1 and 2 and site 3, though site 1 was close to be significantly higher than site 3. Sites 2 and 3 had very similar scores (0.2 unit difference). There were significant differences between sites 1, 2 and 3a and site 4 of 1.7, 1.1 and 0.9 units respectively. Sites 1, 3a and 4 were also significantly higher than historical medians, while site 2 was not significantly different to its historical median. There were no significant differences between current scores and the previous survey for any sites.

Overall, there was some evidence of nutrient enrichment but this was not sufficient enough to conclude that WWTP discharges were having a significant effect on macroinvertebrate communities in the Patea River. There was also insufficient evidence to conclude that leachate from the closed Stratford landfill site was having a significant effect on macroinvertebrate communities in the Patea River.

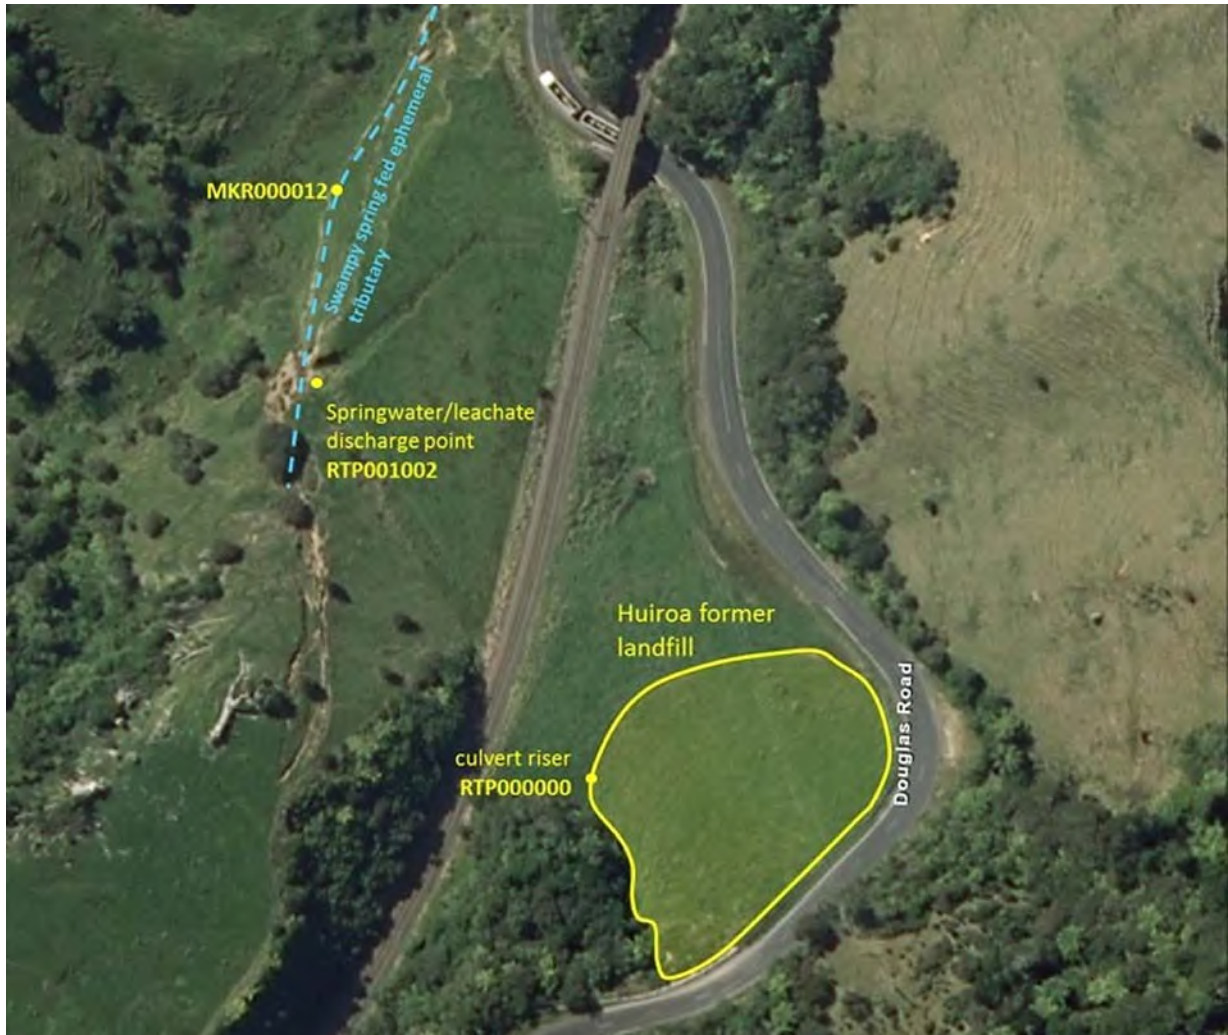
Figure 10 Huiroa landfill and approximate sampling locations

This closed landfill is monitored on a triennial basis, with inspections and sampling undertaken during 2020-2021 and next scheduled in 2023-2024. The location of the landfill and monitoring sites are shown in Figure 10.

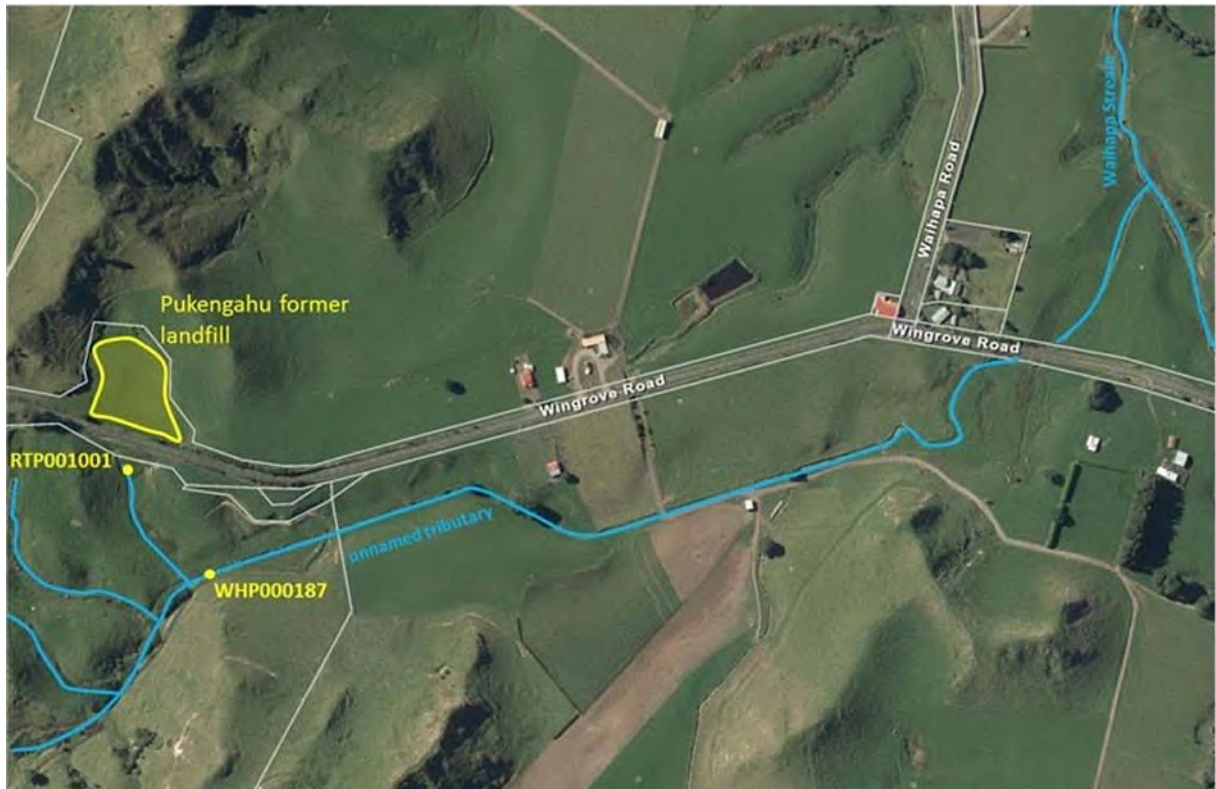
Figure 11 Pukengahu landfill and approximate sampling locations

The site is situated in a small gully off Wingrove Road (Figure 11). At the base of the gully is a small wetland area, which is fed by a spring that is culverted beneath the road and feeds into a small unnamed stream. The site was unmanaged and was mostly used for the discharge of domestic waste by local residents. The landfill closed in 1991 and was reinstated by SDC. It is monitored on a triennial basis, with inspections and sampling undertaken during the 2020-2021 monitoring year, and next scheduled in 2023-2024.
