TAG Oil (NZ) Limited  
Cheal-E Wellsite  
Monitoring Programme Report  
2013-2014  
Technical Report 2014–51

February 2015

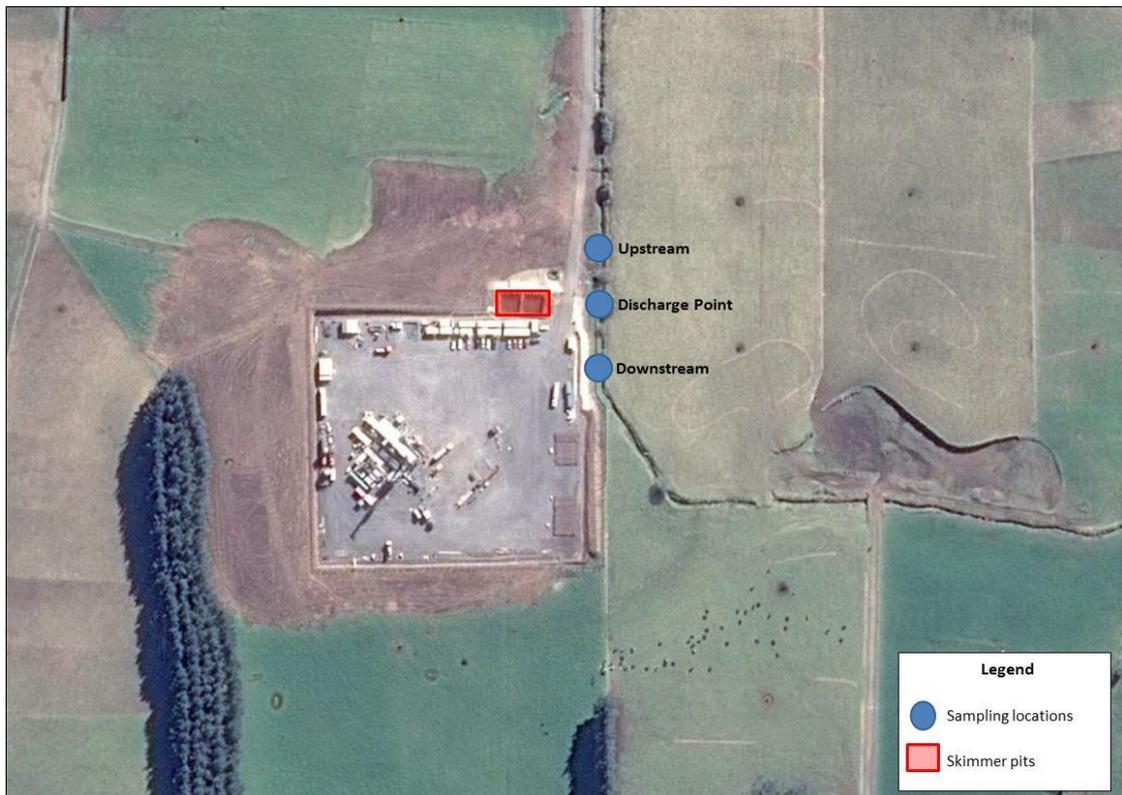
**Figure 2** Stormwater and surface water sampling locations at the Cheal-E wellsite

Analysis of the samples obtained showed that all of the samples were compliant or would have been compliant with resource consent conditions should a discharge have occurred. Results are detailed in Table 1 and sampling locations can be seen in Figure 2.

During the period under review, eight stream samples were obtained in conjunction with the stormwater discharges, on 22 August 2014, 23 September 2013, 23 October 2013 and 1 November 2013, from an unnamed tributary of the Ngaere Stream to ensure that stormwater discharges were not having an adverse effect on the receiving stream environment. Of the stream samples obtained, no exceedences were recorded in relation to consent 6403-1. Negligible effects were noted in the stream. Results are detailed in Table 2 and sampling locations can be seen in Figure 2.

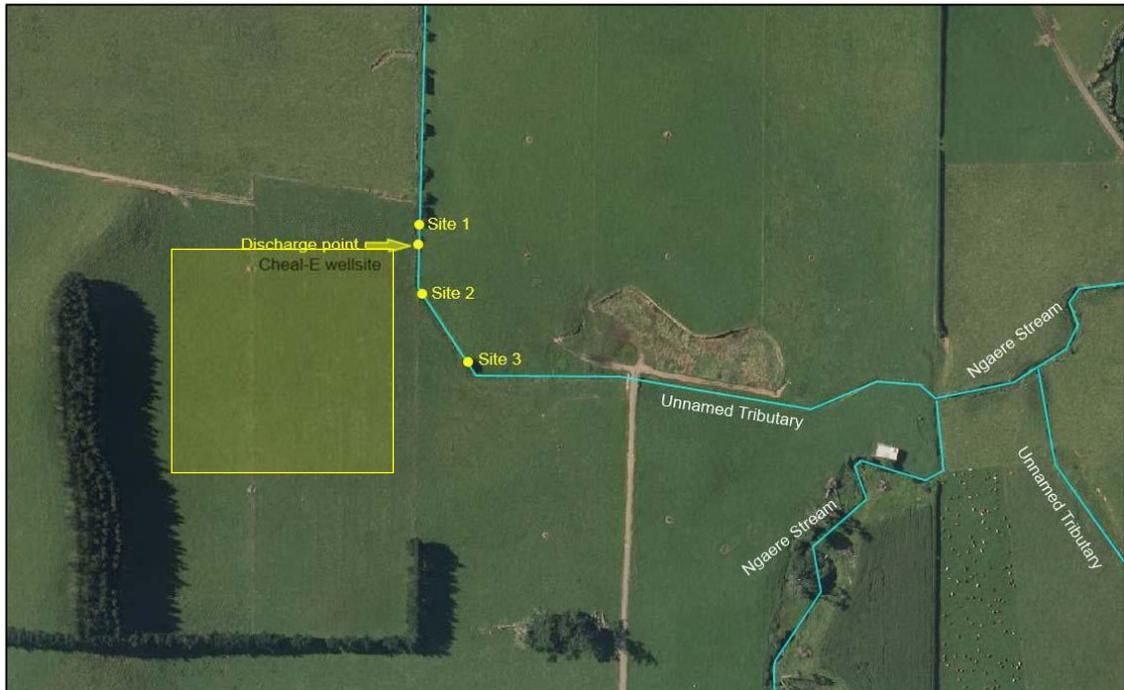
**Figure 3** Biomonitoring site in an unnamed tributary of the Ngaere Stream in relation to the Cheal-E wellsite

This June 2013 survey of three sites, upstream and downstream of the intended skimmer pit discharge point, was undertaken prior to drilling at the Cheal-E wellsite and site construction. Taxa richnesses were moderate and within a narrow range for all sites and the macroinvertebrate communities of the stream contained similar proportions of 'tolerant' and 'moderately sensitive' taxa but no 'highly sensitive' taxa. A total of 26 taxa was found through the reach of the stream surveyed, with 10 of these taxa (38.5%) found at all three sites and 7 taxa (27%) found at any two of these sites. Characteristic taxa were relatively similar between sites with three 'tolerant' taxa and one 'moderately sensitive' taxa abundant at all three sites.

The August 2014 survey of three sites, upstream and downstream of the intended skimmer pit discharge point, was undertaken following drilling at the Cheal-E wellsite and site construction. Taxa richnesses were moderate at site 2 and 3, but moderately low at site 1. The macroinvertebrate communities of the stream contained similar proportions of 'tolerant' and 'moderately sensitive' taxa but no 'highly sensitive' taxa. A total of 23 taxa was found through the reach of the stream surveyed, with 10 of these taxa (43%) found at all three sites and four taxa (17%) found at any two of these sites. Characteristic taxa were relatively similar between sites with one 'tolerant' taxon and one 'moderately sensitive' taxon abundant at all three sites.

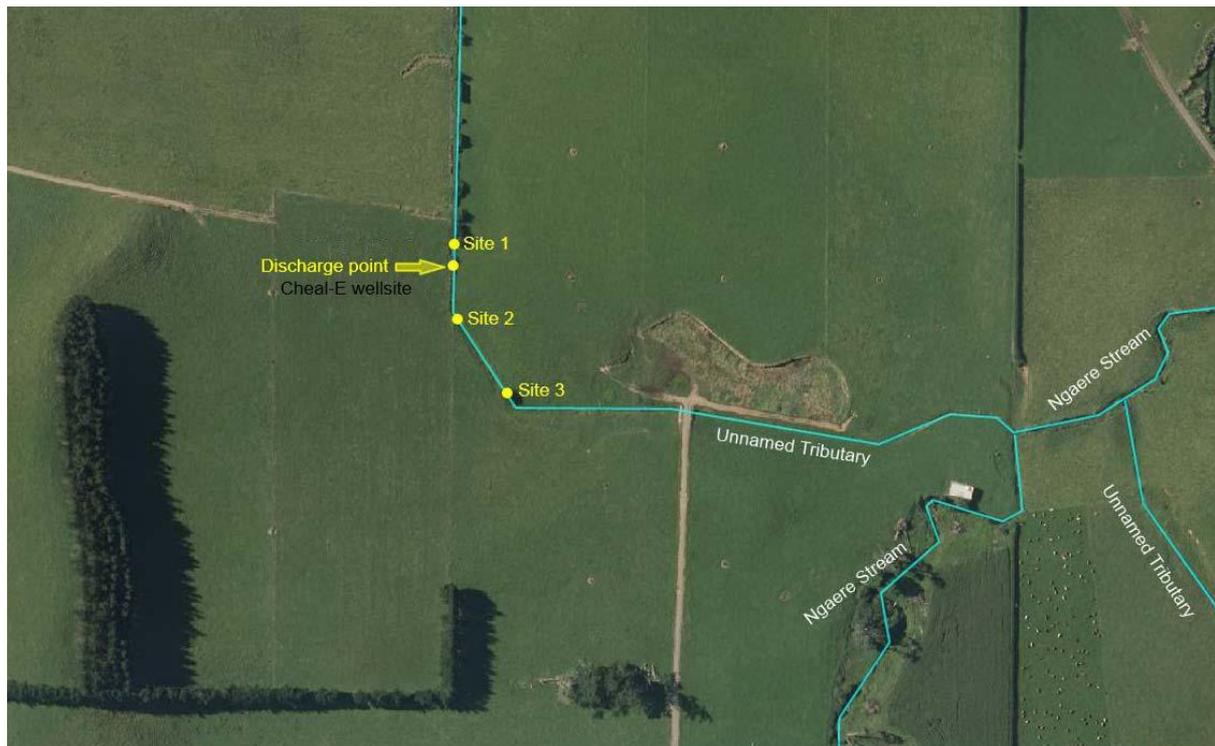
Figure 1 Biomonitoring sites in the Ngaere Stream in relation to the Cheal-E wellsite.

Site no.	Site code	Grid reference (NZTM)	Location	Sampling method	Altitude (m asl)
1	NGR000280	1714464E-5639753N	45m u/s of farm boundary fence	Vegetation sweep	220
2	NGR000281	1714472E-5639710N	Immediately downstream of farm boundary fence	Vegetation sweep	220
3	NGR000283	1714501E-5639656N	Just downstream of lone tree, 70m d/s of boundary	Kick-sweep	220

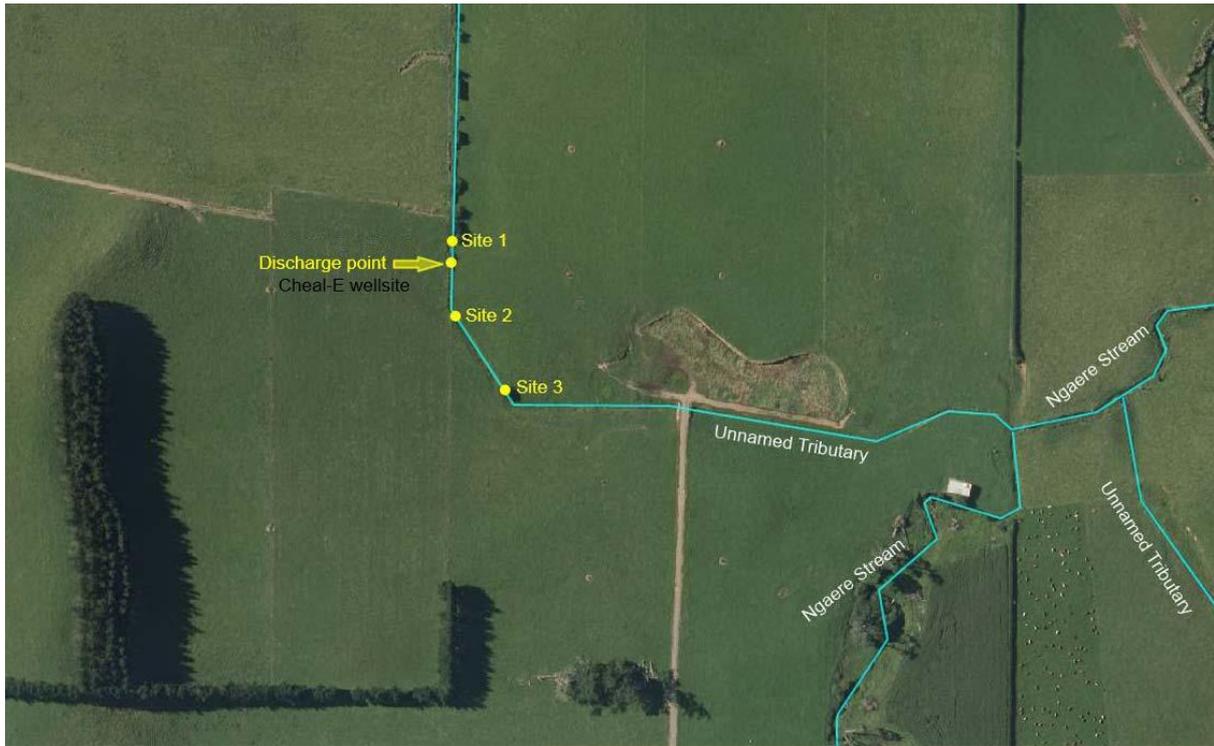
Figure 1 Biomonitoring sites in the Ngaere Stream in relation to the Cheal-E wellsite.

Site no.	Site code	Grid reference (NZTM)	Location	Sampling method	Altitude (m asl)
1	NGR000280	1714464E-5639753N	45m u/s of farm boundary fence	Kick-sweep	220
2	NGR000281	1714472E-5639710N	Immediately downstream of farm boundary fence	Vegetation sweep	220
3	NGR000283	1714501E-5639656N	Just downstream of lone tree, 70m d/s of boundary	Vegetation sweep	220
