Vector Kapuni GTP
Monitoring Programme
Annual Report
2016-2017

Technical Report 2017-86

Taranaki Regional Council
Private Bag 713
STRATFORD
March 2018

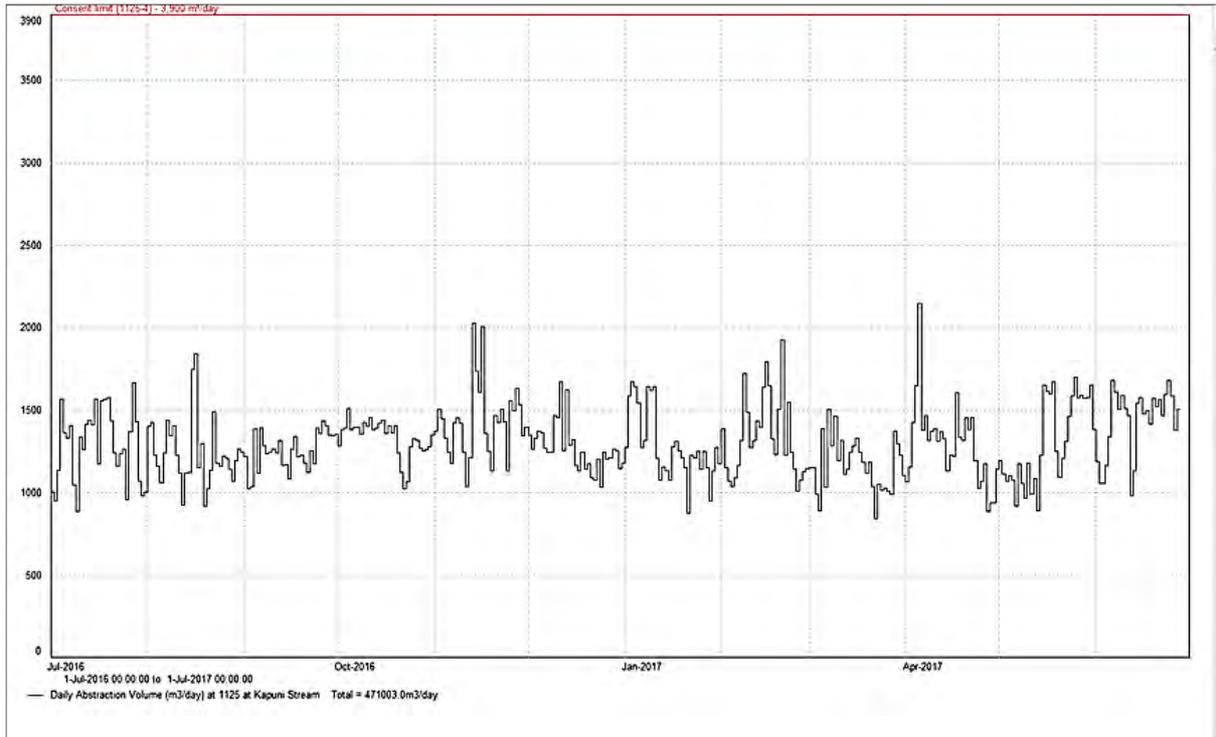
Figure 1 Daily surface water abstraction volumes (1125-4) Vector KGTP 1 July 2016-30 June 2017

The daily surface water abstraction record indicated (Figure 1) that the limit of abstraction 3,900 m³/day was complied with for the duration of the 2016-2017 monitoring year. In total, the Vector site abstracted 471,003 m³ this monitoring period.

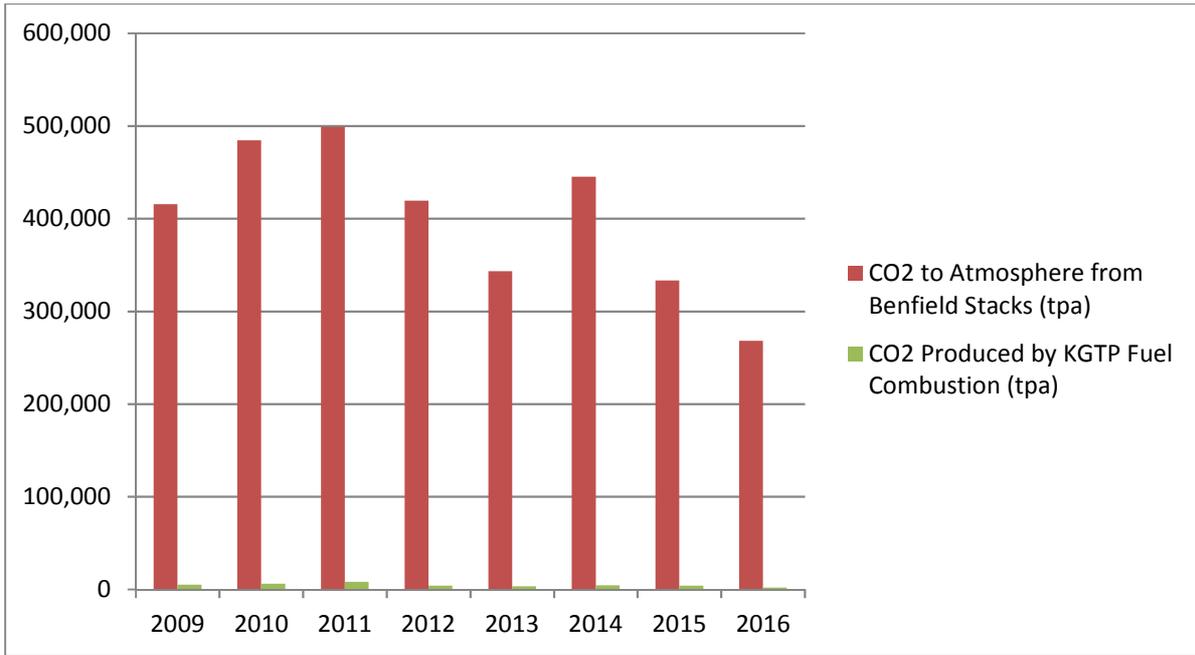
Annual CO₂ emissions in calendar years since 2009 are shown in Figure 3. The amounts released to atmosphere from the Benfield process and from fuel combustion are distinguished. The reductions in 2013 and 2016 are a reflection of reduced quantities of gas processed by the plant compared to previous years.

Figure 3 Annual CO₂ emissions from Vector KGTP in tonnes per annum (tpa)

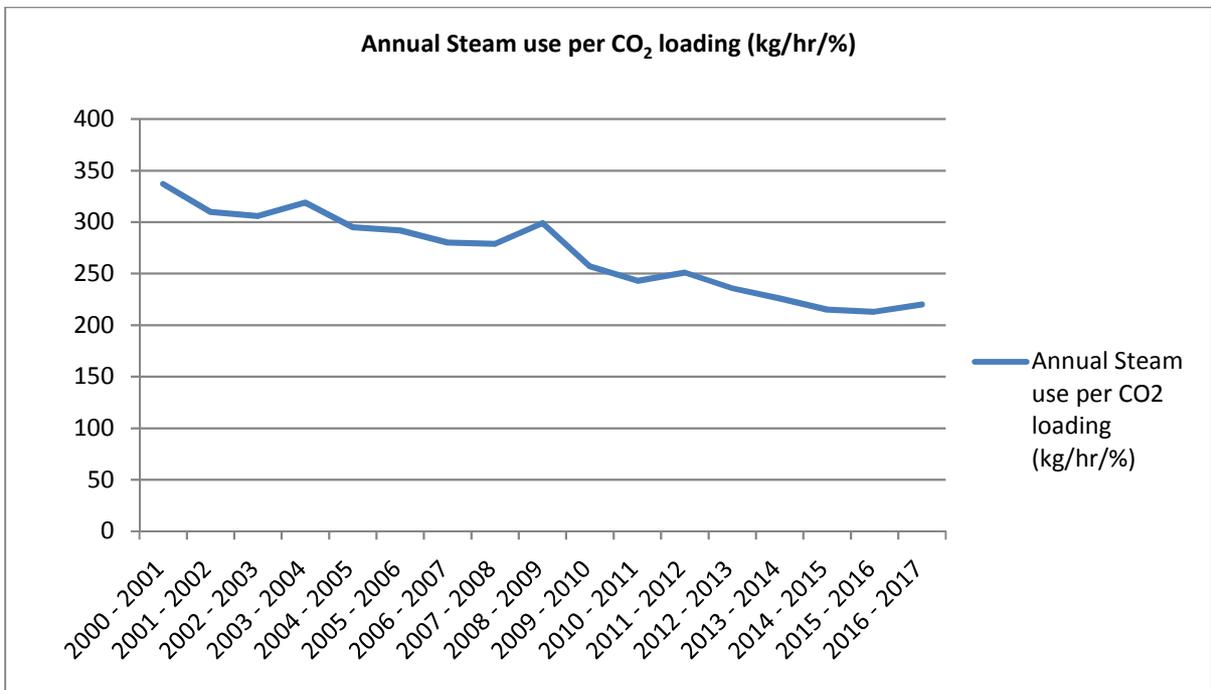
The efficiency of steam use in the Benfield CO₂ removal plant is a key performance indicator (KPI) for the operation of the gas treatment plant in relation to fuel use. Annual steam use per CO₂ loading since 2000-2001 is depicted in Figure 4. Vector reports that the continual improvement in steam use efficiency from 2009 onwards is not due to any particular process improvement, but rather a continued focus on consistently running the plant at higher efficiency targets from year to year, and that further improvements are likely to be small as maximum efficiency is approached.

Figure 4 Annual steam use per CO₂ loading Vector KGTP

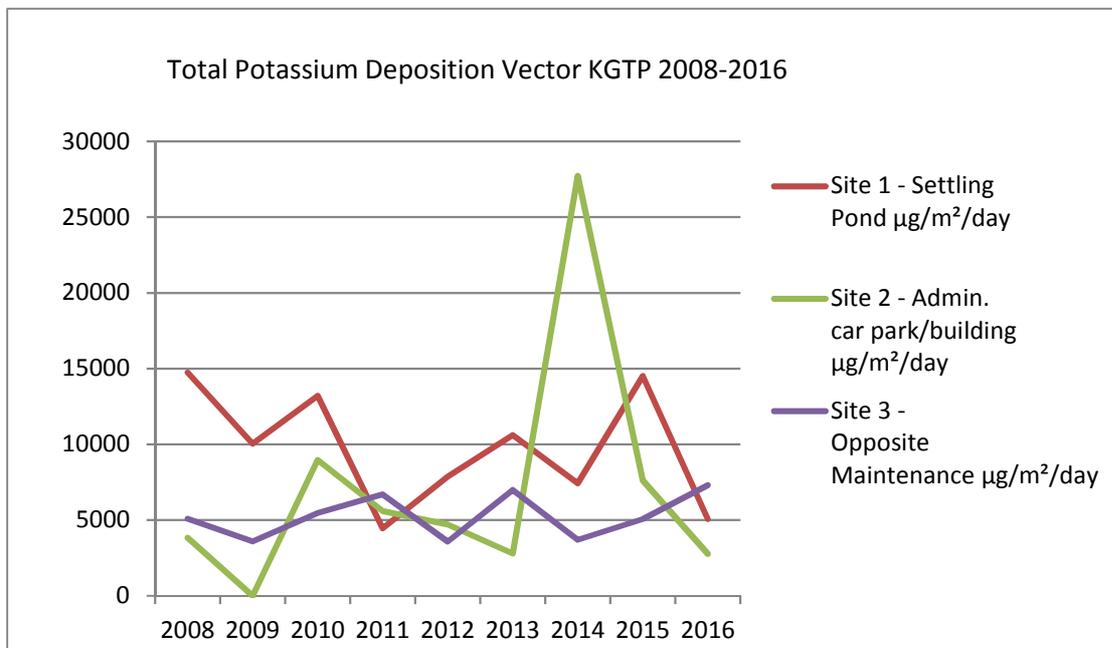
Monitoring of metal deposition, for potassium, vanadium and zinc, is conducted annually at three sites around KGTP by deployment of air deposition gauges. The locations of the sites are immediately east and south of the processing area, that is, downwind and crosswind relative to the prevailing westerly wind, and beside Palmer Road to the southwest. There are no guidelines or standards for metals deposition. The data gathered since 2008 is appended (Appendix III). The data has also been tabulated in the following Figure 5, 6 and 7. While there is considerable variation in some of the samples, the data do not show any significant change in metal deposition rates over time.

Figure 5 Total potassium deposition monitoring 2008-2016

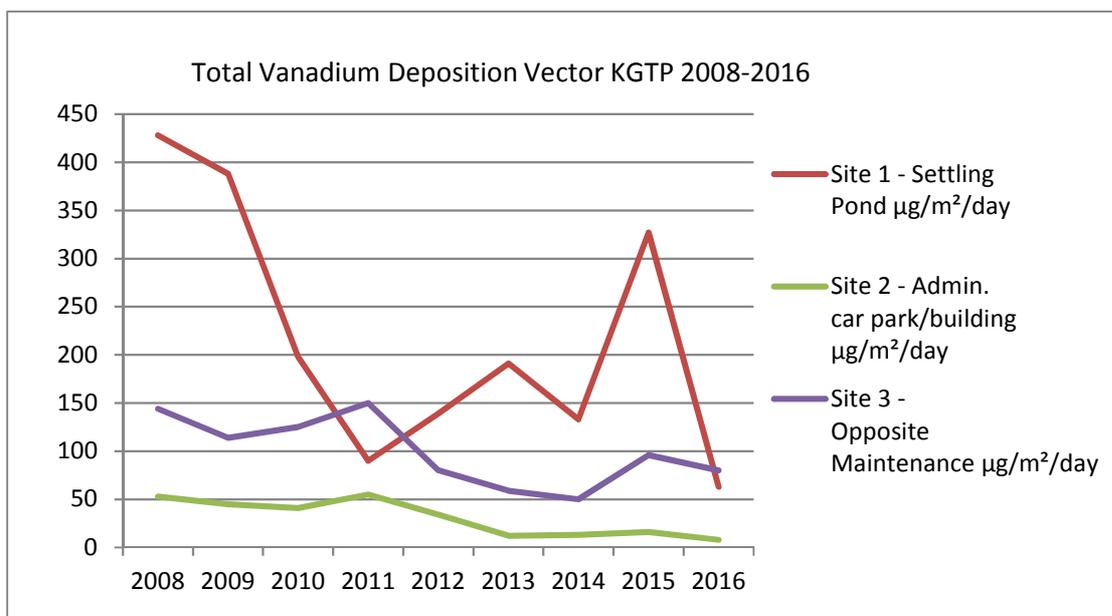
Figure 6 Total vanadium deposition Vector 2008-2016

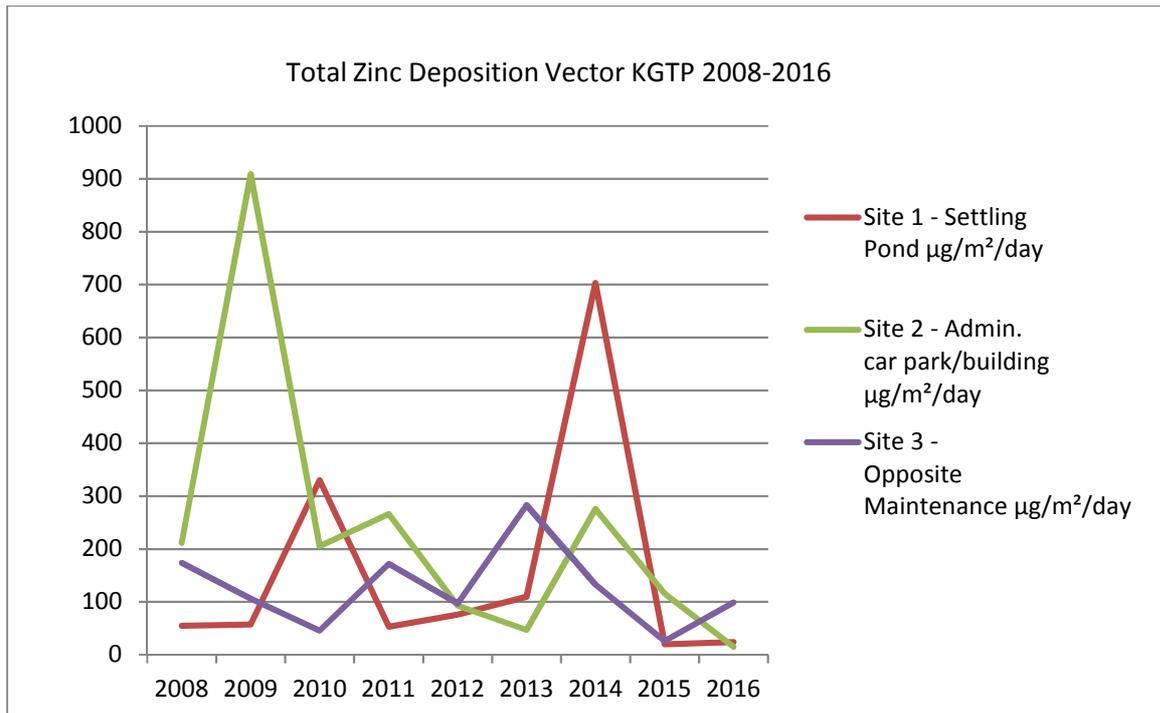
Figure 7 Total zinc deposition Vector 2008-2016
