**Waverley Bulk Transport Limited
Quarry Monitoring Programme
Biennial Report
2013-2015**

Technical Report 2015-27

October 2015

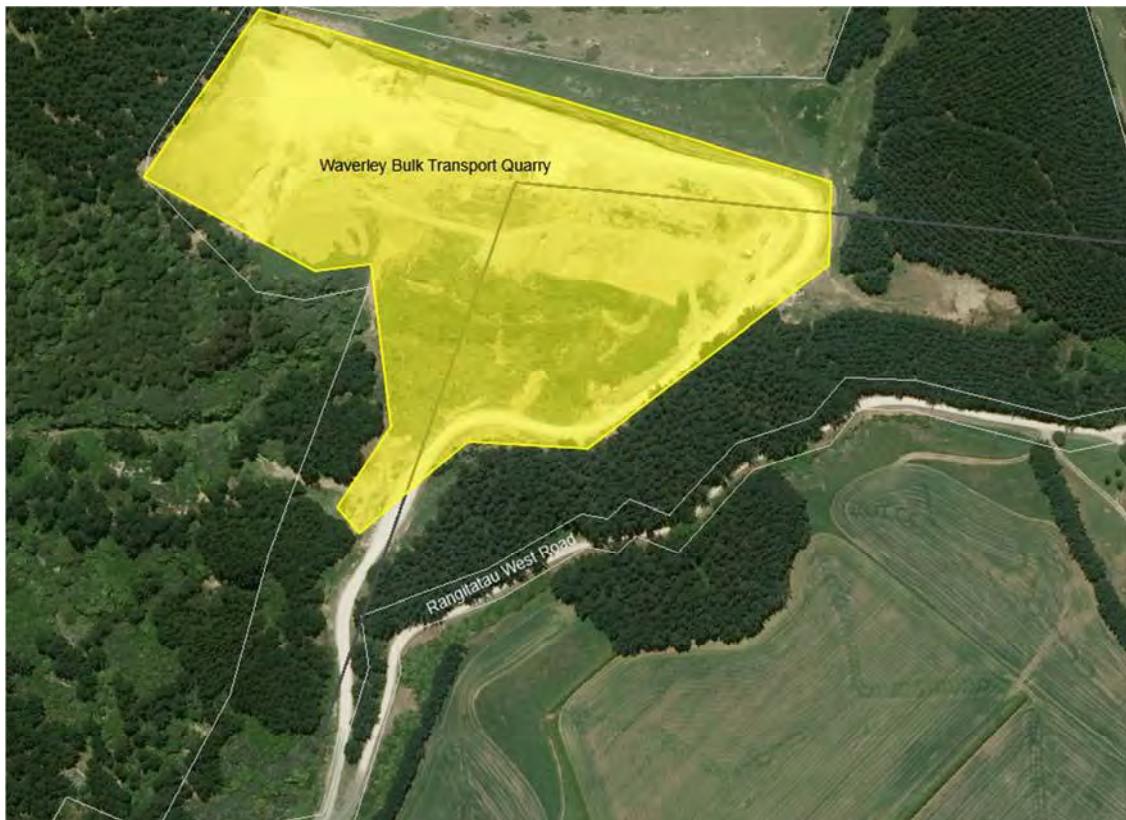
Figure 1 The Company's Rangitatau West Road quarry

The Company's Rangitatau West Road quarry is situated on a rocky bluff approximately two kilometres above the Makokako Stream. The site was established in 2005-2006 and has a current exposed quarried area of approximately two hectares. The aggregate is processed by dry crushing and no aggregate washing is carried out on site. The site is well screened from the road and neighbouring properties by a surrounding pine plantation.

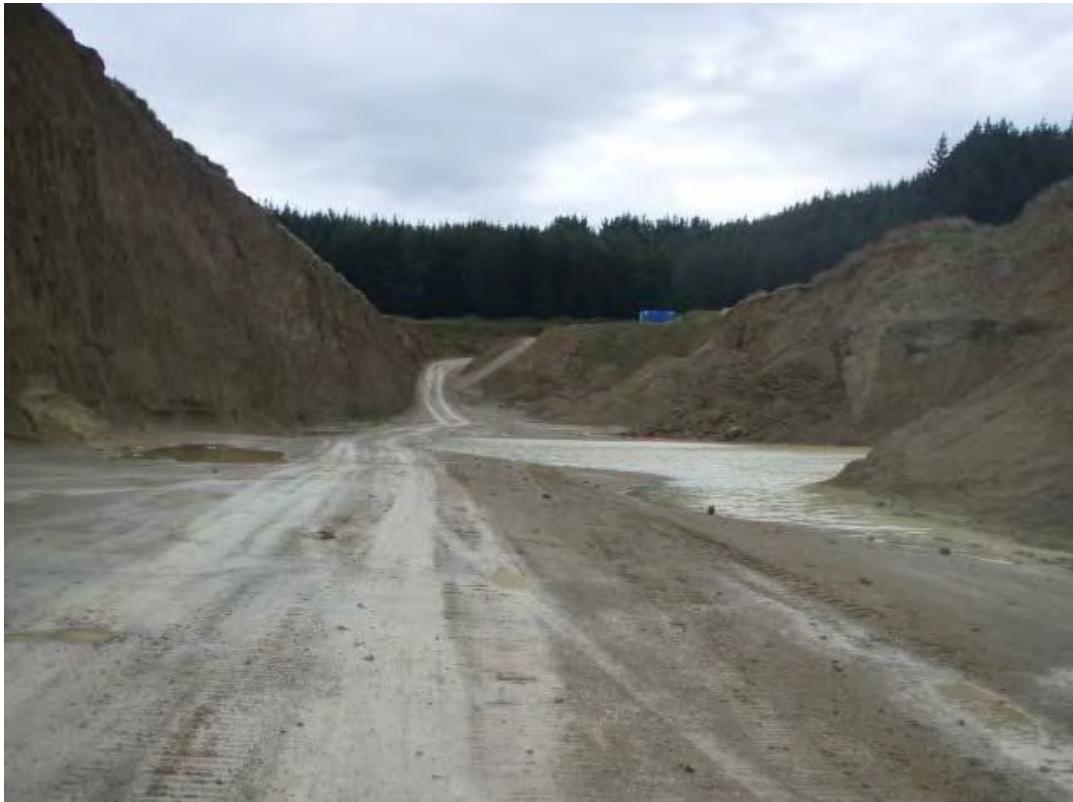
The contour and aspect of the strata being quarried allows all of the stormwater from quarried areas to be contained within the quarry pit and discharge is currently entirely via seepage to ground.

When the site was first established a silt pond was maintained outside and above the main pit. Stormwater was pumped out of the pit to be treated through it before discharge. It is intended that the site is operated in a manner that ensures that the bottom of the cut always slopes back to the hillside or the quarry pit. This ensures that

no untreated stormwater can escape from the site. The site also contains some minor springs whose waters need to be controlled appropriately on an ongoing basis.

Photo 1 Stormwater collection area at base of quarry pit from which stormwater drains via seepage to ground

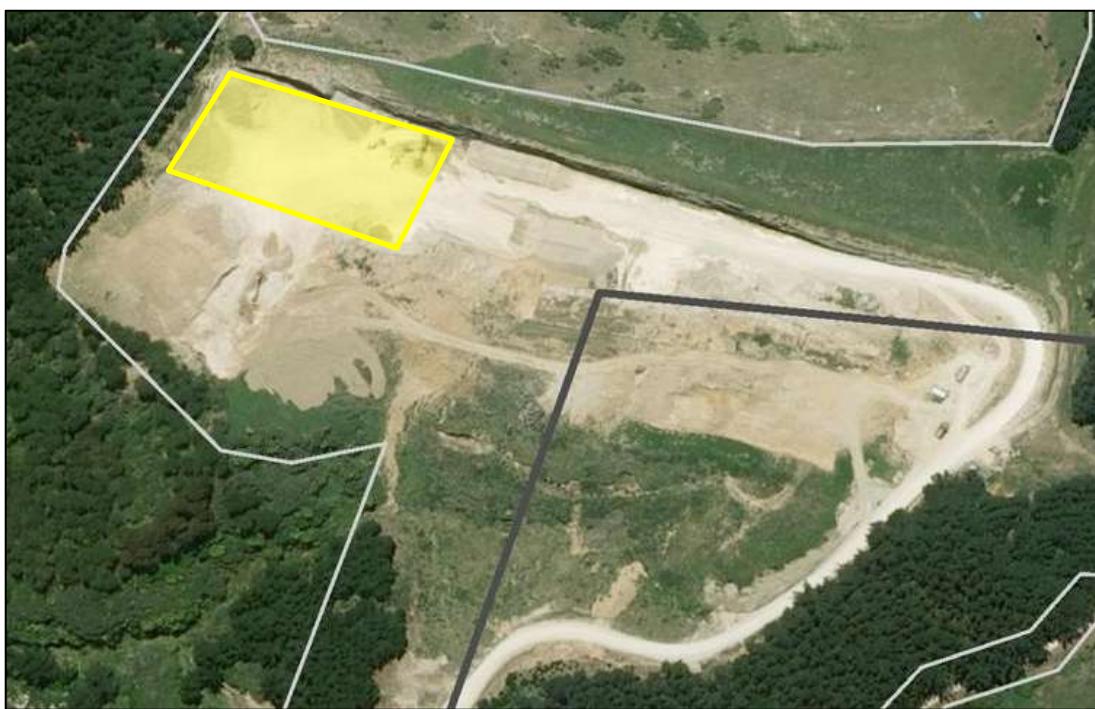
1. The discharge of cleanfill shall only occur in the area shaded yellow on the plan attached as Appendix 1.
2. The contaminants to be discharged shall be limited to cleanfill and/or inert materials. For the purposes of this condition, "clean fill and inert materials" are defined as materials consisting of any concrete, cement or cement wastes, bricks, mortar, tiles (clay, ceramic or concrete), cured asphalt, non-tanalised timber, porcelain, glass, gravels, boulders, shingles, fibreglass, plastics, sand, soils and clays, and/or tree stumps and roots, whether singly or in combination or mixture, or any other material (subject to condition 3) that when placed onto and into land will not render that land or any vegetation grown on that land toxic to vegetation or animals consuming vegetation.

Figure 4 Area where the discharge of cleanfill is permitted.
