South Taranaki District Council
Kaponga, Manaia, Patea, and Waverley
WWTP's

Monitoring Programme

Annual Report

2020-2021

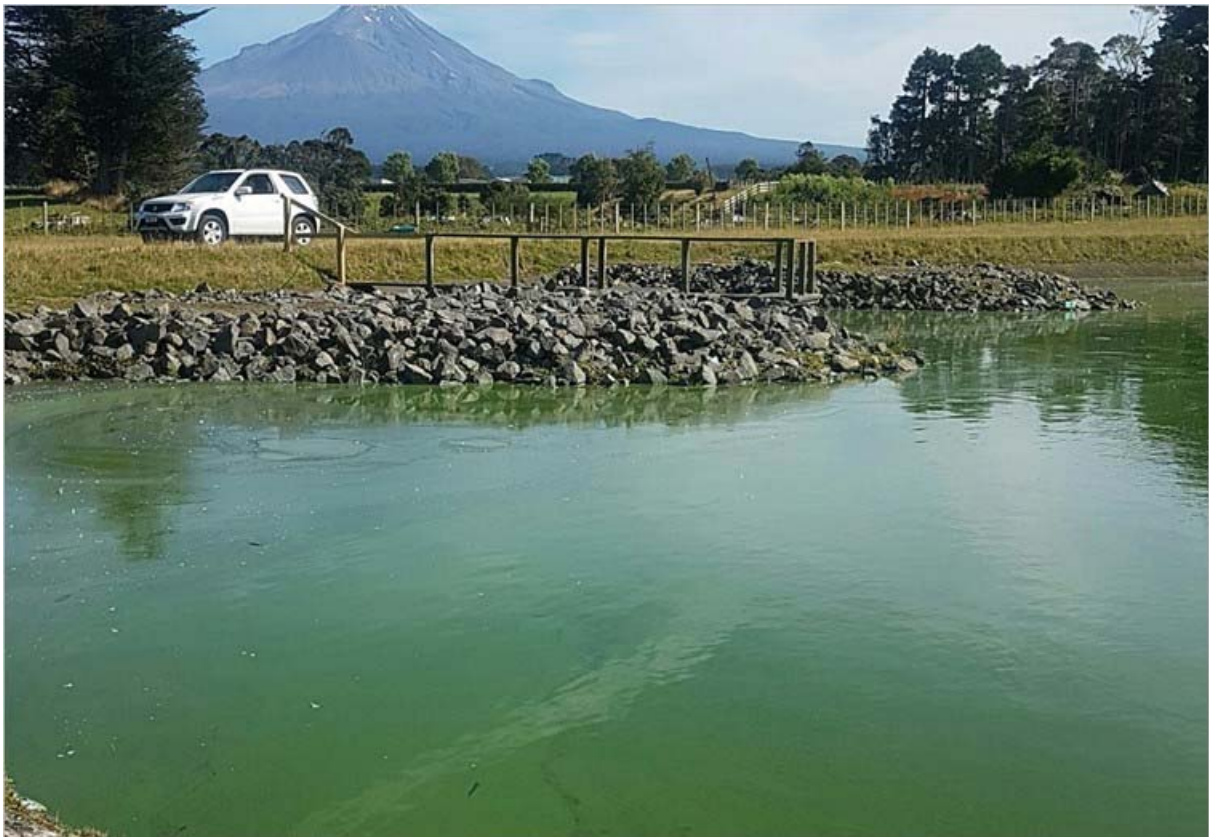
Photo 1 Kaponga WWTP

The Kaponga WWTP is a single oxidation pond system (constructed in 1971) that has been separated into two sections by a wooden dividing barrier. The pond is gravity-fed mainly domestic wastes from a population of approximately 330 people, although it was designed for a population of 650. A sludge survey performed by consultants for the consent holder (MWH, 2005) found that there had been a slow rate of sludge accumulation and at such a rate, it was estimated that the system would not require desludging for another 17 years. Sludge surveys will be repeated at five-yearly intervals (STDC, 2015). Issues of stormwater infiltration, improved mixing within the ponds' system, and reduction of the microfloral component of the treated wastewater discharge, were identified in consideration of upgrading the treatment system during the consent renewal process in the 2007-2008 period (CH2M Beca Ltd, 2006). Upgrades to the system were completed by late May 2008. Infiltration remedial work has a lesser priority for the Kaponga township collection system than elsewhere in South Taranaki.

Riparian fencing and planting of the river margin adjacent to the ponds system has also been undertaken. The installation of a mechanical step-screen at the inlet was undertaken during the latter months of the 2012-2013 monitoring period. This screen system has telemetry alarming. A flow meter was installed on the pond inlet in the 2017-2018 year as per consent conditions.

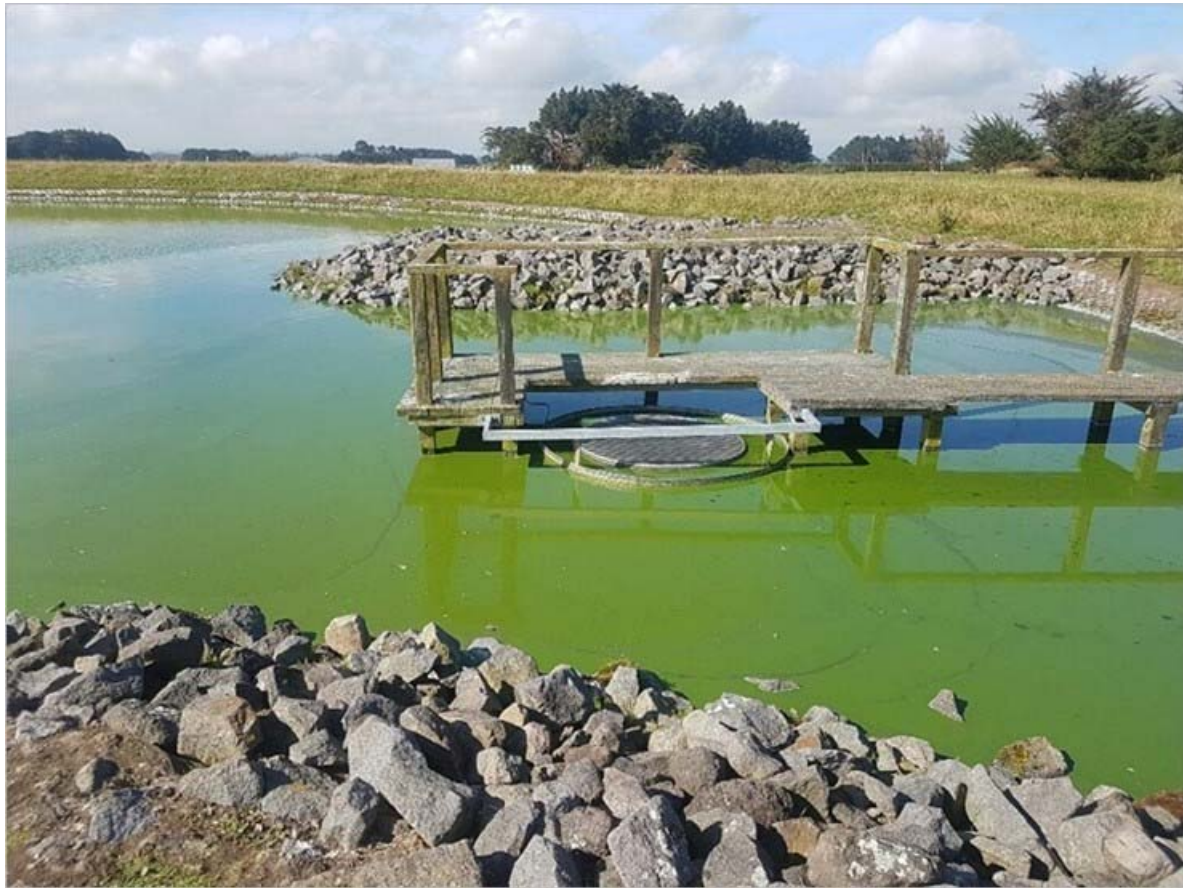
Photo 2 Algal bloom on the surface of the pond caused by high microfloral levels.

Pond microflora are very important for the stability of the symbiotic relation between aerobic bacteria in the primary pond. These phytoplankton may be used as a bio-indicator of pond conditions, for example cyanobacteria are often present in under-loaded conditions and chlorophyceae are present in overloaded conditions. To maintain facultative conditions in a pond system there must be an algal community present in the surface layer.

The principal function of algae is the production of oxygen which maintains aerobic conditions while the main nutrients are reduced by biomass consumption. Elevated pH (due to algal photosynthetic activity) and solar radiation combine to reduce faecal bacteria numbers significantly.

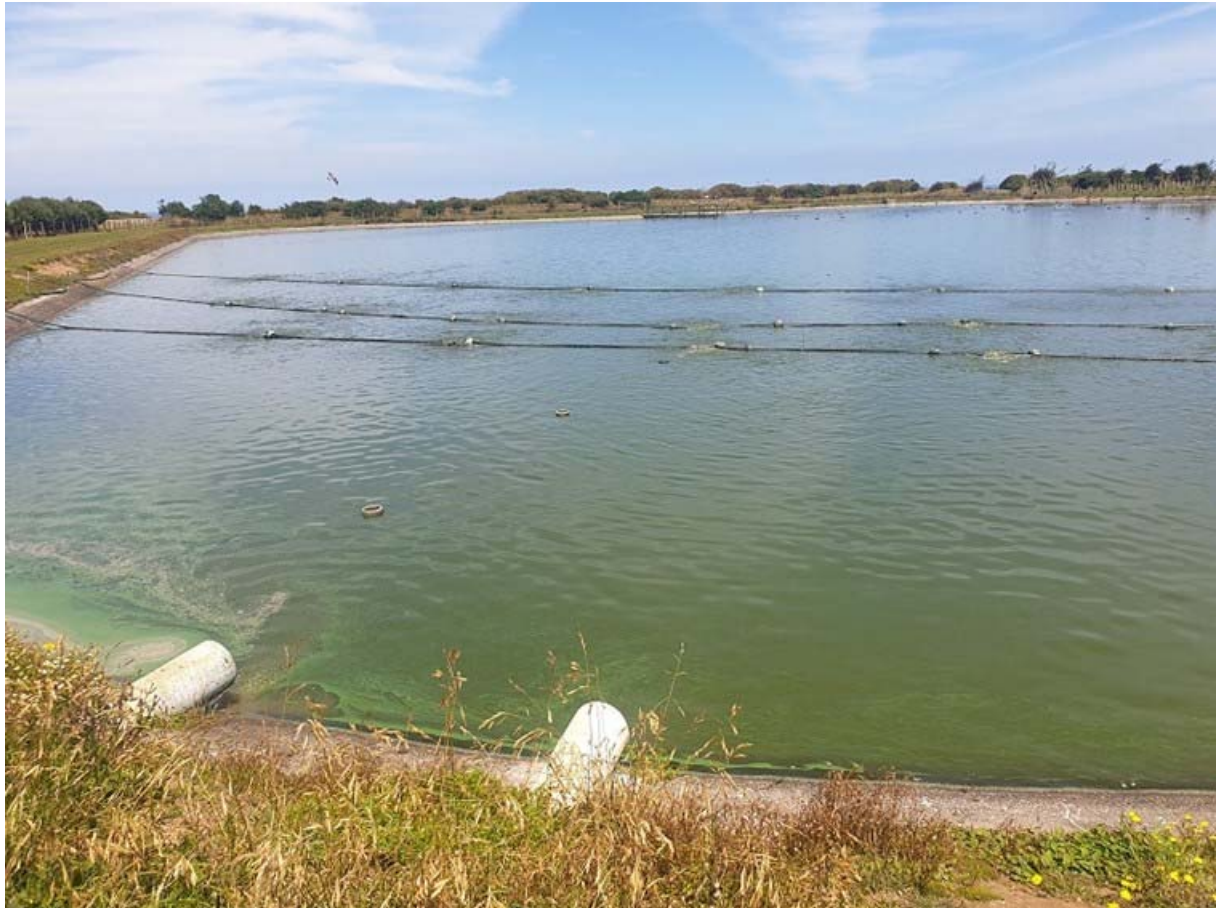
Photo 3 Manaia WWTP

The Manaia WWTP (Photo 3) is a single treatment oxidation pond (constructed in 1984), followed by twin wetlands (in parallel) receiving mainly domestic sewage together with trade wastes from the bakery industry. These trade wastes are regulated by the STDC Trade Waste Bylaw 2017.

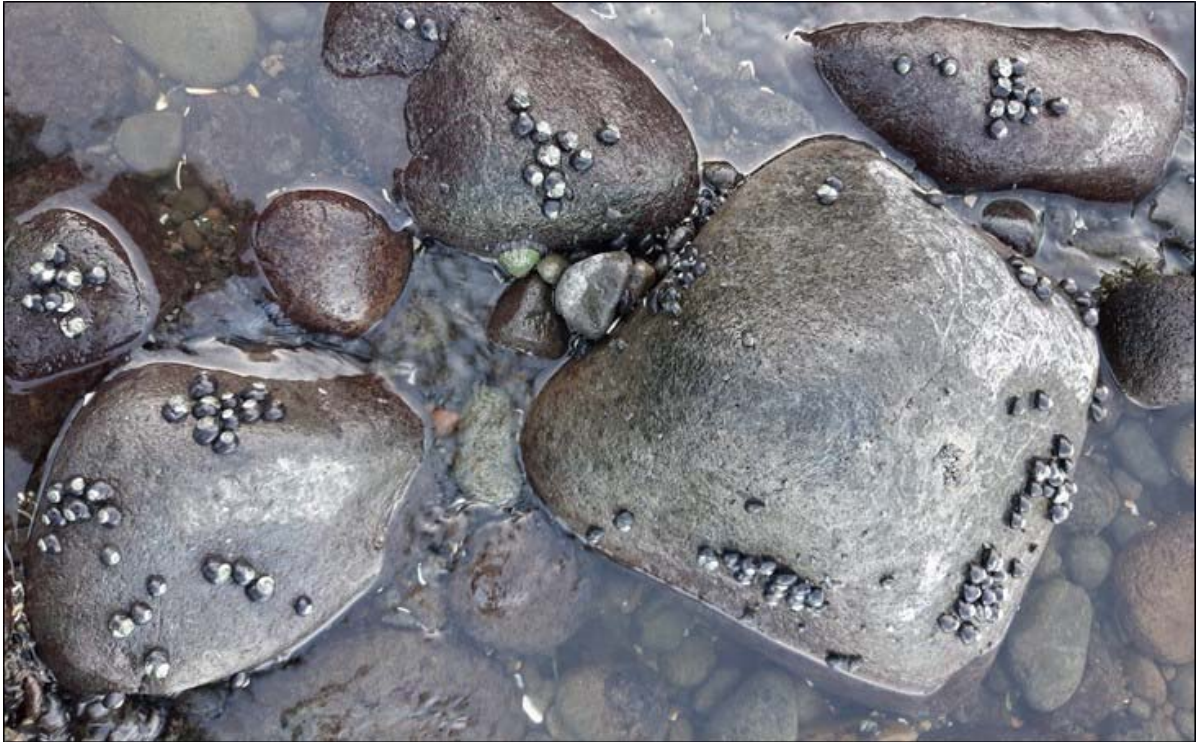
Photo 4 High intertidal zone (direct influence)

There was a moderate flow in Manaia Creek during the inspection. As it flowed onto the reef, the stream was slightly turbid green/brown in colour. This colouration was evident from the stream mouth to the low water mark, although it was less pronounced in the lower tidal zone. No foaming or surface scum was observed on the reef, and no sewage odours were detected. There were no visual effects or odours attributable to the stream beyond the immediate mixing zone at the stream mouth.

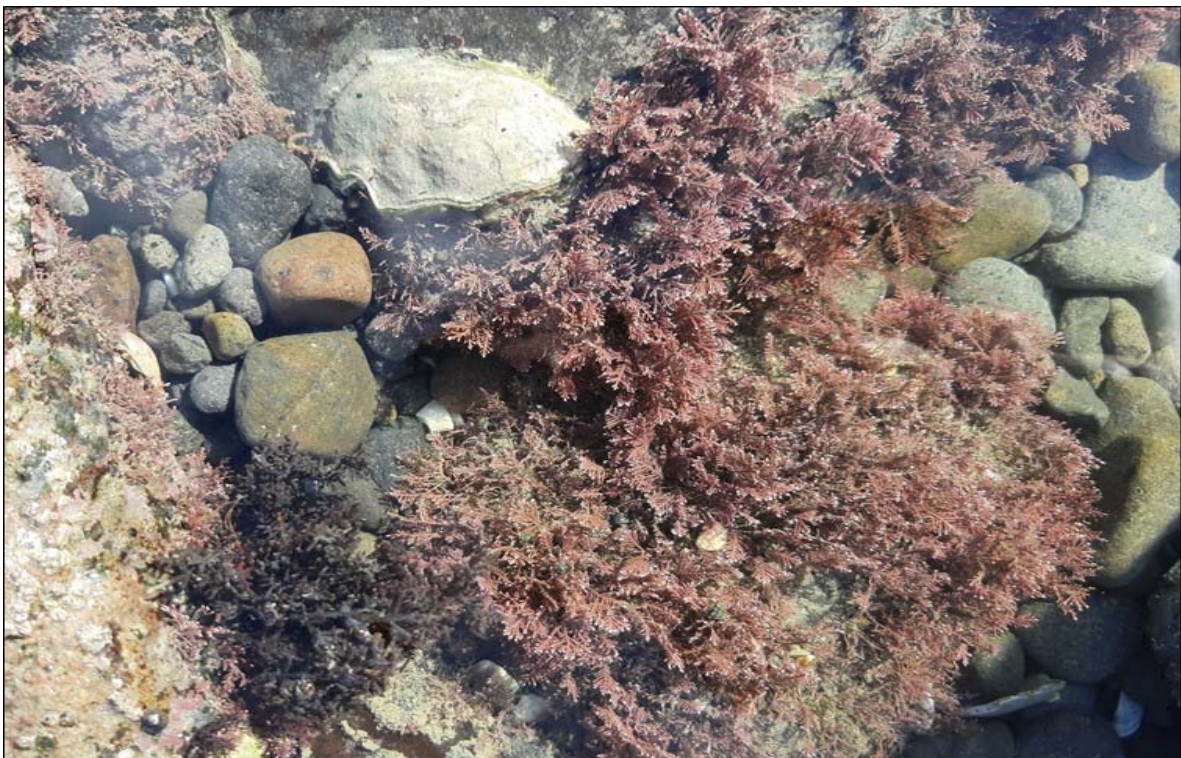
Photo 5 Low intertidal zone (approximately 50 metres west of the stream)

Manaia Creek appeared to have a localised effect on the intertidal reef ecology within its direct influence. At the high shore, the most notable effects were the discoloured pools, the microbial film and the high abundance of *Diloma* sp. Further down the shore, the limited seaweed coverage and low overall number of algae and animal species appeared to be related to the freshwater flow. This difference was less pronounced between the two high shore sites; as there is typically less species diversity in the high shore zone (Photo 4). Overall, the effects of the stream on the intertidal reef were highly localised and did not appear to extend beyond the designated mixing zone. The diversity and abundance of intertidal communities away from the influence of the stream was typical of that found at other reef sites around Taranaki (Photo 5).

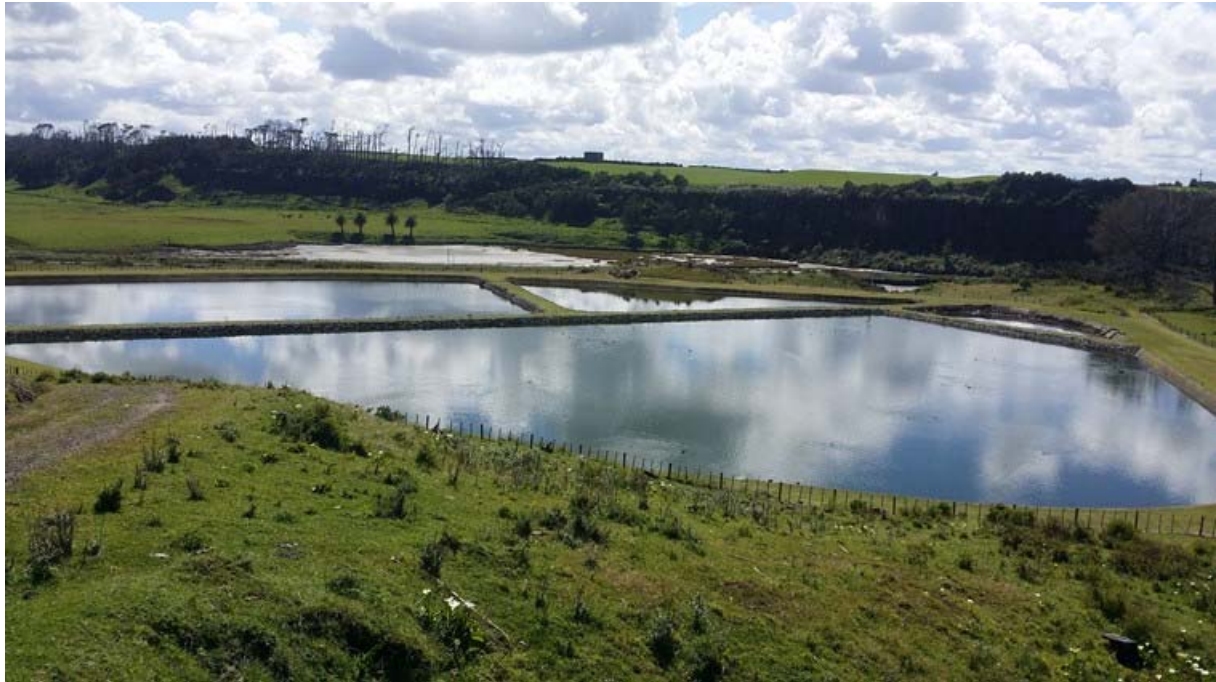
Photo 6 View of Patea WWTP

The Patea WWTP (constructed in 1973 for a population of 2,400) was originally comprised of a single large oxidation pond which was upgraded to a three cell system in 2008 (Photo 6). There are currently no significant industrial wastes being discharged into this system, which services a population of 1,191 (as measured in 2018). The nearby York Street pumping station has provision for river overflow via a separate outfall in the event of emergencies.

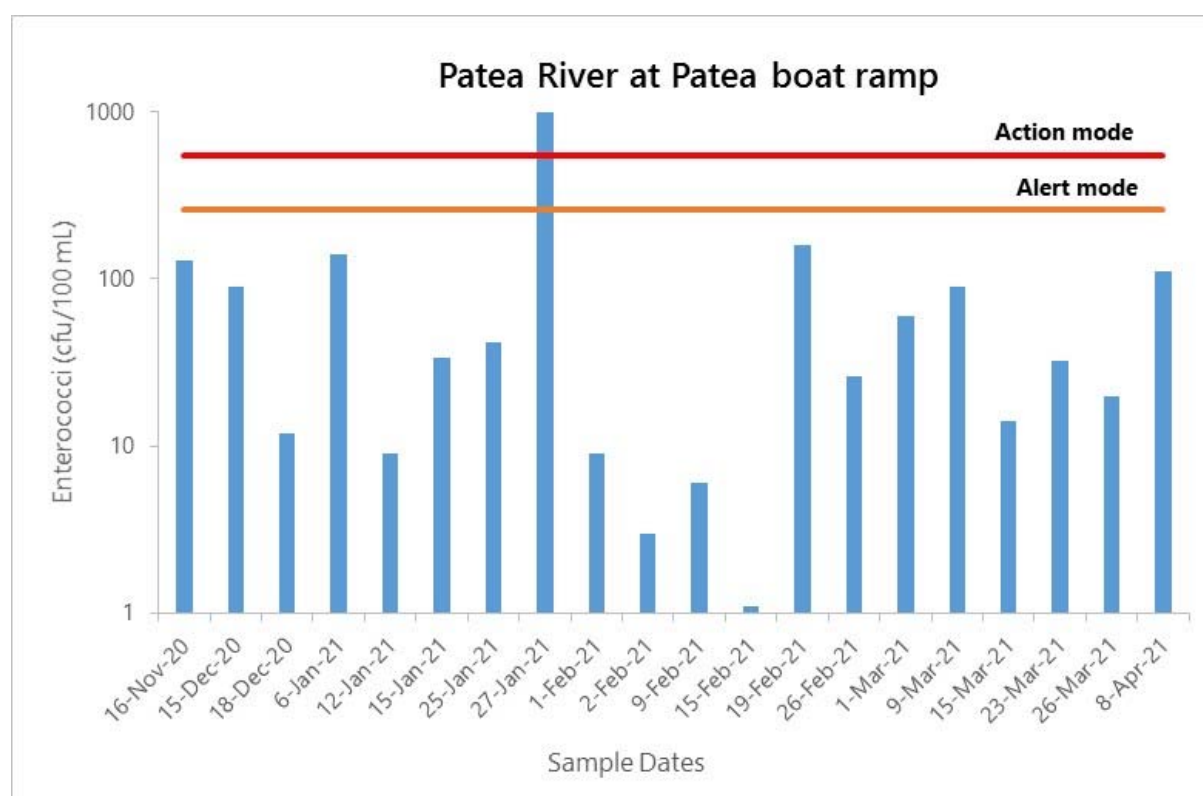
Figure 4 *E. coli* numbers for lower Patea River at the boat ramp

Bacteriological water quality was typical of the lower reaches of a large ringplain-eastern hill country catchment, with moderate numbers under river (freshwater) dominated conditions and fewer when influenced by saline penetration of the coastal seawater. The number of *E. coli* exceeded the 'Action' limit on one occasion in January 2021, this occurred during a low tide run when there was the least dilution available. This data is indicative of relatively good bacteriological water quality conditions and within the expected range for this site. Very little bathing activity was noted during the 2020-2021 period at this site, which is used mainly for boating access and occasionally for fishing and walking. The Council had undertaken microbial source tracking (MST) using DNA marker techniques over the 2011-2012 period at this site and at the upstream site at SH3 bridge on two occasions (high and low tides) (see TRC, 2012). Faecal coliform bacteria were found to have been sourced predominantly from cattle on both occasions at the two sites while gulls contributed to populations at the boat ramp site under both tidal conditions. A faint trace of human source derivation was found (downstream of the Patea WWTP treated discharge) at the boat ramp site only under low tidal flow conditions.

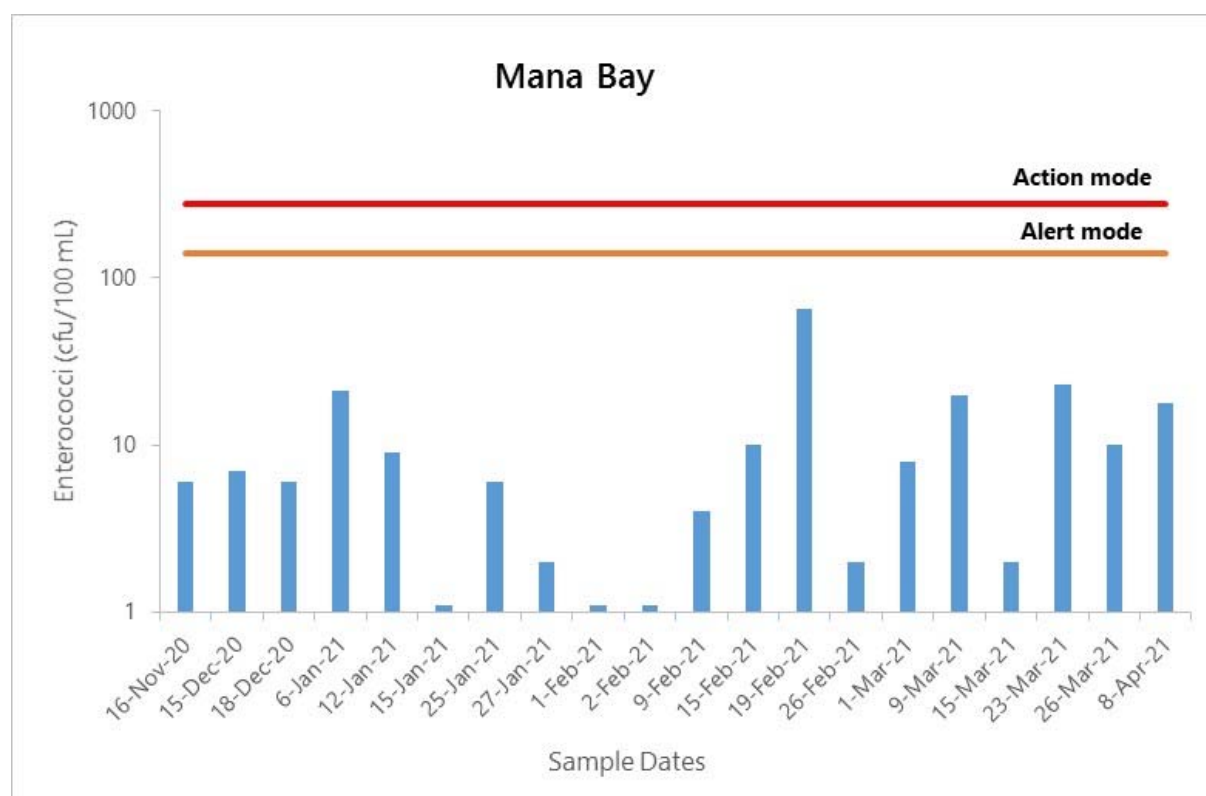
Figure 5 Enterococci numbers for Mana Bay

Water quality at Mana Bay was good throughout the season, with all samples below the 'Alert' level guideline. (Figure 5).

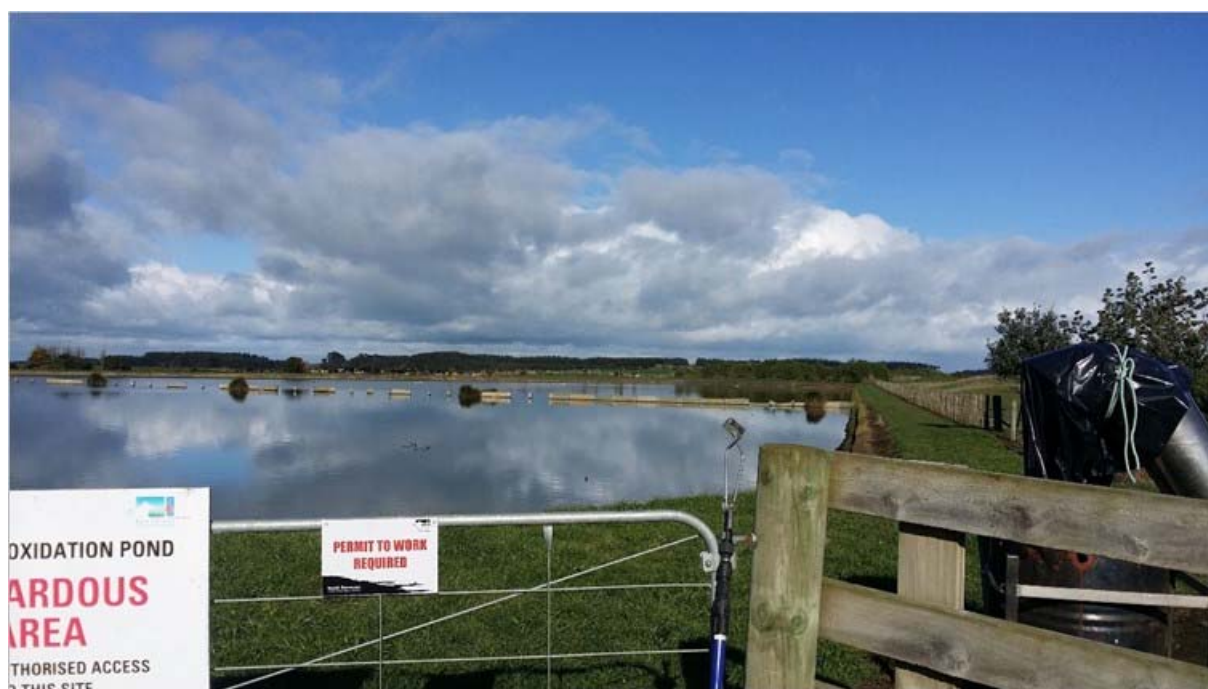
Photo 8 Waverley WWTP

It previously received wastes from the stock truck facility on SH3 sited approximately 2 km south of the township. However, the stock truck wastes disposal was changed to a self-contained anaerobic-aerobic pond system, with on-site discharge to adjacent land during the 2006-2007 period.

The WWTP system was reconfigured during the 2008-2009 period with the existing outfall abandoned, the secondary pond converted to a primary pond with a new inlet design, repairs made to the dividing wall, and the primary pond converted to a secondary pond with a repositioned outlet connected into the original outfall to the Wairoa Stream. 'Sludge-bugs' were introduced into the system for the purpose of microbial sludge digestion in September 2013 and this was completed by December 2014 with more than 5,000 cubic metres of sludge removed (STDC, 2015). Inlet flow monitoring was added in 2010. Mechanical screening of the incoming wastes was installed at the inlet during the latter half of the 2012-2013 period, which has associated telemetry alarming.
