South Taranaki District Council

Opunake WWTP

Monitoring Programme

Technical Report 2022-10

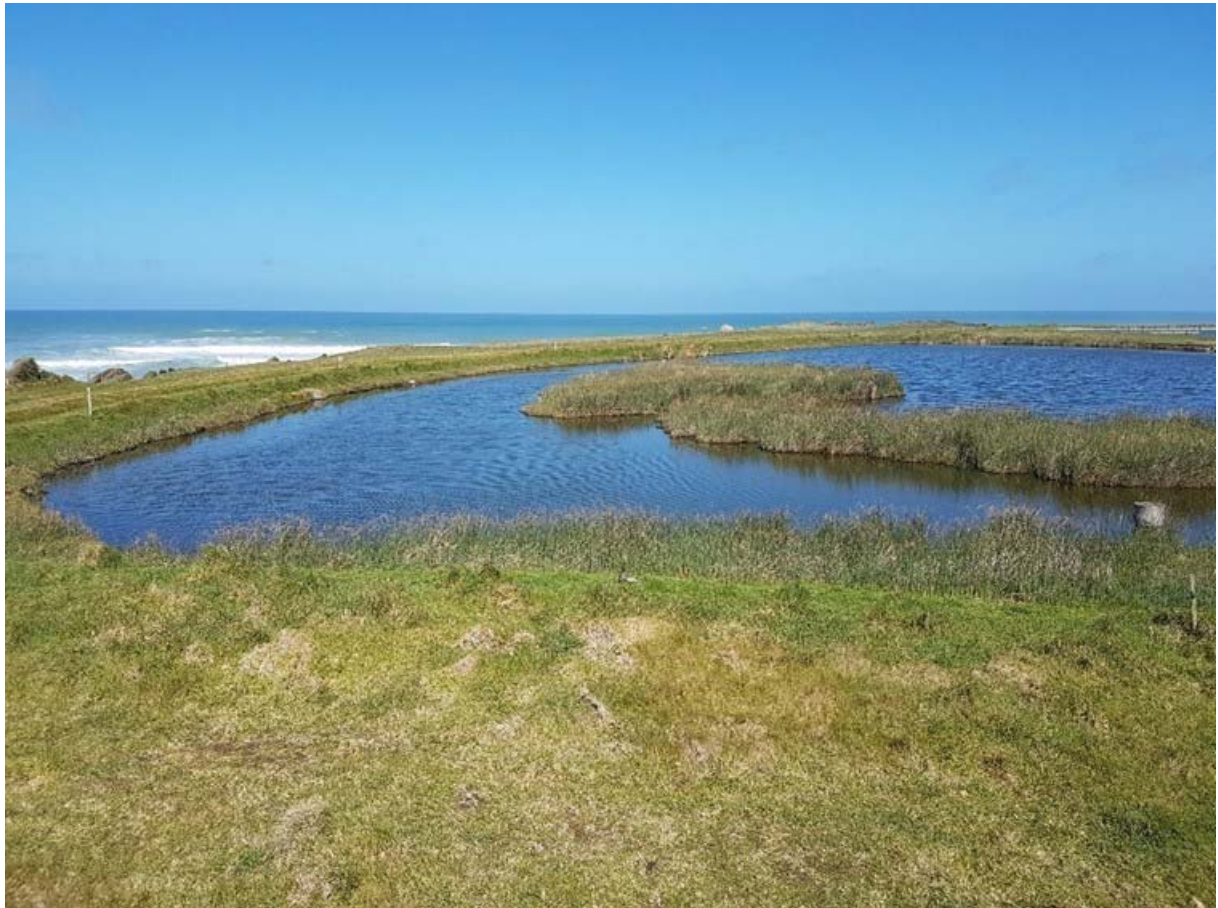
Photo 1 Opunake WWTP wetlands

Both wetland pond levels were normal. These were green/brown in colour and slightly turbid. The wetland sump pump was operating at the time of inspection. No surface water or ponding were noted in the vicinity of the overland soakage trench system.

Both wetland ponds were dark green and turbid. The overland soakage trench system was inspected with no issues noted. Surface water from recent rain was discharging via the open trenches towards the coast. A noticeable plume caused by the creek discharge was apparent at the coastal monitoring site south east of the unnamed stream.

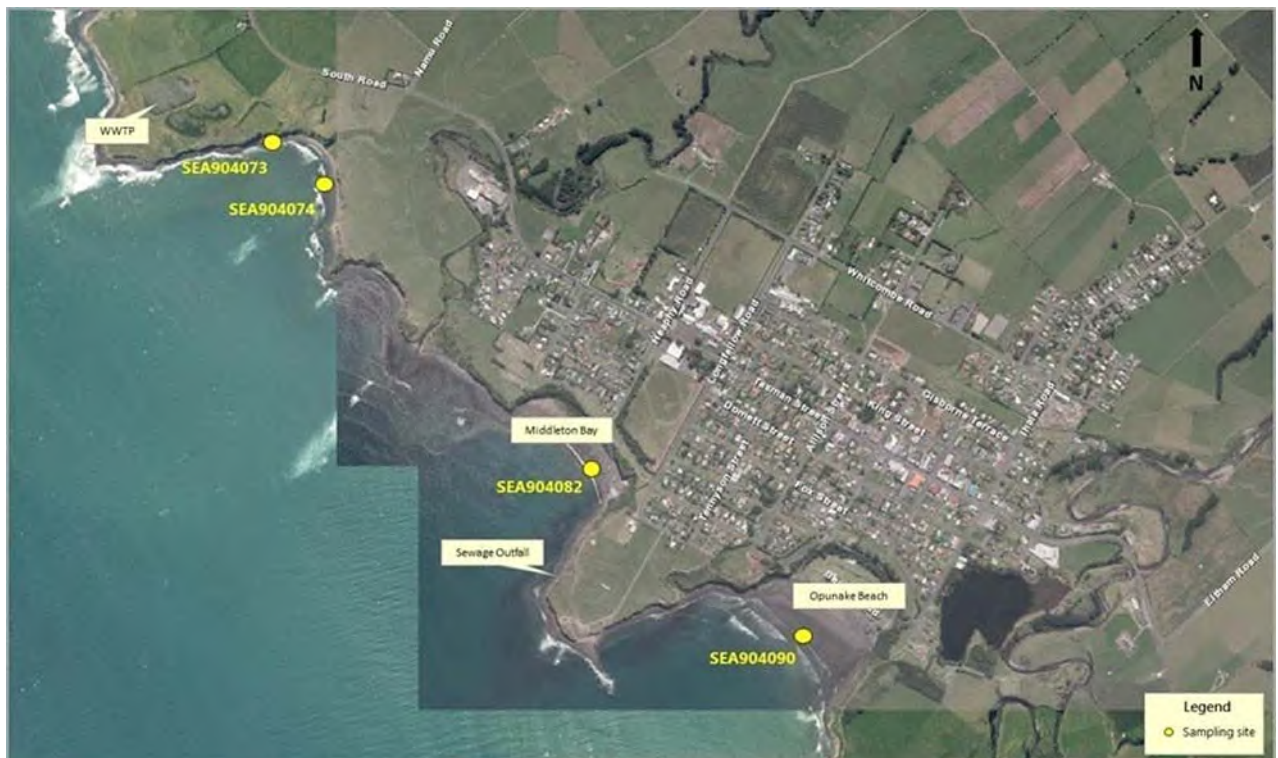
Figure 3 Location of receiving water sampling sites for Opunake WWTP

Monitoring of the impacts of the Opunake WWTP on receiving waters is measured using both water quality surveys of the receiving waters of the Tasman Sea beyond the boundary of the mixing zone with the unnamed coastal stream; and contact recreational bacteriological quality surveys of the Tasman Sea at Middleton Bay and Opunake Beach (Figure 3).

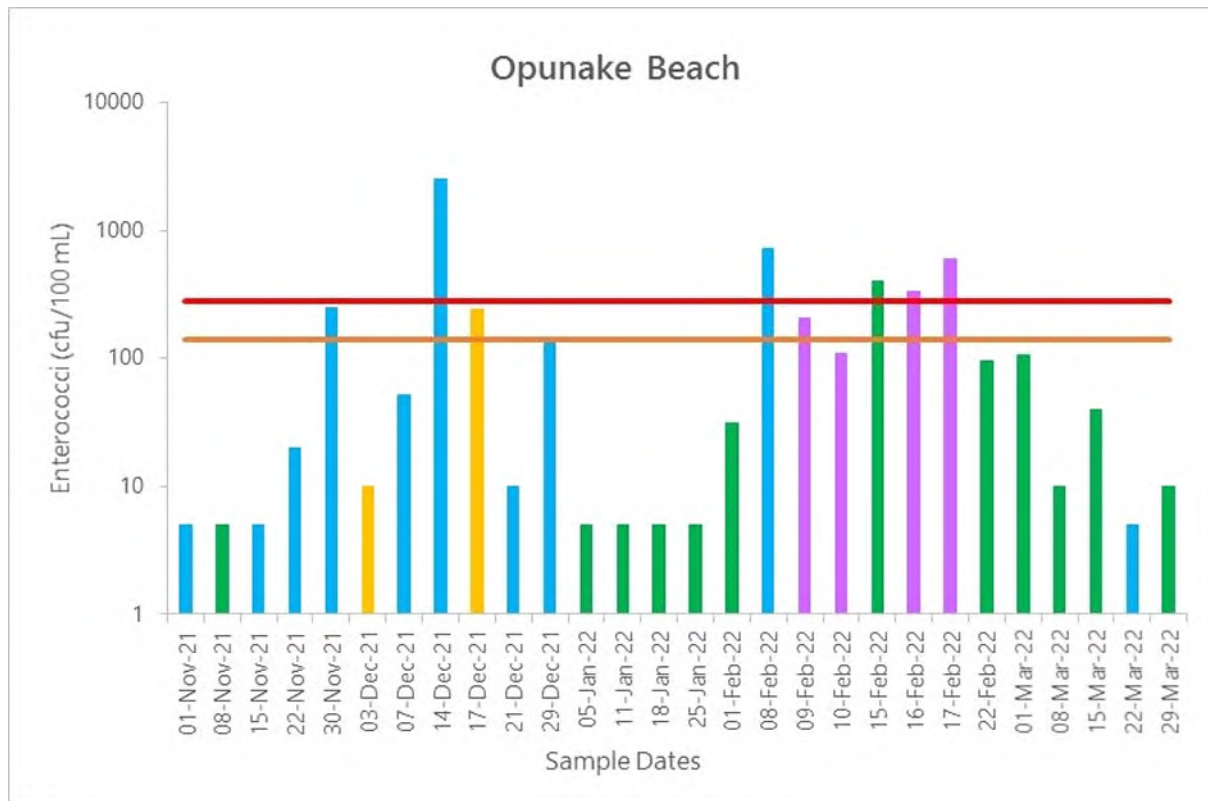
Figure 4 Enterococci results for Opunake Beach summer 2021-2022

Green = SEM samples, blue = MfE samples, orange = follow up samples, purple = extra overflow samples
 Results of <10 are displayed on the graph as 5

The coastal bacteriological water quality at Opunake Beach was variable throughout the monitoring period. The median enterococci of the combined SEM, MfE and follow-up samples was 15 cfu/100 ml, similar to the median of 10 in just the SEM samples. Extra samples collected after overflow events contained high numbers of enterococci with a maximum of 594 cfu/100 ml and a median of 269 cfu/100 ml (four samples). Signage was in place during this time to alert recreational users to the higher health risk.

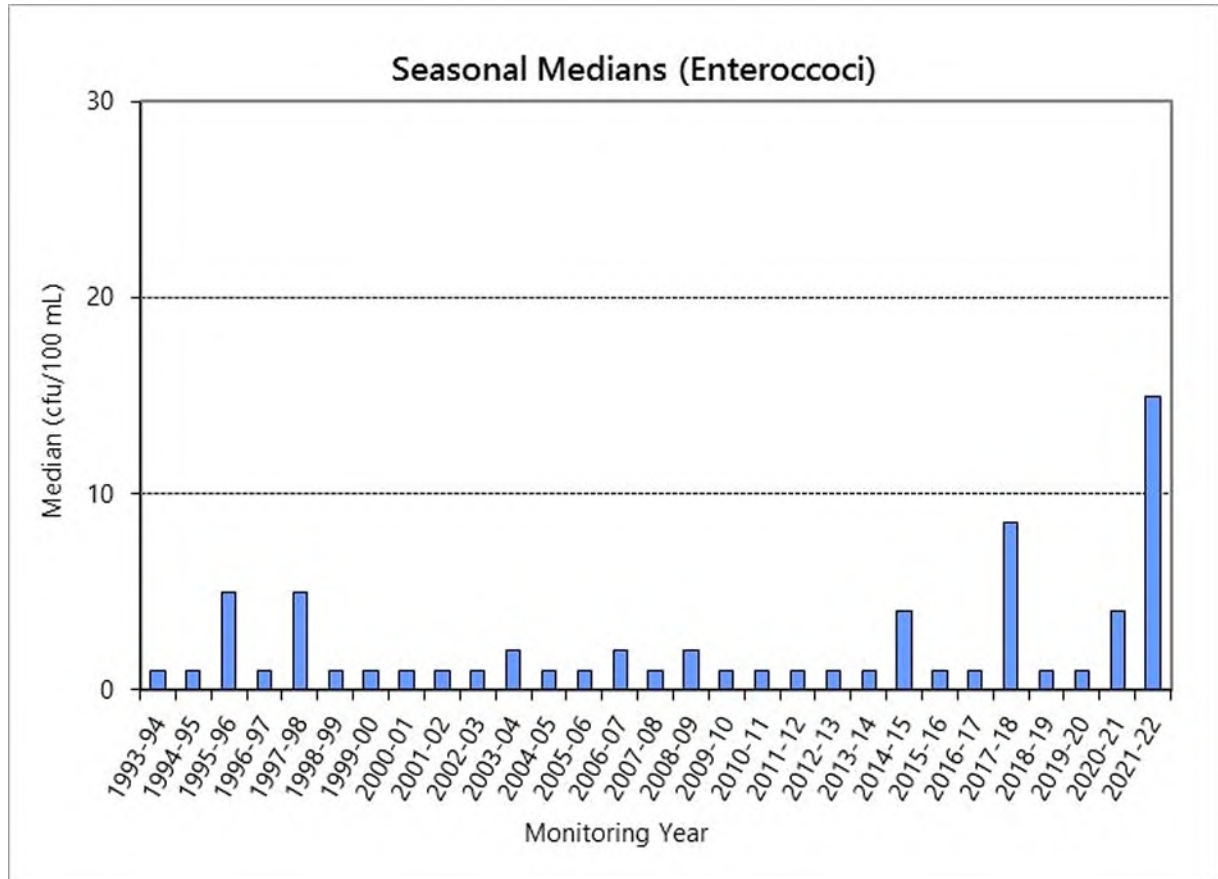
Figure 5 Median bacteriological results at Opunake Beach since summer 1993-1994

Figure 5 shows that, in terms of median numbers of enterococci, the contact recreational water quality at this site is generally very good. The median was higher than usual and the highest found to date during the 2021-2022 monitoring period but was still quite low.

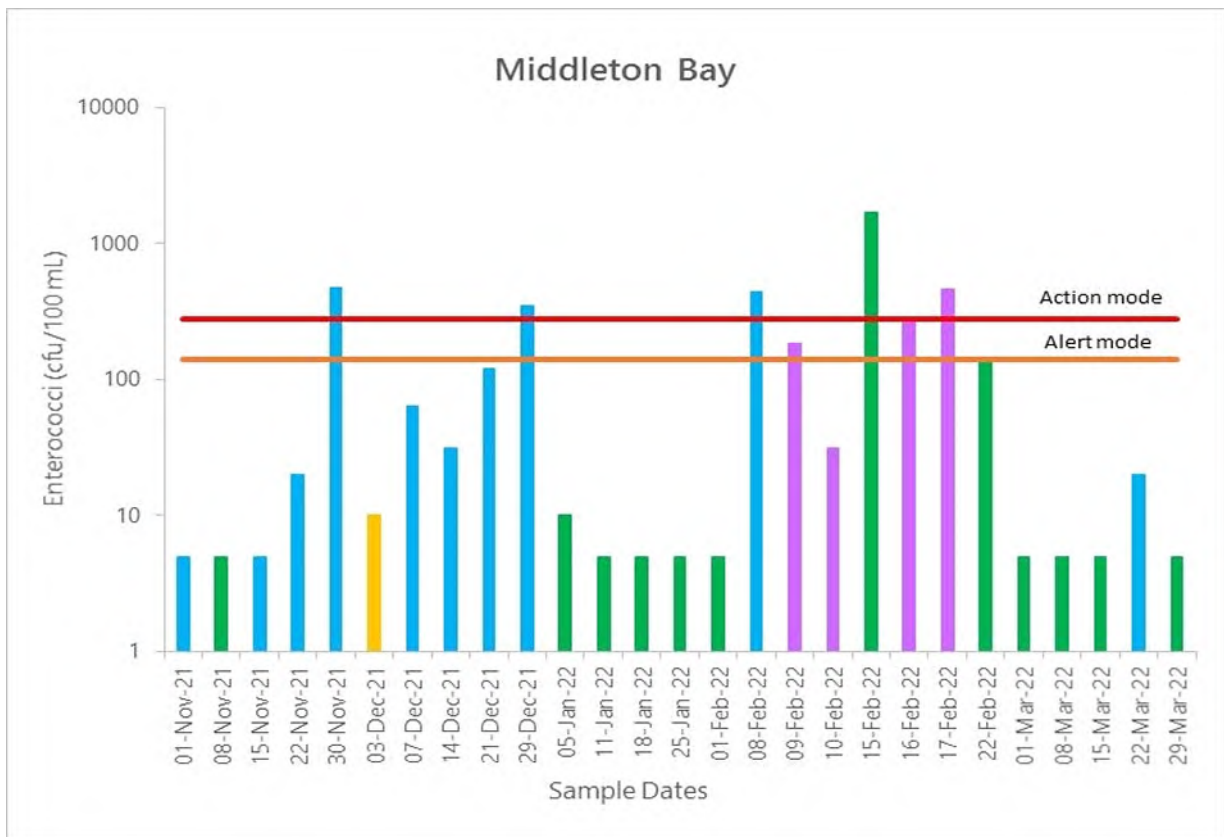
Figure 6 Bacteriological (enterococci) results from Middleton Bay during summer 2021-2022

The generally high water quality was emphasised by the seasonal median count of 10 enterococci (cfu/100 ml) for the 23 regular samples collected during the survey period. However, numbers of enterococci were very high on occasion (maximum of 1,674 cfu/110 ml). 'Action' mode was exceeded on two occasions early in the season. The six samples that exceeded 'Alert' and/or 'Action' mode between 8 and 22 February 2022 were collected during Cyclone Dovi and while the untreated sewage was being discharged out the Hector Place outfall.

Green = SEM samples, blue = MfE samples, orange = follow up sample, purple = extra overflow samples
 Results of <10 are displayed on the graph as 5
