Stratford District Council
Stratford WWTP
Monitoring Programme
Annual Report
2017-2018

Technical Report 2018-34

Taranaki Regional Council
Private Bag 713
STRATFORD
November 2018

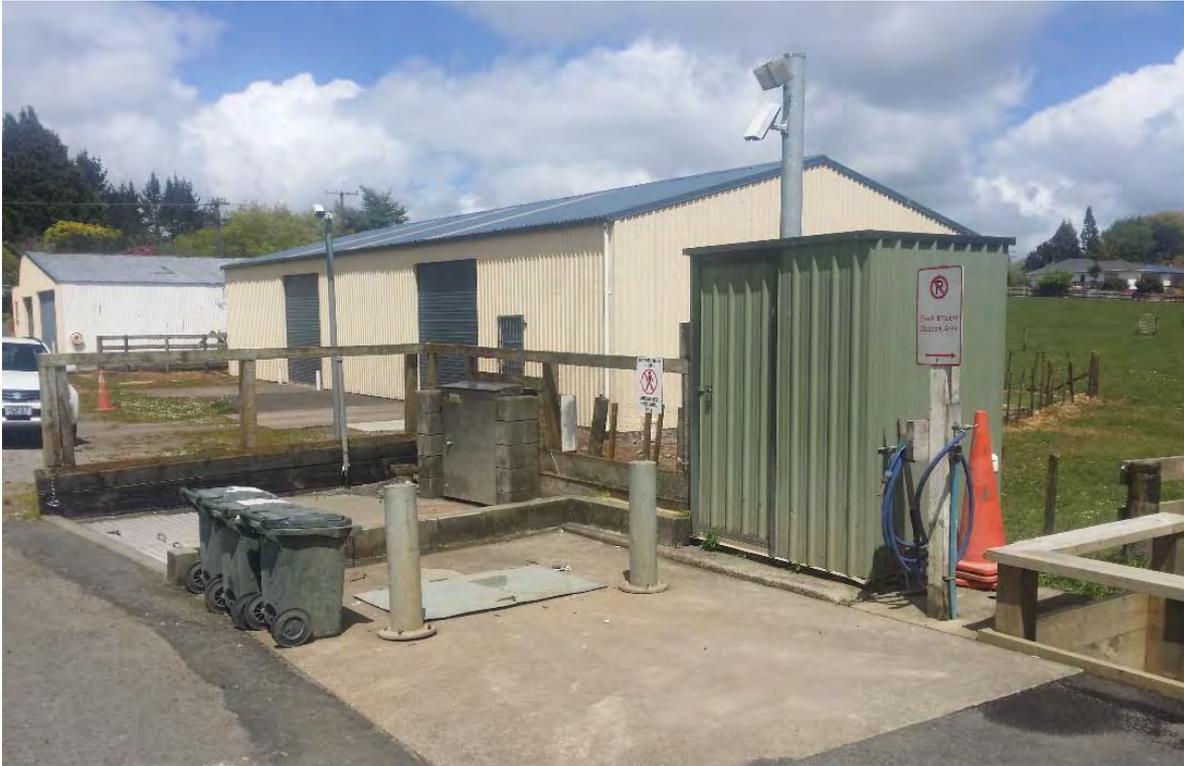
Photo 2 Esk Road wastes facility

The Esk Road septic wastes unloading facility was also inspected. The area was found to be tidy with no odour issues noted (Photo 2).

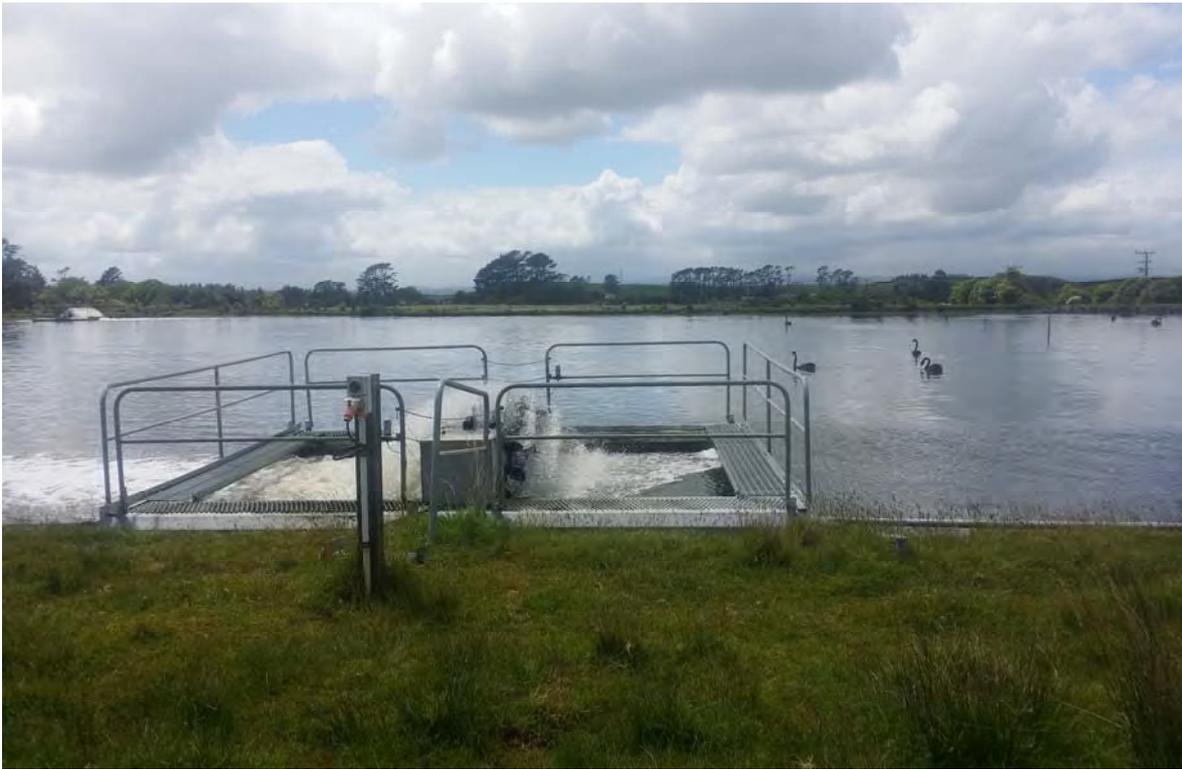
Photo 3 View of Stratford WWTP primary pond with aerators operating

Results in Table 2 indicate a relatively wide range of DO concentrations (between 9.2 % and 84 % saturation) in the surface layer of the tertiary maturation cell near the outlet. This was typical of the results generally recorded at this point (i.e. supersaturation is seldom recorded), and indicates that DO was present at all times in the surface layer of the cell. The lowest DO readings were recorded in the late spring period, which was attributed to unusually dry weather and low pond flow and circulation. The variation in saturation levels measured to date has been typical of a biological treatment system in which the photosynthetic contribution of the microfloral population often causes wide dissolved oxygen variations. Mechanical aeration of the primary pond by all four aerators (Photo 3) was operative on all inspection occasions.

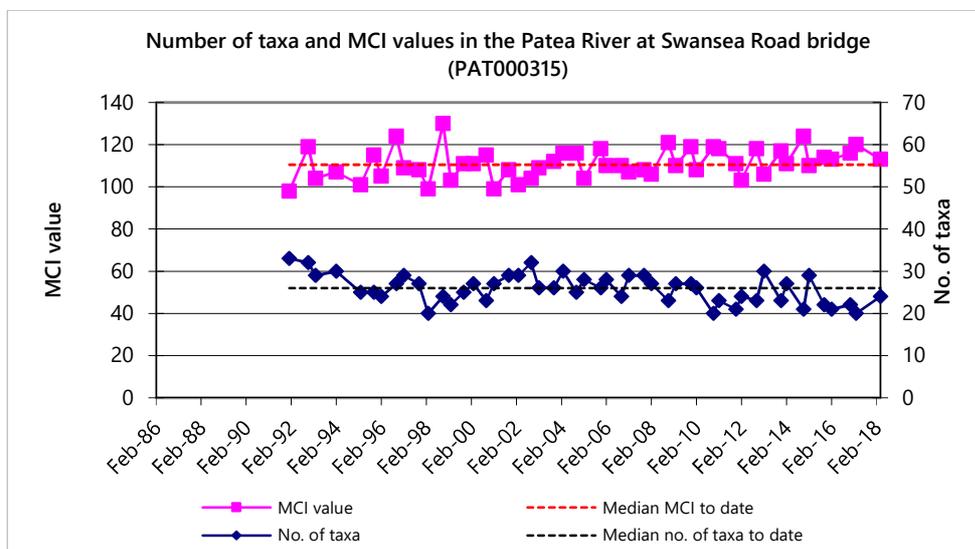
Figure 2 Taxa richness and MCI scores recorded to date at site 1

The SQMCI_s score of 7.1 units was significantly higher than the median SQMCI_s score of 6.1 units (Table 4) and the same as the preceding survey (7.1 units).

The community was dominated by one 'tolerant' taxon [caddisfly (*Hydropsyche/Aoteapsyche*)], three moderately sensitive taxa [mayfly (*Coloburiscus*), dobsonfly (*Archichauliodes*) and crane fly (*Aphrophila*)] and one 'highly sensitive' taxon [mayflies (*Deleatidium*)] (Table 5).

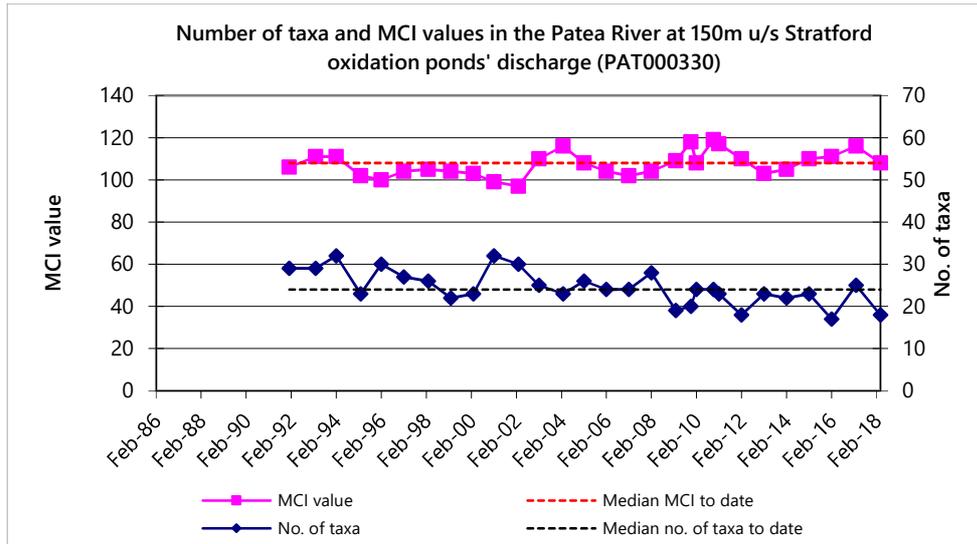
Figure 3 Taxa richness and MCI scores recorded to date at site 2

The SQMCI_s score of 6.6 units was not significantly different to the median SQMCI_s score of 6.0 units (Table 4) and the preceding survey (7.1 units).

The community was dominated by one 'tolerant' taxon [oligochaete worms], one 'moderately sensitive' taxon [mayfly (*Coloburiscus*)], and one 'highly sensitive' taxon [mayfly (*Deleatidium*)] (Table 5).

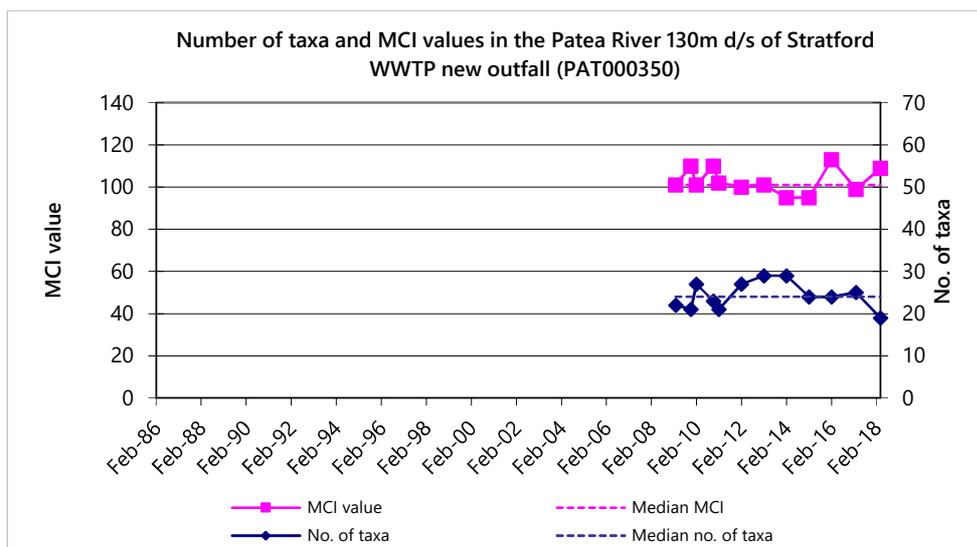
Figure 4 Taxa richness and MCI scores recorded to date at site 3a

The SQMCI_s score of 3.7 units was significantly lower than the median SQMCI_s score of 5.9 units (Table 4) and to the preceding survey (5.0 units).

The community was dominated by two 'tolerant' taxa [midges (*Chironomus* and *Orthocladiinae*)], two 'moderately sensitive' taxa [mayfly (*Coloburiscus* and water fleas (*Cladocera*)] and one 'highly sensitive' taxon [mayfly (*Deleatidium*)] (Table 5).

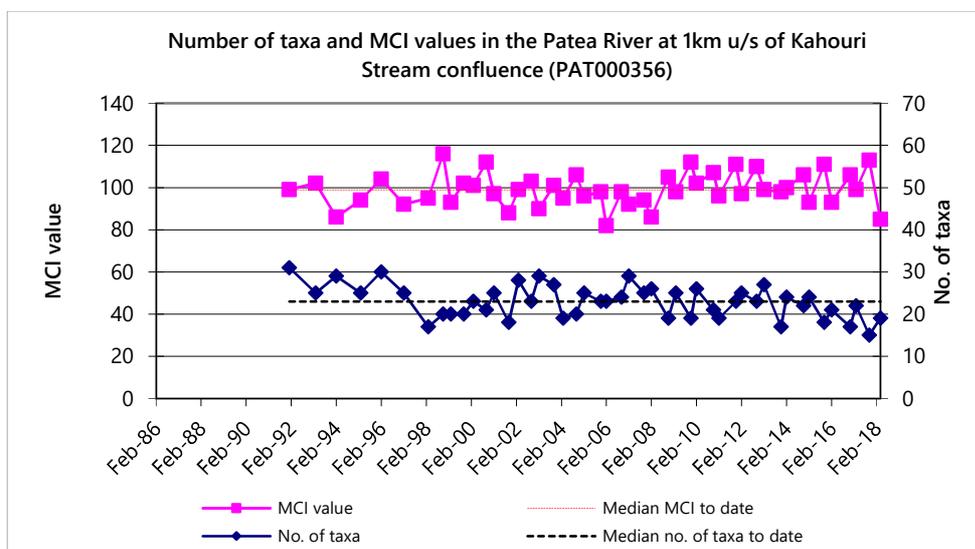
Figure 5 Taxa richness and MCI scores recorded to date at site 4

The SQMCI_s score of 3.8 units was not significantly different to the median SQMCI_s score of 4.1 units (Table 4) but was significantly lower than the preceding survey (6.5 units).

The community was dominated by five 'tolerant' taxa [oligochaete worms, caddisfly (*Hydropsyche/Aoteapsyche*), and midges (*Chironomus*, *Maoridiamesa* and *Orthocladiinae*)], one 'highly sensitive' taxon [mayfly (*Deleatidium*)] (Table 5).
