## **Consents and Regulatory Committee**

Tuesday 24 April 2018

Taranaki Regional Council, Stratford

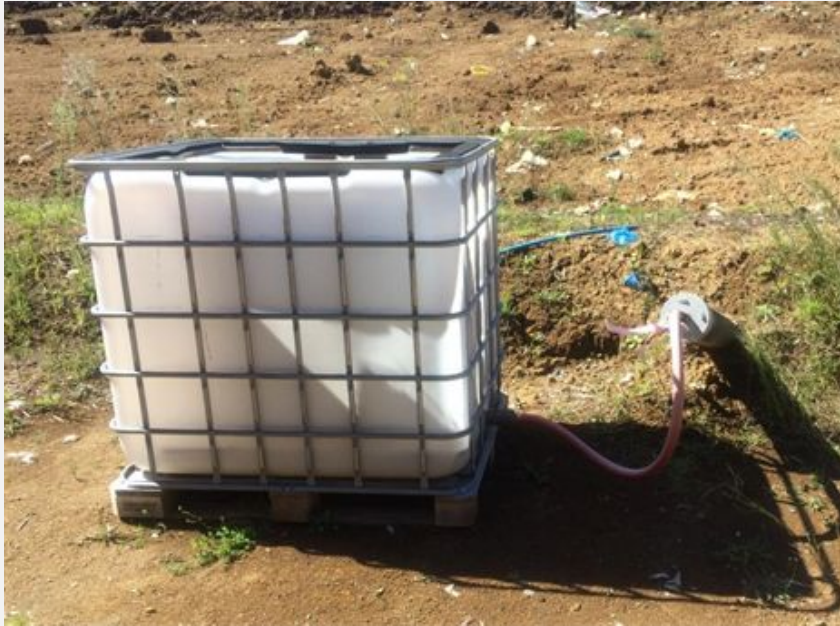
**Photo 1 Trial biofilter installed on one of the protruding leachate lines**

- Intermediate cover was applied to all but a relatively small area that was to be completed as and when weather permitted.
- Clay was used to try to prevent fugitive emissions around leachate line protrusions.

These mitigation measures were somewhat successful and during 2015-2016 eight odour complaints were received, a large decrease from the previous period. NPDC proposed to implement stage 3 of the recommendations and install a landfill gas collection and management system as a more permanent and effective solution to minimise landfill gas emissions and to prevent odours becoming offensive or objectionable beyond the site boundary.

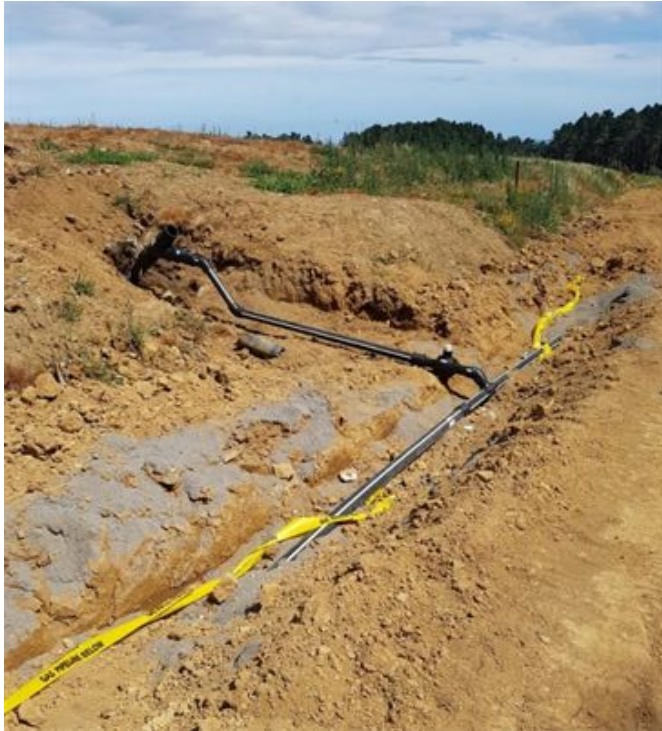
**Photo 2 Leachate pipes feeding into the gas collection system**

A fully enclosed flare was selected as the best option for gas collection and the first phase of the pipework involved utilising the existing leachate pipes and connecting these via a pipeline around the perimeter of the landfill to the flare (Photo 2). The design and build of the fully enclosed flare (Photo 3) was completed as per the original programme within six months of the contract award, however the civil works phase experienced significant delays due to an unseasonably wet weather in the 2016-2017 period and was not completed until the summer of 2017-2018.

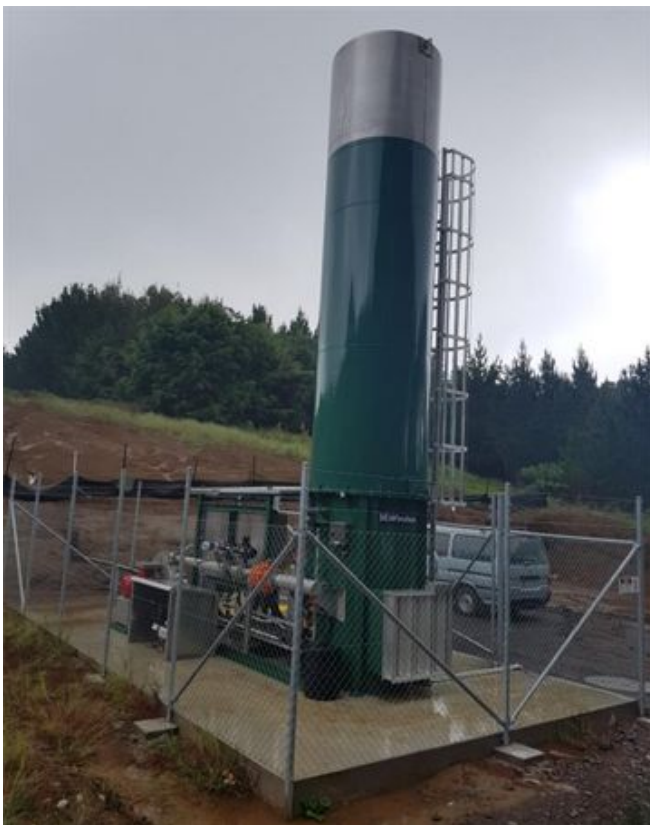
**Photo 3 The fully enclosed flare**

Commissioning of the landfill gas management system occurred during January to March 2018, with operational and monitoring procedures developed to ensure the gas system is managed as expected. NPDC operations staff have been provided with training in order to carry out operation of the system in a safe and effective manner, while ongoing support and maintenance will be provided by consultants.

Based on data collected since the operation of the flare has commenced it has been confirmed that the flare is operating within its design limits.

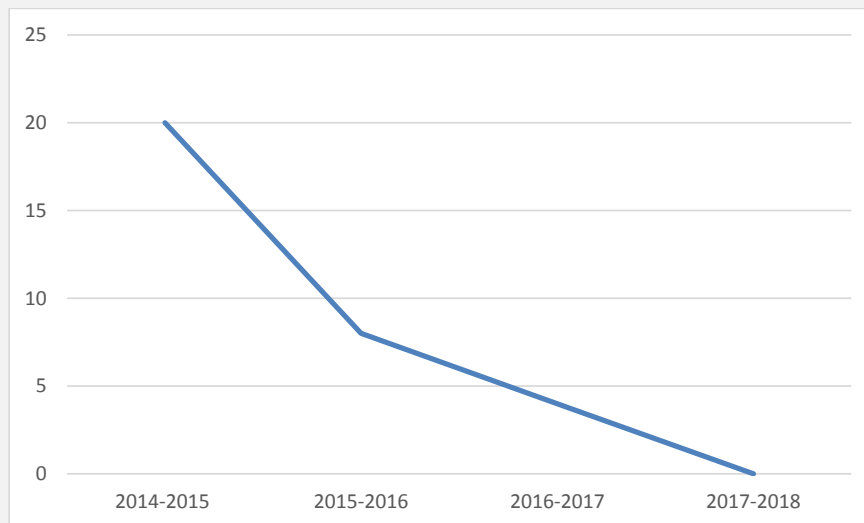
**Figure 1 Number of odour complaints received by the Council in relation to the Colson Road Landfill (2014-2018)**

There has been a noticeable reduction in odour around the landfill perimeter since operation of the flare began and this, along with the other mitigation measures NPDC has implemented, has resulted in no odour complaints being received in relation to the site since June 2017. Work is continuing to ensure the gas capture system is “tuned” to extract from the right locations at the right rates, to minimise fugitive emissions while optimising combustion conditions, and this will be checked by a cap landfill gas emission survey after this has been done.

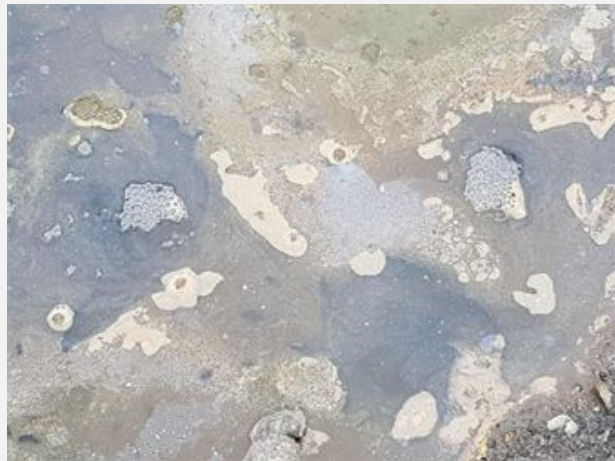
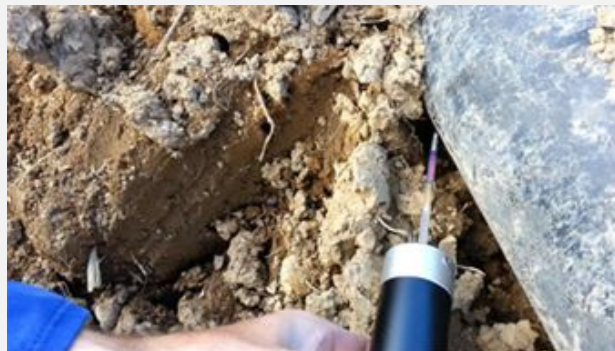
Operational changes to reduce emissions:  
Special waste pit filled in

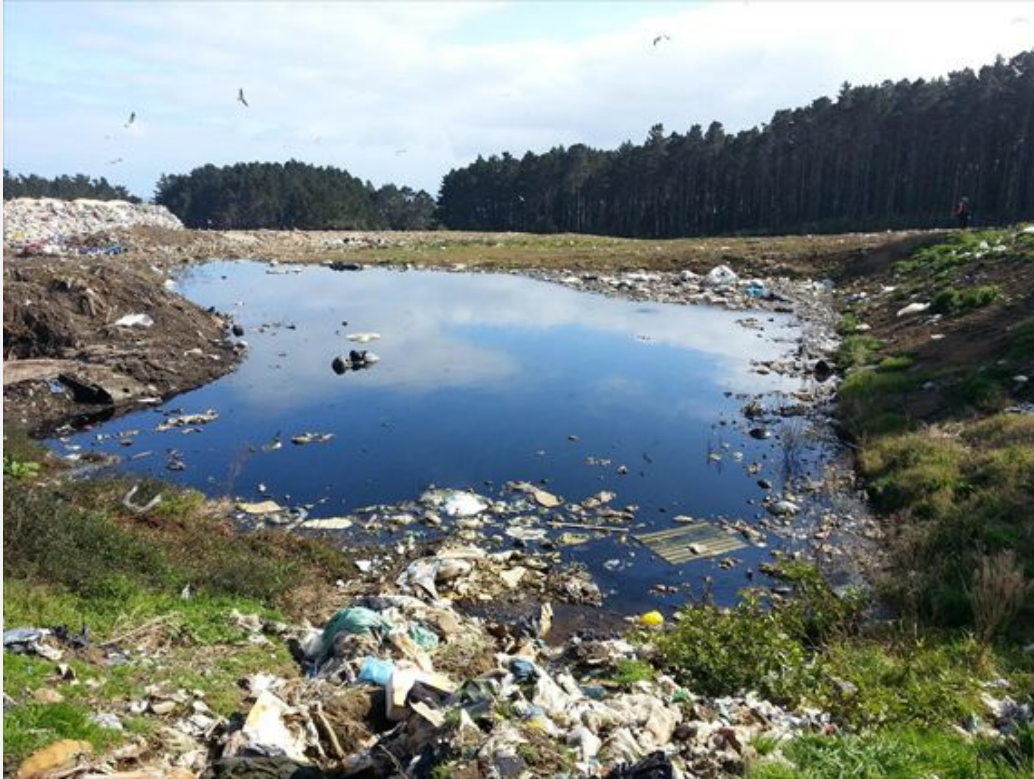
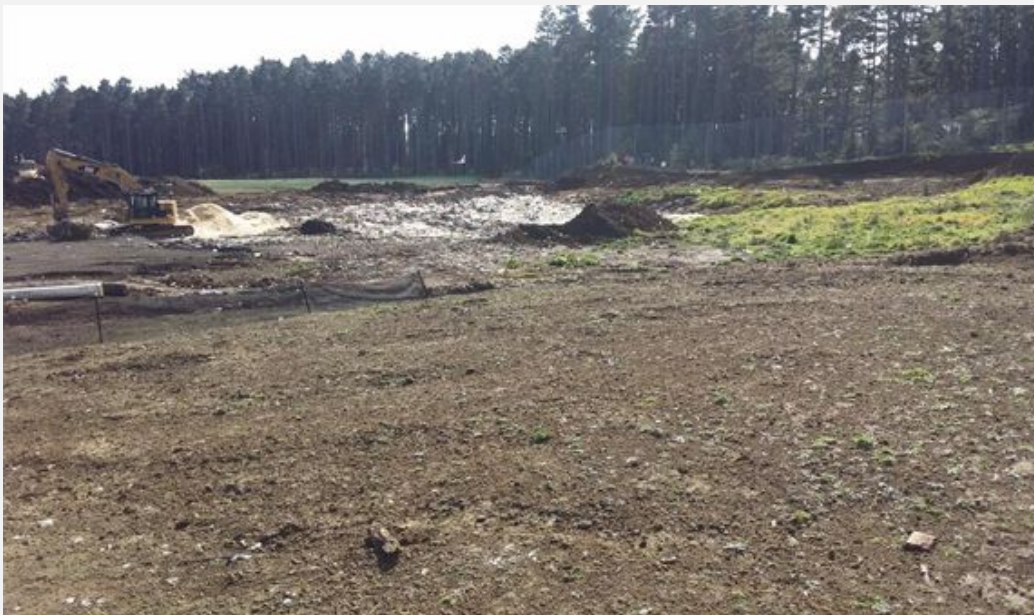
New style special waste pits – small, with cover applied soon after waste received
