AGENDA

Consents & Regulatory

Tuesday 20 July 2021, 9.30am

Technical Report 2020-84

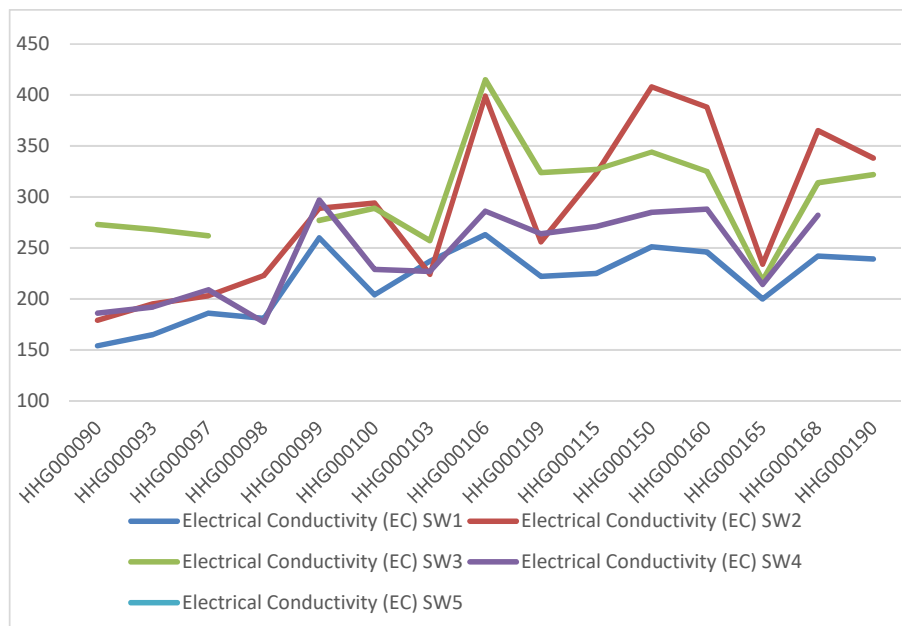
Figure 6 Conductivity uS/cm by site Haehanga Stream 2019-2020

In terms of the Haehanga Stream and the 2019-2020 monitoring, there were incremental increases in chloride and ammonia down through the length of the Haehanga Stream. It is further noted that these increases were within consent conditions. Figure 6 demonstrates the increase in conductivity within the surface water as a result of the consent holders operations. Similar increases in chloride were also recorded (Figure 7).

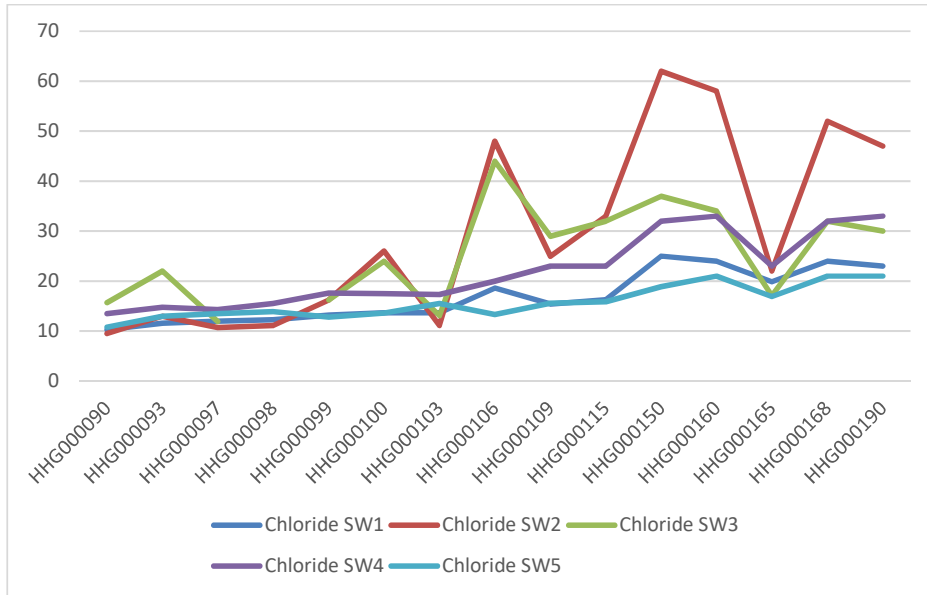
Figure 7 Chloride g/m³ by site Haehanga Stream 2019-2020

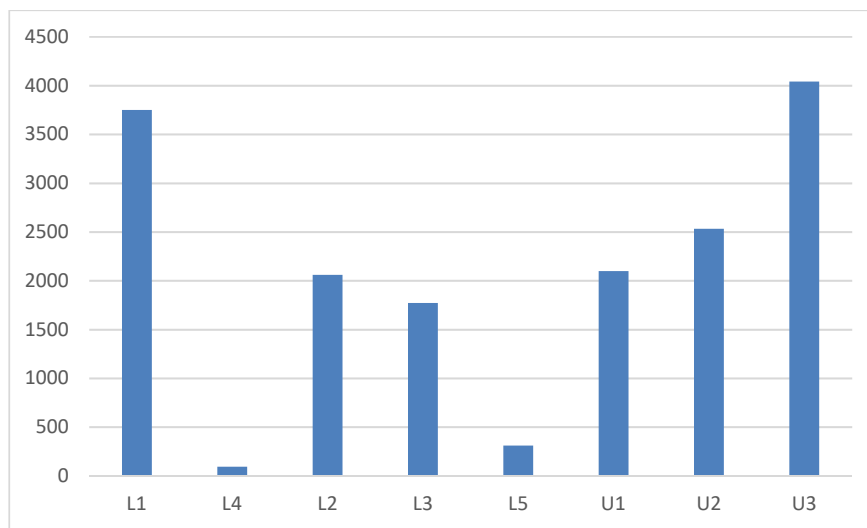
In terms of chloride loading applications (Figure 12), six irrigation areas (L1 – L3 and U1 – U3) received in excess of 1,500 kg of chloride per Ha. In the case of L1 (3,700 kg Cl/ha) and U3 (4,000 kg Cl/ha), the applications were high.

Figure 12 Estimated chloride applications in kg per ha by area 2019-2020

Drilling mud and produced water is the main source of the elevated chloride within the irrigation fluid. The consent holder will cease the acceptance of any drilling waste related material on the 31 December 2020. This is proposed to reduce the chloride loading in the long term.

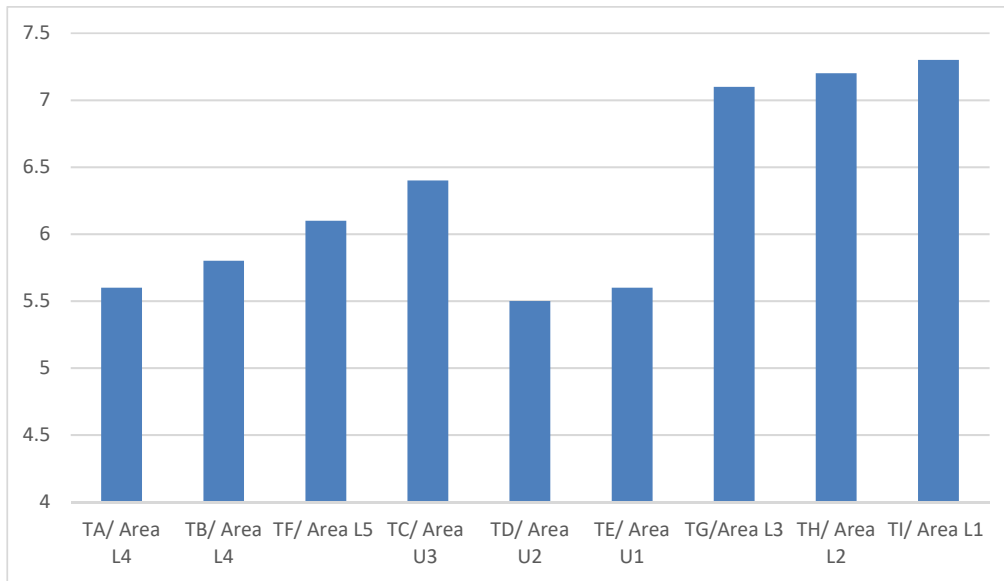
- Soil pH results ranged 5.5-7.3 pH. The majority of the soil pH results were slightly acidic however, the irrigation areas (L1-L3) to the north of the duckpond all held pH results above 7 pH, Figure 14.

Figure 14 Soil pH results by irrigation area

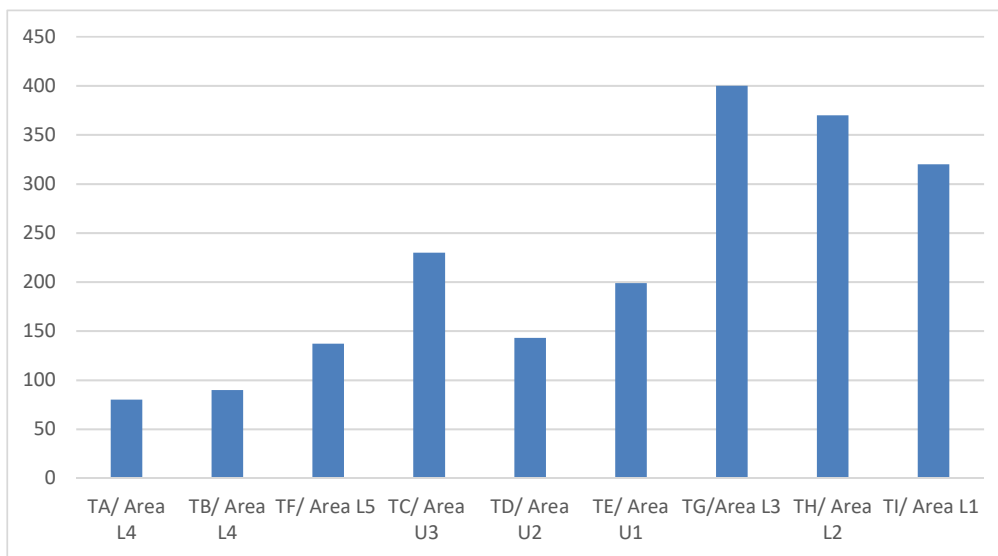
- Soil sodium results were found to be elevated within the high application rate (U1-U3 inclusive) and long-term irrigation areas (L1-L3 inclusive), Figure 15.

Figure 15 Soil sodium results by irrigation area

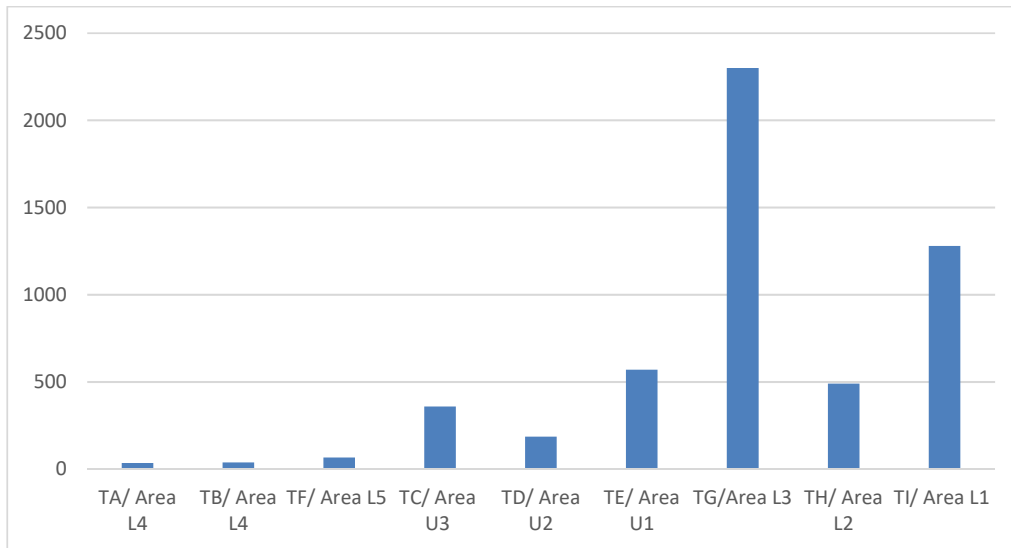
- Sodium absorption ratio (SAR) results were of low concentration, the most elevated result of the data set was at area U2 with a value of 3.5 SAR.
- Total recoverable barium results demonstrate the result of irrigating drilling mud constituents to land (Figure 16). In this monitoring period the elevated result was recorded at area L3, with a concentration of 2,300 mg/kg. Please note that area L3 is one of the long term irrigation areas.

Figure 16 Soil barium results by irrigation area

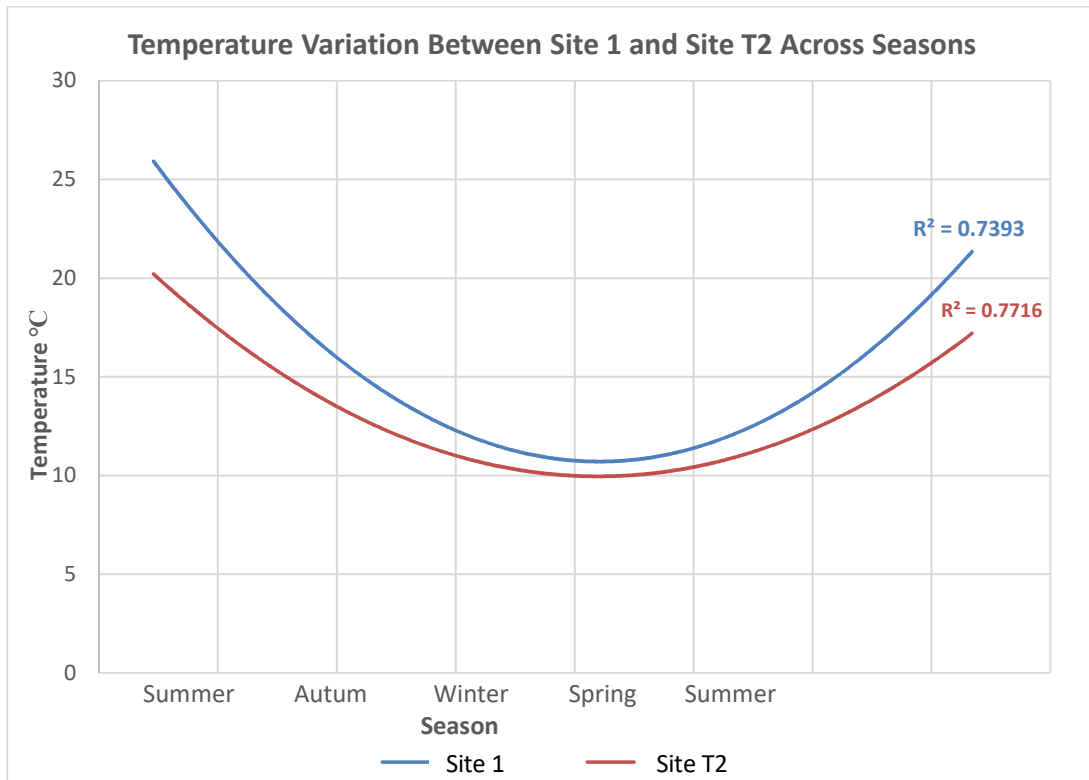
All sites in the main stem Haehanga lack bed shading during most of the day. This causes water temperature to rise up to 28°C in the summer, which is outside the thermal preference and, in some cases, tolerance of many stream dwelling species. Unshaded streambeds also promote algal and periphyton growths which were reported as abundant in the previous survey. Site T2 in the unnamed tributary historically has the highest macroinvertebrate health scores and has a mostly shaded bed with much lower temperatures in the Spring, Summer, and Autumn months compared to site 1 (Figure 19). The increased temperature and increased algal growth reported in previous reports is likely contributing to the negative trend in the macroinvertebrate community over the past few surveys.

Figure 20 Seasonal temperature comparison between site 1 and site T2 (2010-2019)
